Inspection Report

Property Address:
330 & 332 SE Somewhere
Lee's Summit MO 64063

Holmes Inspection Company

Date: 7/30/2013	Time: 09:36 AM	Report ID: 42785 - 346
Property: 330 & 332 SE Somewhere Lee's Summit MO 64063	Customer: Nancy Buyer

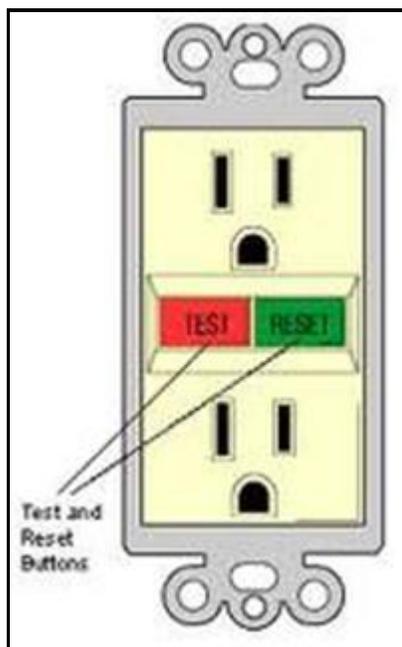
1.2.A Picture 1 GFCI

No electrical outlet seen. There should be one in each bath and they should be GFCI protected.

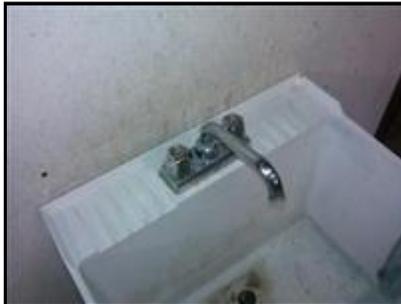
2.1.A Picture 1

- (1) The supply lines have typical rust or corrosion.
- (2) The hot water was not working or not present on the wash sink in the warehouse area, and it was loose the floor

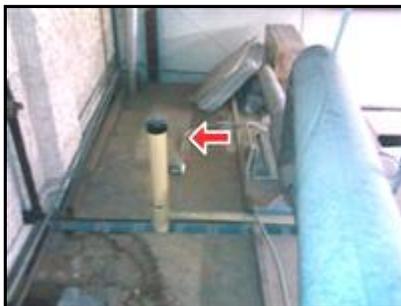
2.2.A Picture 1

- (1) The drain, waste or vent lines have typical rust or corrosion.
- (2) We noted a "capped air vent" in the bathroom area. Its possible the baths have no drain / vent to outside air. A plumber can Service and Correct or repair as needed.

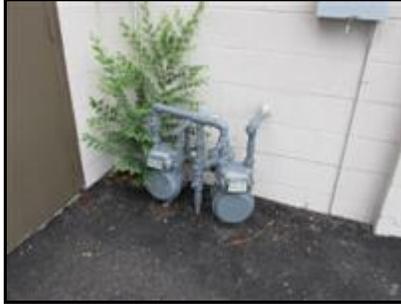
2.3.A Picture 1

The gas meters are in the parking area. Pipe Bollards were not present at the gas meters. Bollards are metal or concrete posts designed to protect the gas meters and pipes from vehicular impact.

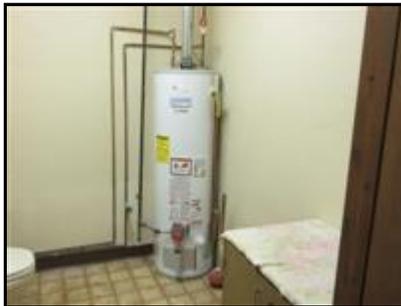
2.4.A Picture 1

The water heater is installed inside the bathroom. This is a prohibited location per building codes and standards. For safety relocate it and give it a proper place to drain to if it should ever leak.

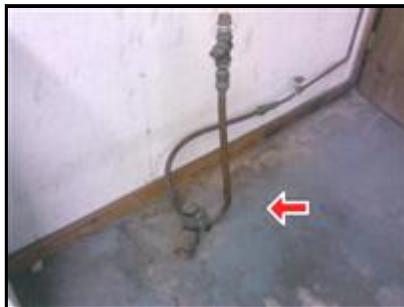
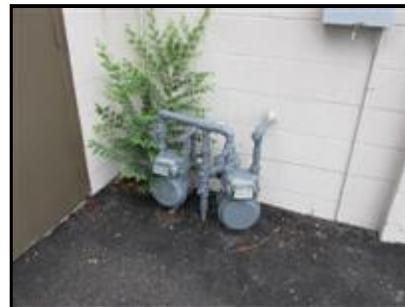
- There was soft copper gas lines at rear room. It does not appear to be in use. Although commonly used in the past, many localities now recommend replacing them with something more durable. We recommend verifying with the applicable utility provider or code authority prior to closing, if they should be modified or replaced or terminated and capped
- The gas meters are in the parking area. Pipe Bollards were not present at the gas meters. Bollards are metal or concrete posts designed to protect the gas meters and pipes from vehicular impact.

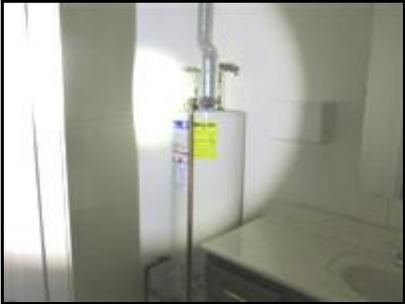
2.4.B Picture 1

The water heater is installed inside the bathroom. This is a prohibited location per building codes and standards. For safety relocate it and give it a proper place to drain to if it should ever leak.

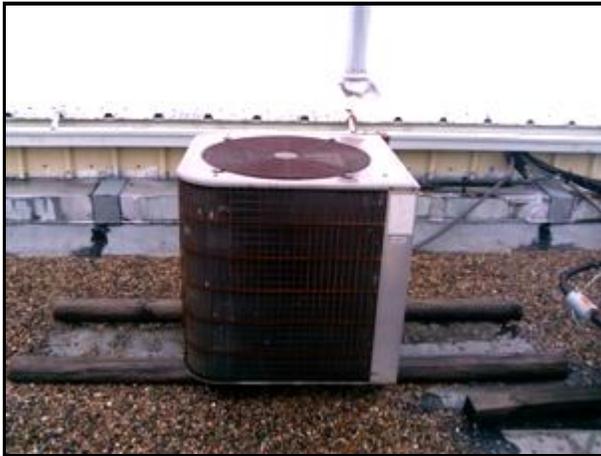
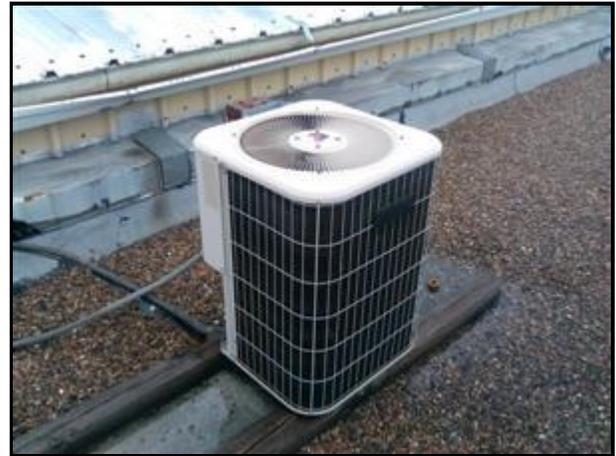
(1) Both units were running and cooling, but the cooling temperatures seemed low in this building. The insulation was missing on some of the freon lines. Seal the area where the freon lines enter the building and re-insulate the freon lines.

Service units and check freon levels, etc.

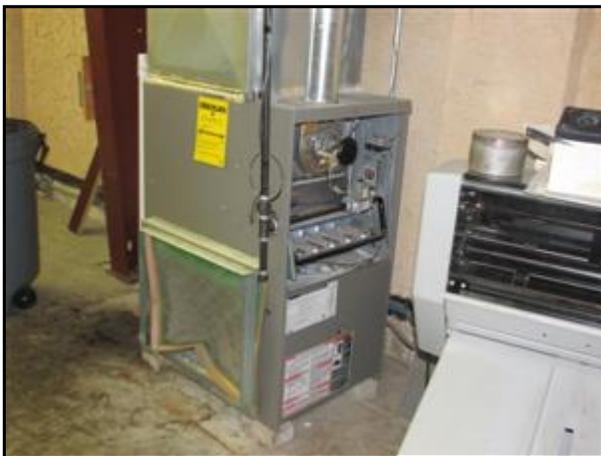
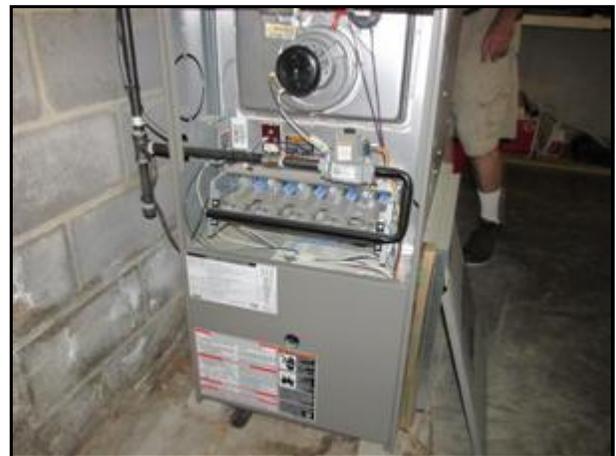
(2) Both units were running and heating, but the furnace on the South wall shared with building #332 had difficulty coming on (one time yes / one time not). It also had 2 thermostats and looks like they are doing some type of zoning with it (the thermostat nearest the unit was taped into heat only mode).

Service both units and check operation, controls, etc.

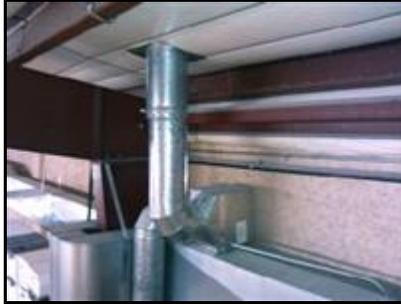
3.5.A Picture 1

(1) There was an exhaust fan that we noted had Continuous Operation & Ventilation in this warehouse. For a new buyer, this may not be needed. Verify with HVAC technician.

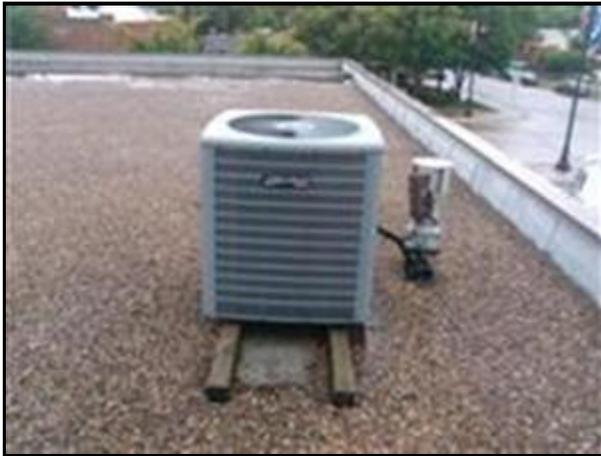
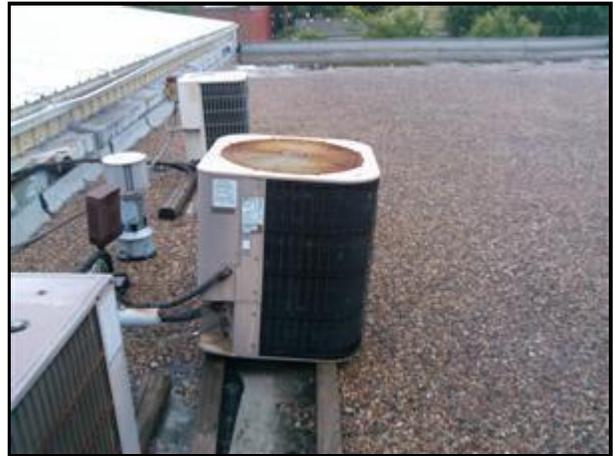
(1) Both units were running and cooling, but the cooling temperatures seemed low in this building. The insulation was missing on some of the freon lines. Seal the area where the freon lines enter the building and re-insulate the freon lines.

Service units and check freon levels, etc.

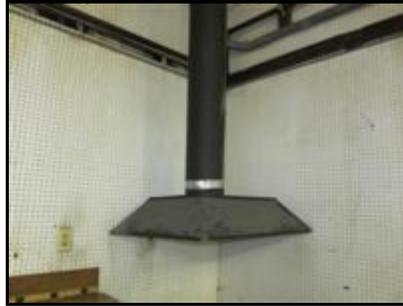
3.5.B Picture 1

(2) There was an exhaust fan in the shop area that works. What it is used for is unknown

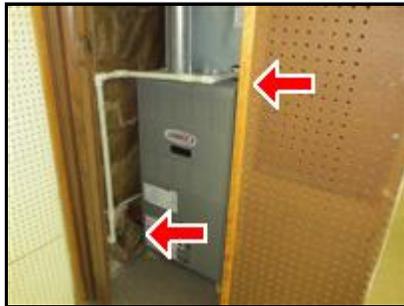
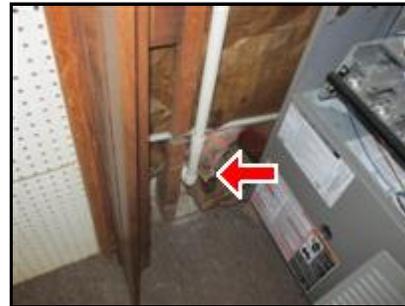
(3) The North unit drains its condensate water into a floor drain in Bldg #330. You typically don't drain your condensate into another building. An HVAC tech can advise you how to change this if needed

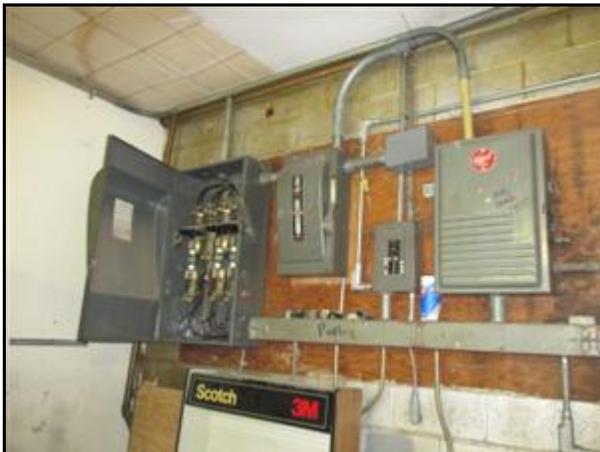
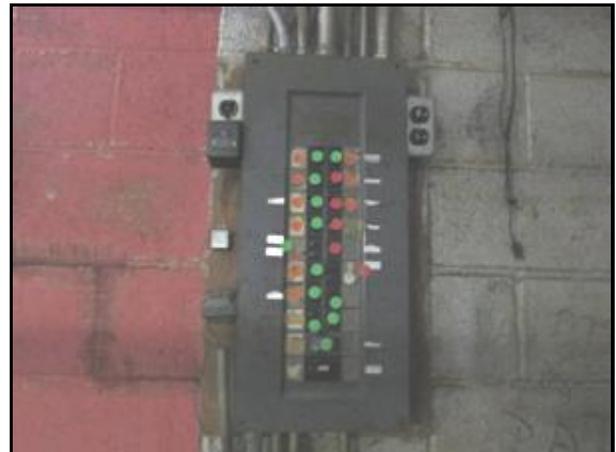
(2) There were multiple sub-panels present. During the examination of the electrical panel(s) we noted deficiencies in need of electrician repair, such as the following examples:

One breaker was tripped and would not reset; panel screws missing and existing ones the wrong type (sharp and pointed screws are a safety hazard at electrical panels); live uncapped wires (terminate or use); some electrical circuits not labeled or mis-labeled as for their usage (this prevents us from telling if the circuit, wire, etc used is correctly sized); only 4 ground wires seen for panel with over 12 breakers; neutrals doubled in same holes in buss bar; and its an old "**Pushmatic**" type panel (**FYI** - It has recently been shown by independent testing laboratories that the type of electrical panel present has been prone to become problematic with age. Some of these issues have been: failures of the panel; breakers to stick, not reset or to not trip when needed; or other safety issues. In our opinion it would be prudent to have a licensed electrician evaluate the panel(s) prior to closing).

Double-tapped" circuits; unprotected openings OR missing wire clamps; a few electrical circuits not labeled or mismatched as to their usage (this prevents us from telling if the circuit, wire, etc used is correctly sized); not enough ground wires for circuits present; and 3 wires to the panel vs 4 wires).

These are samples of unreliable conditions or deficiencies noted. Have a competent / licensed electrician read **ALL** electrical comments anywhere in the report; review the electrical system conditions present; then service, modify or repair any defects or unreliable conditions as necessary to properly and safely correct them.

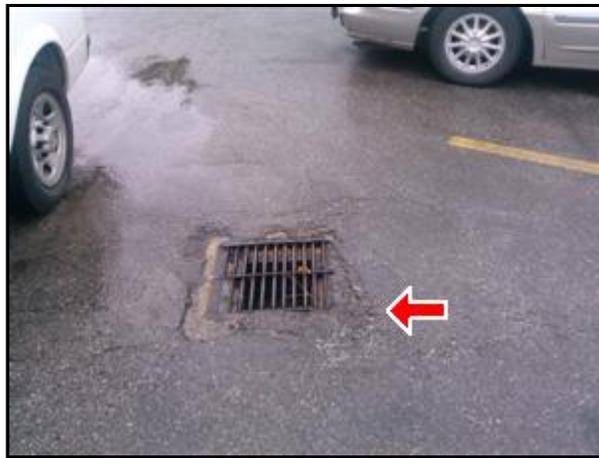
5.0 Picture 1

- Parking lot drains are not tested for flow. It was raining during the inspection and it appeared to drain.
- Common damage or deterioration such as: cracks, movement, or spalling was noted at the surface of the drive.

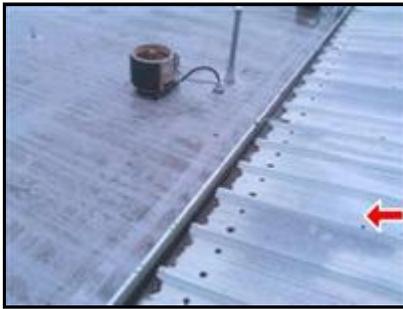
6.0.A Picture 1 Paint worn off

Typical maintenance recommended. This usually consists of the repair of open cracks in flashing or roof coverings: open seams : deteriorated roof covering : etc.. On the Metal it includes, Re-sealing or replacing screws and /or coating any rusty areas with an addition coating or elastomeric material.

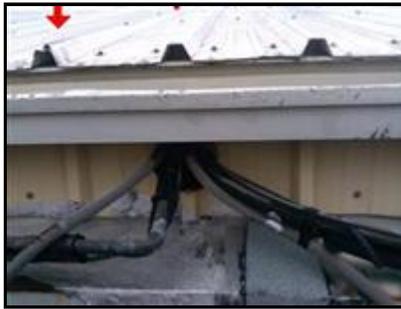
6.0.A Picture 2 Missing closure strips

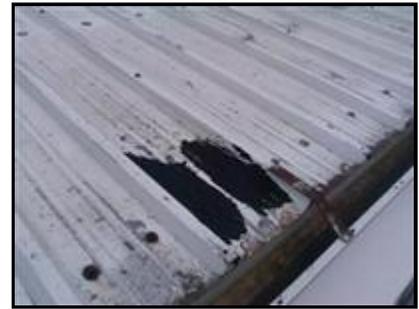
6.0.A Picture 3 Prior repairs noted. Improper material used.

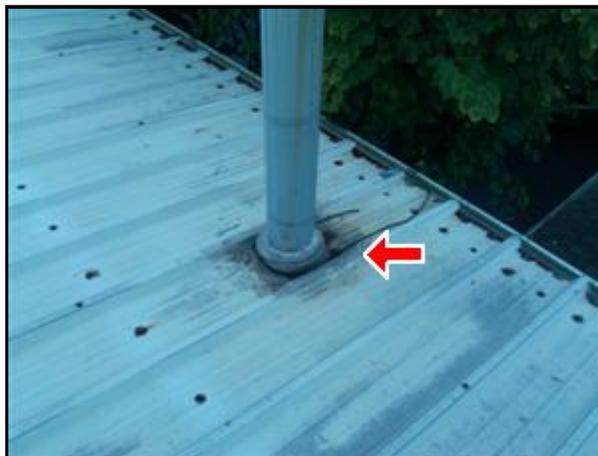
6.0.A Picture 4 Reseal flashings

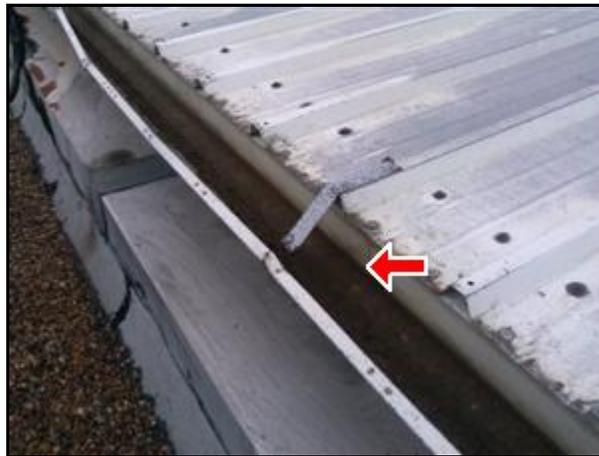
6.1.A Picture 2

(2) There was damage to the gutters at front of the building. Bowing or a poor slope was noted at some of the gutters. Gutters, downspouts and/or drains were clogged at various locations.

Service and Correct

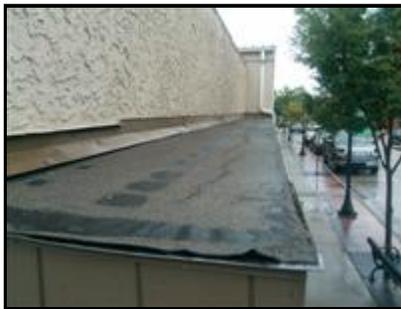
6.0.B Picture 1

Roof covering appears to be nearing the end of its useful life.

Typical maintenance is recommended for the low slope roll or membrane roof. This usually consists of the repair of open cracks in the flashings or roof coverings; open seams; deteriorated roof coverings; etc. This should help ensure the water tightness of the structure and should be done on a regular basis.

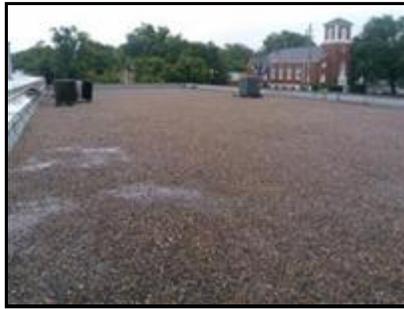
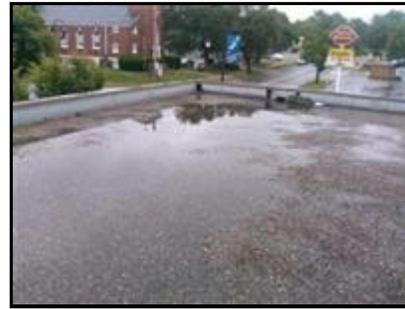
(3) Unit #332 (Built Up Roofing w/gravel). Roof covering appears to be nearing the end of its useful life.

The general condition shows signs of more advanced weathering or aging. Minor separation of flashings noted. Regular maintenance and inspection is advised to achieve continued service. There is evidence of poor drainage and/or ponding of water. Service and correct as needed.

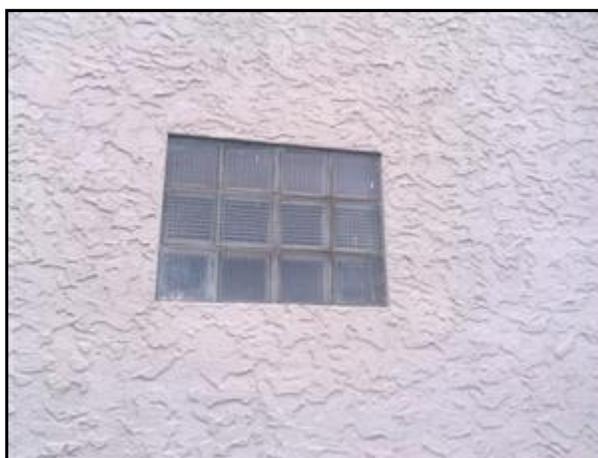
9.2.A Picture 1

A few glass block windows were cracked or broken. Service and Correct as needed

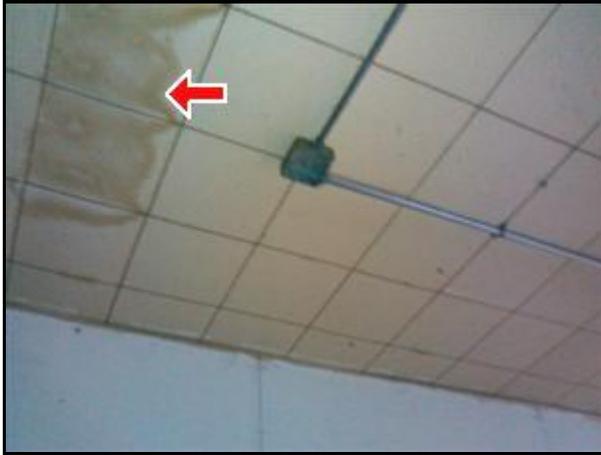
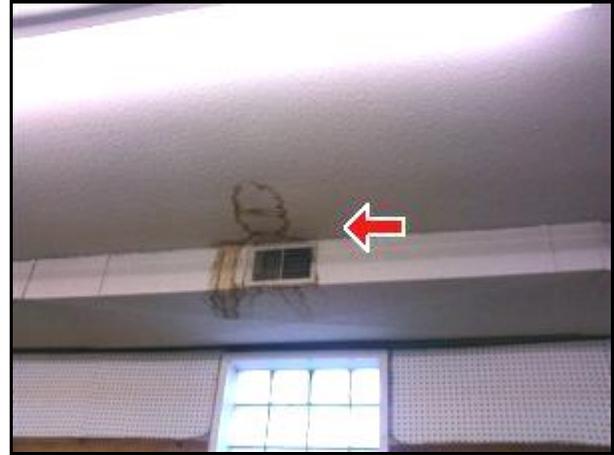
(2) There is evidence of past moisture staining.

The water stains are dry at this time, but monitor them in the future.

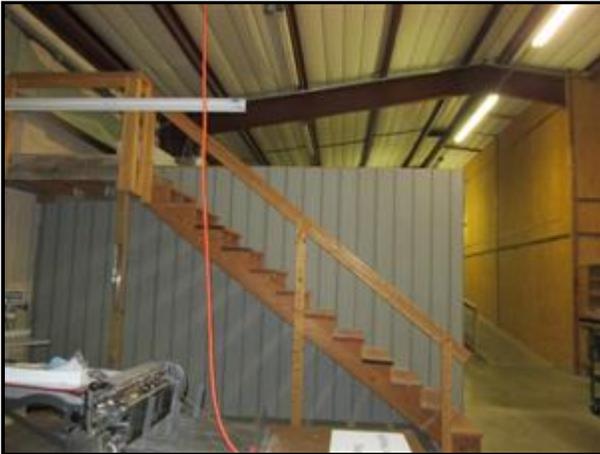
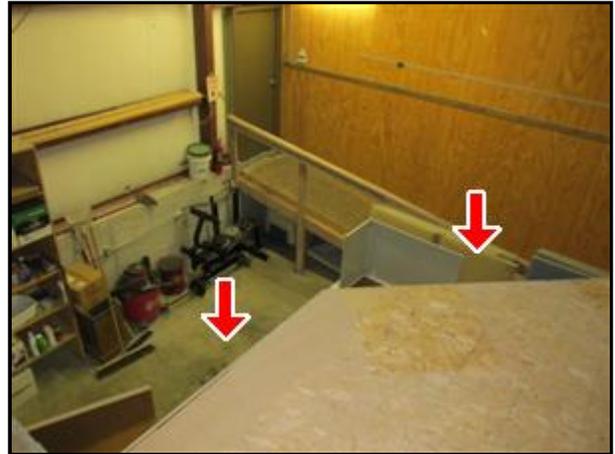
The steps to the loft have large gaps between rails (should be no more than 4" wide); there is no guard rail around the loft area (8' drop to floor below). Service and correct.

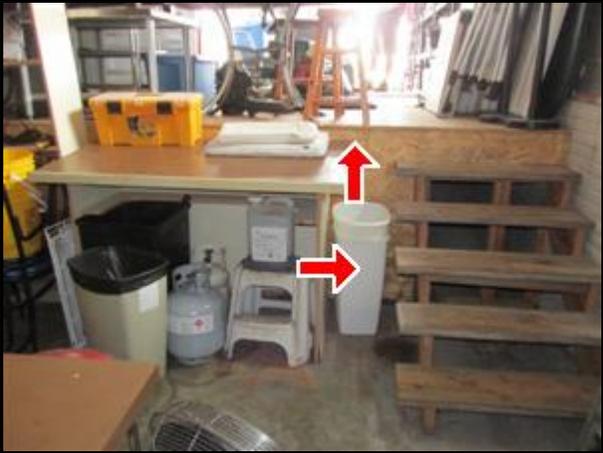
10.4.A Picture 1

The steps in the garage / rear shop area have no grabrail / balusters at steps; no guardrail at the platform (over 30" drop to floor). Service and correct.
