HOLMES INSPECTION CO.

Re: General Building Inspection
3456 – 3460 Older Street
Kansas City, MO

COMMERCIAL BUILDING(S)

3456 – 3460 OLDER STREET

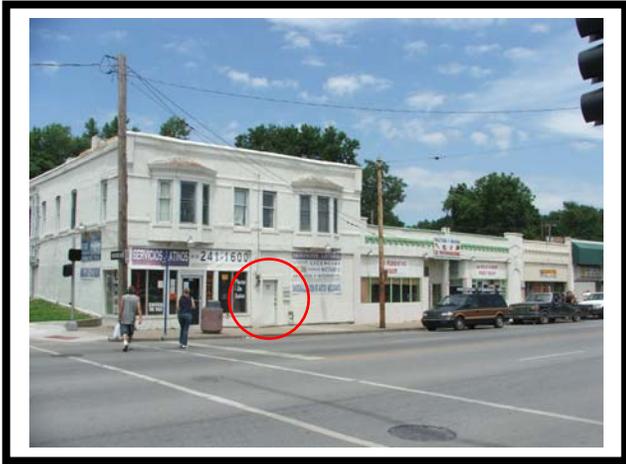
Photo 1 – Front Elevation of All 3 Buildings and Front Door (circle) to the 2 Apartments above the “Servicios Latinos” business

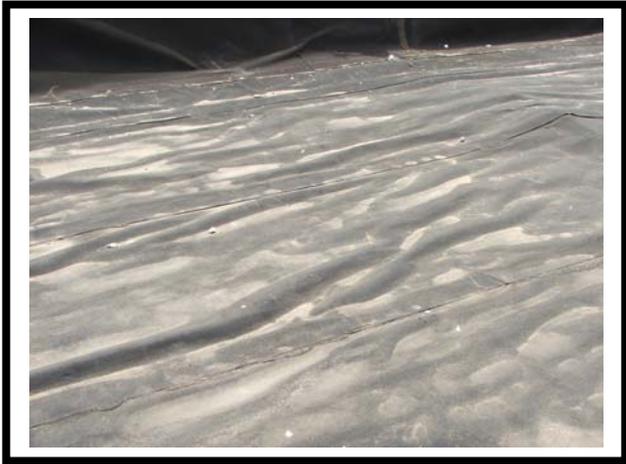
Photo 13 – Raised & Loose Roof Coverings are Holding Water over 48 hrs After a Rain

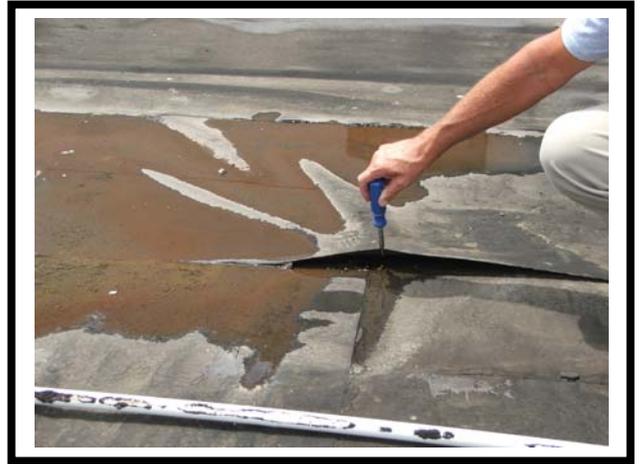
Photo 14 – Ponding Water & Open Seams

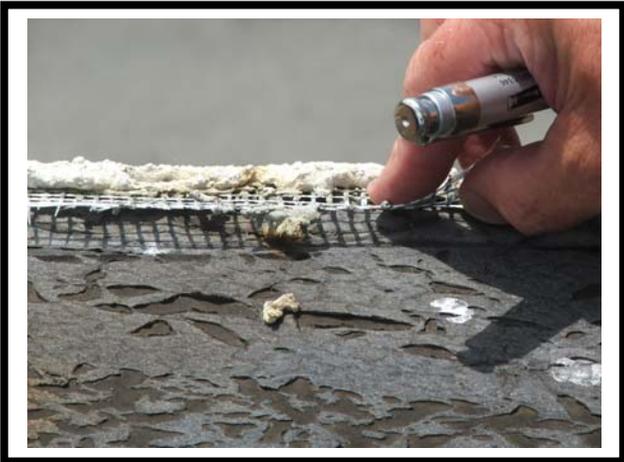
Photo 21 – Worn Roof Covering At Edges

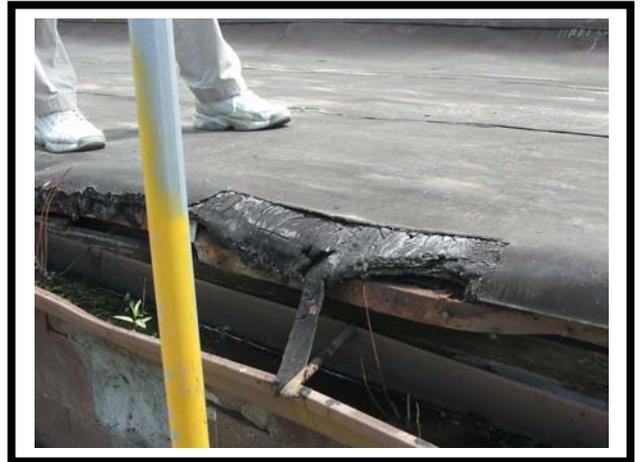
Photo 22 – Roof Torn at Rear Over Gutters

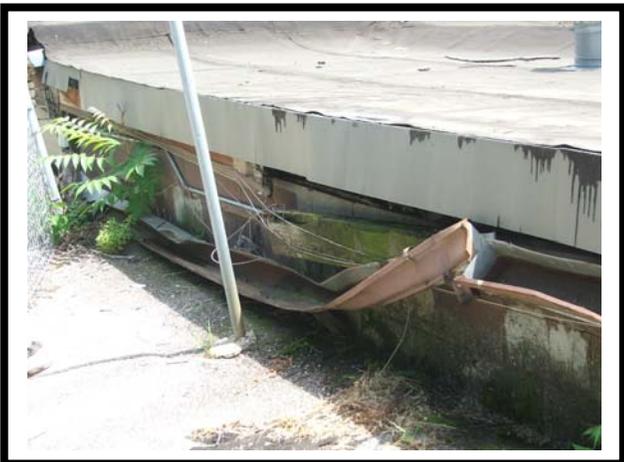
Photo 23 – The Gutters Are Damaged and Pulled Out of the Wall at the Rear of Bldg

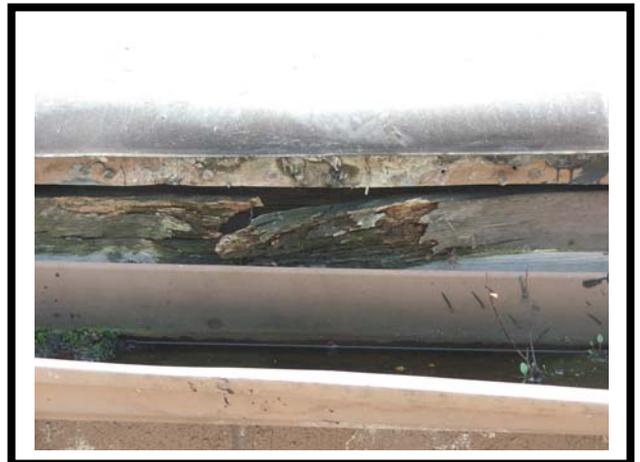
There was wood rot or other damage needing repair at the rear of the buildings around the fascia, tenant decks, door frames, etc (**photo #24, #25 & #28**). Some of the damage looks like it may be caused by termites or other pests (**see photo #28**). We recommend having a pest control company check this.

Photo 24 – Gutter Holding 3” or so of Water in Rear Gutters & Wood Damage at Fascia

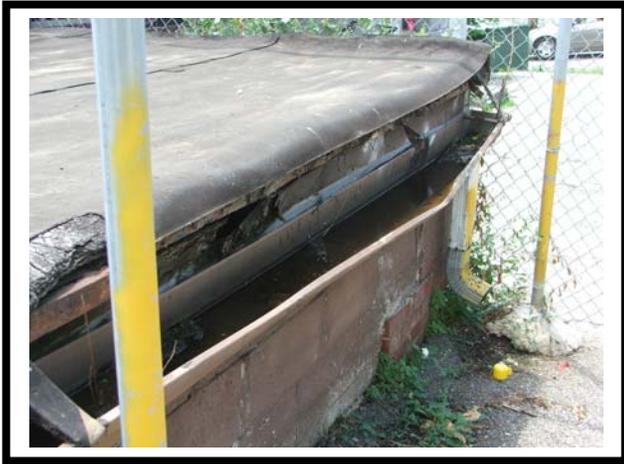
The gutter downspouts drop water at the base of the retaining wall at some locations (**photo #25**). Extend the downspouts away from the wall and verify the sub-surface drain is free-flowing. Water should never be allowed to pond or flow toward the building. The gutters and downspouts are damaged, bowed, standing water, causing wood or moisture damage to the wood fascia (**see photos #23, #24, #25 & #26**). The gutters and downspouts all need repair and/or replacement at this time.

Photo 25 – Gutters Hold Water; Moisture Damage to Fascia; Downspouts Drop Water Next to Foundation at Rear of Bldg.

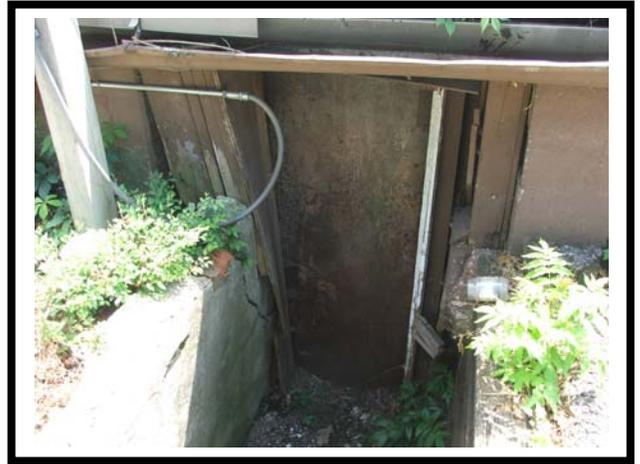
Photo 26 – Outside Rear Door to Either Storage or Basement / Crawlspace Area is Obstructed and Area Was Not Accessed

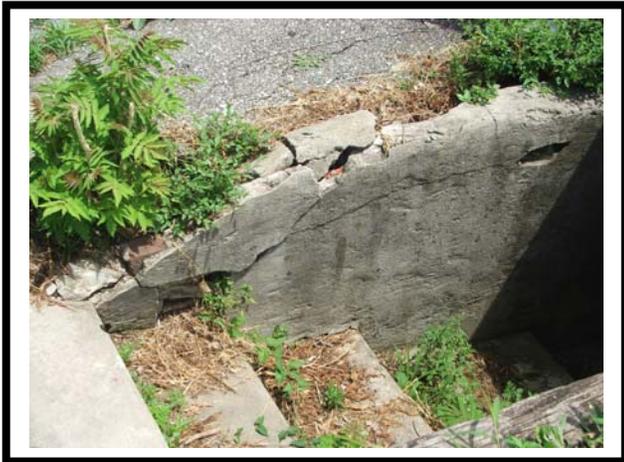
The retaining walls shown in **photos #12, #4, & #27** have significant movement/cracking and we recommend repair to prevent further movement or deterioration.

Photo 27 – Earth Grown up Over Rear Stairs to Enter Storage, Basement or Crawlspace. Retaining Wall Broken, Damaged etc.

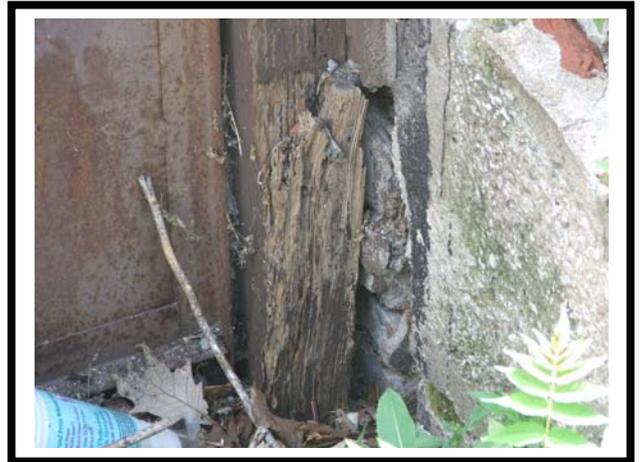
Photo 28 – Dry Rot or Suspected Termite Damage at Frame of Door Leading to the Area in Photos #26 and #27

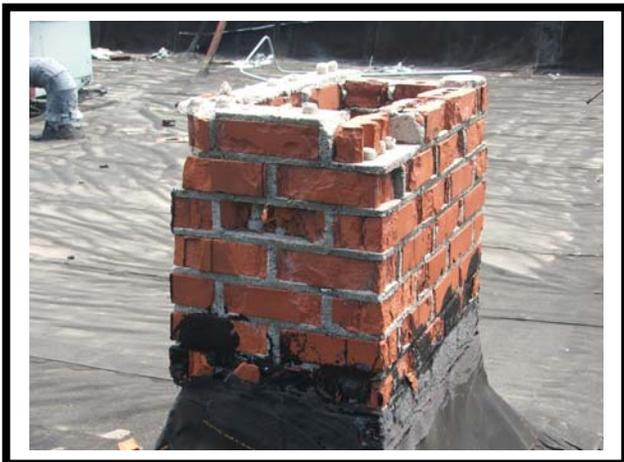
Photo 29 – Brick Chimney on Roof has Missing Brick, Missing Mortar, No Cap

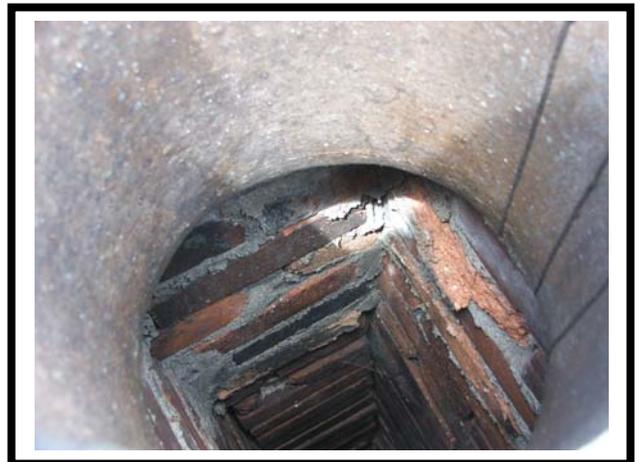
Photo 30 – Unlined Chimney on Rooftop

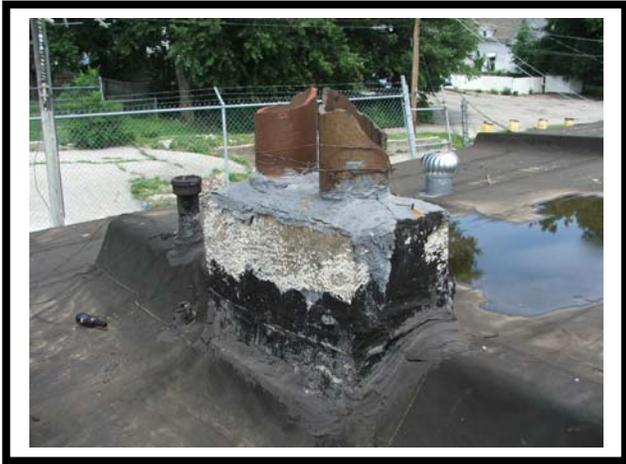
Photo 31 – Old Chimneys; Broken Tile, Unlined Chimneys; No Caps, Poorly Sealed

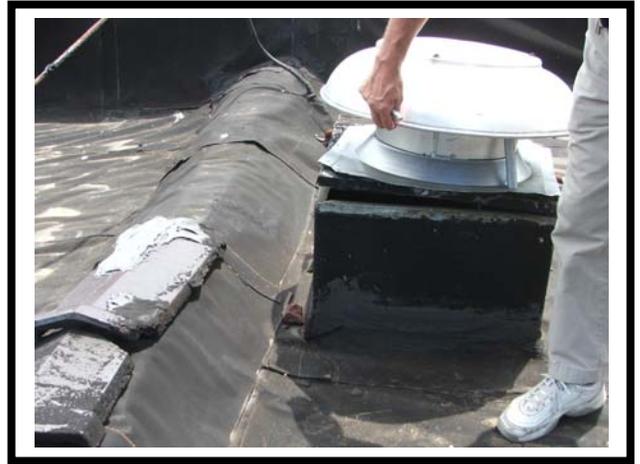
There is specialized exhaust or grease vent equipment venting onto the roof (**photo #32**) that you should determine if it is yours to maintain/repair or the tenants. We assume it is for the Sandwich Shop because it is by the common wall, but it is not marked. There were various issues with it already discussed under roof section, like loose, unsealed casings. There were abandoned electrical wires on the roof that although they appear dead - you don't know if a switch will make them live and a safety hazard. Repair as needed.

Photo 32 – Vent Fan on Roof Loose and Not Sealed Down Properly – Leak Potential, etc

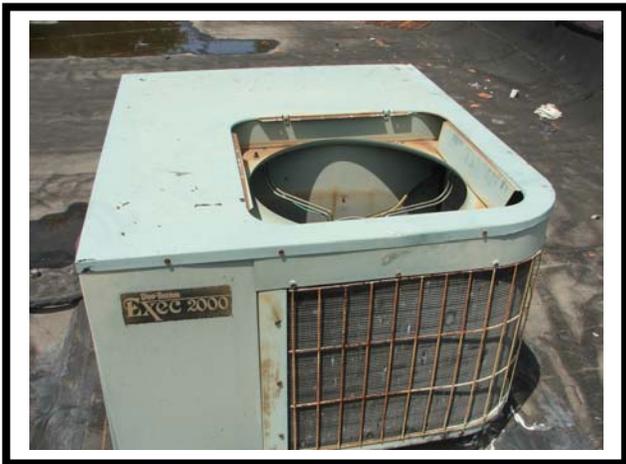
There were 2 HVAC units on the roof over the Saigon Store (see photos #33 and #34). The one at the rear of the roof has most of its guts stripped out and is not operational. Live electrical wires should be terminated, used or capped. The front unit has uninsulated ductwork and didn't come on when tested. Both units were made by Duo-Therm and appear to be 3 ½ Ton A/C units. In looking at the style of the units we would guess they were at least 20 years old.

Photo 33 – Old Rooftop A/C Over Saigon Store at Rear of Roof has No Compressor, Fan, etc & is Not Operable in this Condition

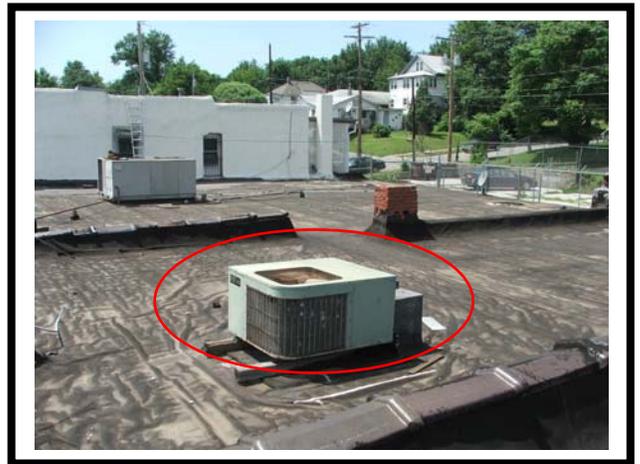
Photo 34 – A/C Unit Over Saigon Store at Front of Roof has Uninsulated Ductwork and the Unit Did Not Come On When Tested

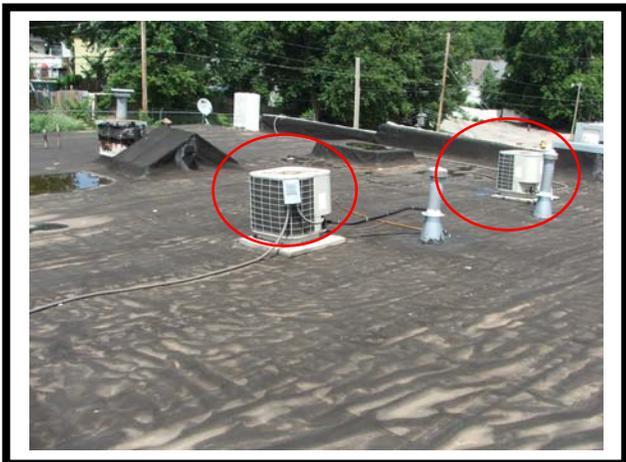
There were 2 HVAC units on the roof over Apartments 3700-A & 3700-B (see photo #35). They look newer than the other A/C units present, however the data tag was worn smooth and the brand, age, size, etc is unknown. The condensate lines were draining onto the roof (photo #43); there were live wires (photo #36) outside conduit. Conduit was over 25' long and laying on the roof (water/shock potential).

Photo 35 – The 2 A/C Units on Roof Over Apts. Data Tag Worn Smooth. Age and Size Unknown – They Look Newer Than Others

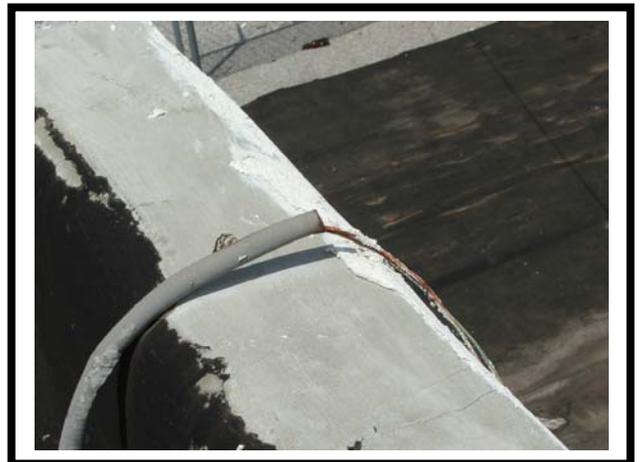
Photo 36 – Live Wires on Roof Over Apts for A/C Units. Wires over 25' Long and Conduit Laying on Roof – Water Potential

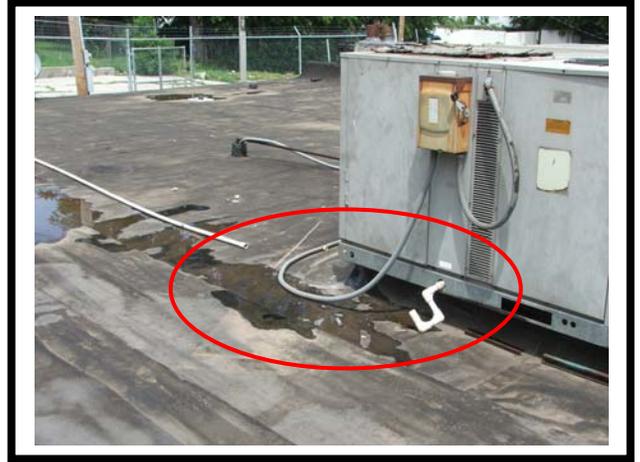
Photo 38 – Goodman Heat/Cool Unit on Roof of Mexican Restaurant. Condensate Line is Loose and Leaks onto Roof

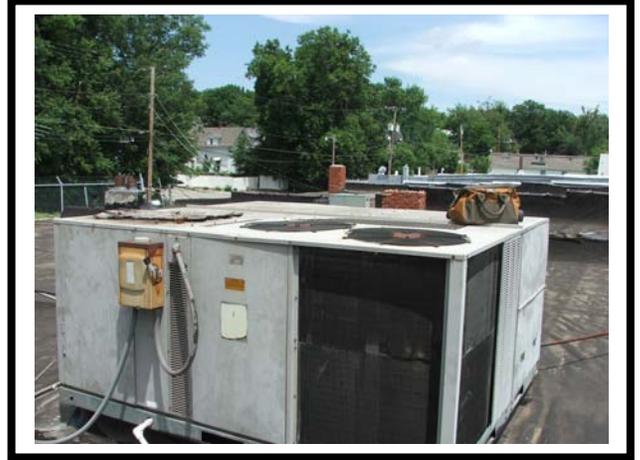
There was 1 Package HVAC unit (photo #40) on the roof over the Mexican Shop (3704/3706). Its data tag indicated it was a Goodman brand and could provide both heating/cooling. This could be hard to do without gas service. The condensate line was broken off and draining onto the roof (photo #38); the blower belt was loose and it had exposed wire splices (photo #39); the electrical disconnect was falling off, corroded, leaking water (photo #41); and the utility line penetrations to the business below was open and can leak water (photo #42). The unit has 2 fans and 2 compressors. Both fans were running, but only 1 compressor was operating on a hot day. We believe the unit to be at least 15-16 years old.

Photo 40 – Goodman Unit Has Dual Fans and Dual Compressors – Only 1 Set was Running on a Hot Day ?????

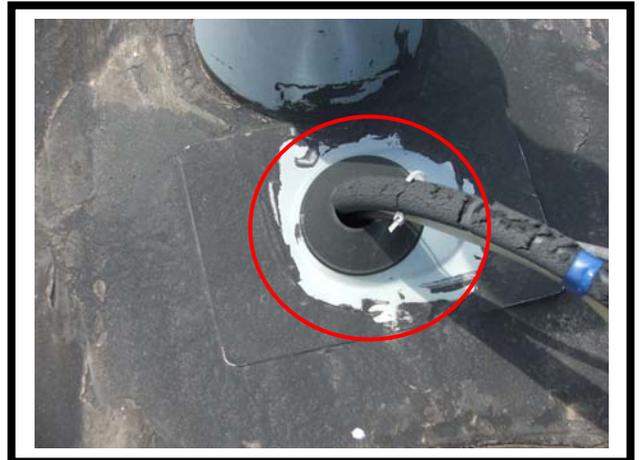
Photo 42 – Openings in A/C Freon Line Flashing to Bldg Below is Water Leak Site.

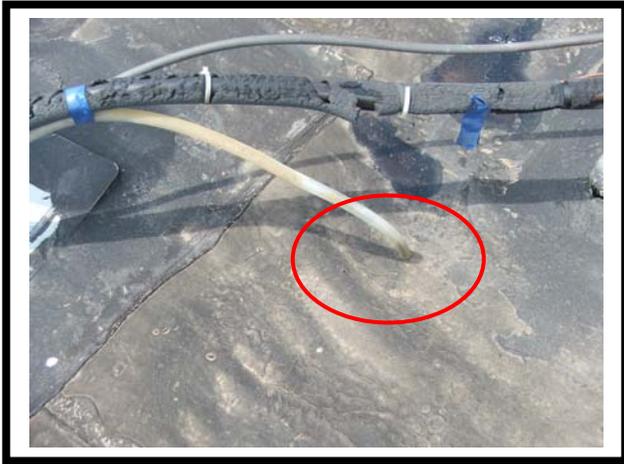
Photo 43 – The A/C Condensate Line is Disconnected & Leaking onto Roof

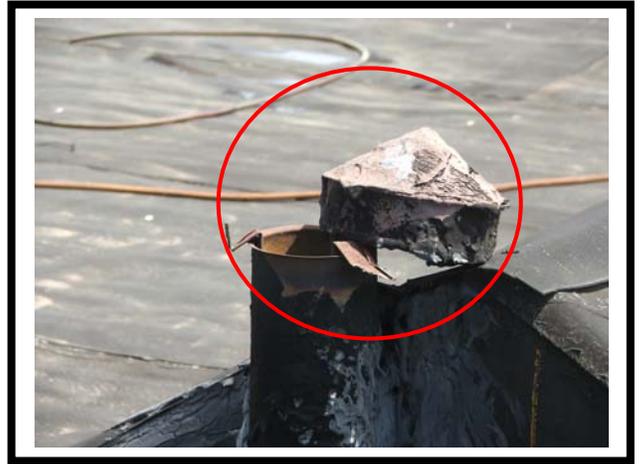
Photo 44 – Plumbing Vent Cap Has Fallen off pipe on Roof – Water Leak Potential

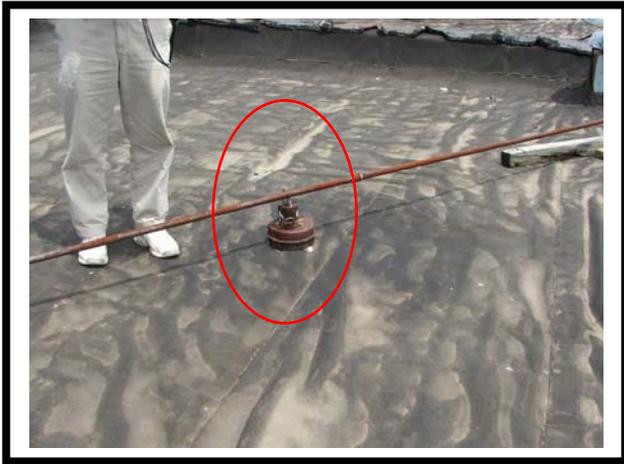
Photo 45 – Gas Lines “temporarily” being Supported off roof surface by old motor part

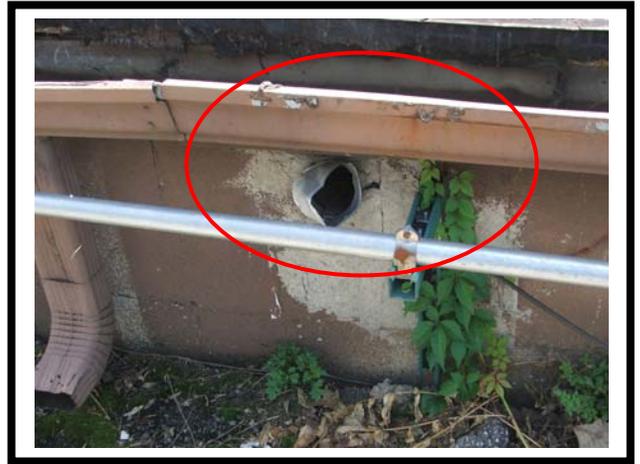
Photo 46 – Looks Like Old Flue or Vent Pipe Broken Off at Back Wall of Bldg Behind Mexican Restaurant

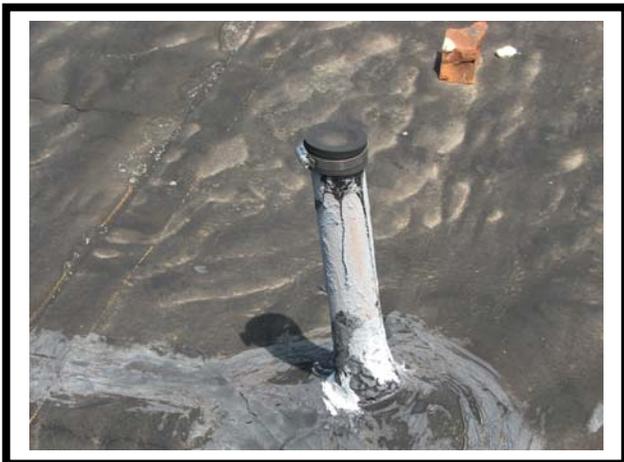
We noted one of the plumbing vents on the roof that was capped off (photo #47). We can not determine if it is still needed or not. Have a plumber verify the need for this. We noted another plumbing vent so short that snow would cover it up (photo #15). There were rusty gas lines on the roof being temporarily supported above the surface by an old motor part (photo #45). There were flues with missing vent caps (photo #44), and old flues or vent pipes broken off outside the rear wall of the building behind the mexican sandwich shop (see photo #46). Plumbing repairs are needed outside and inside. Interior comments or photos will be shown on the INTERIOR PHOTO LOG.

Photo 47 – Old Vent Pipe on Roof – It is Not In Use and Capped Off - Why ???

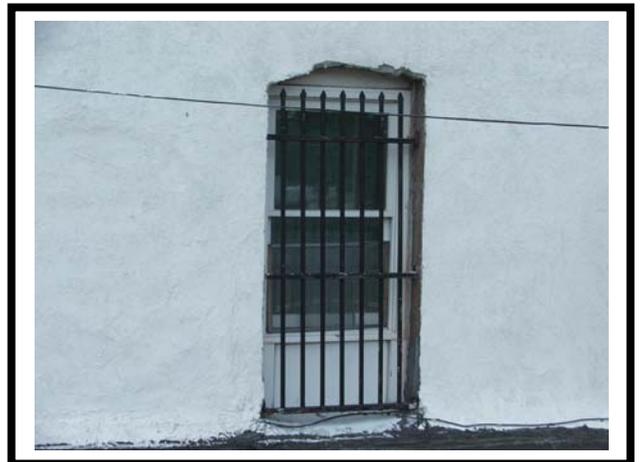
Photo 48 – Burglar Bars Bolted to Outside of Walls at the Windows. Most Apt Emergency Egress Windows Like This – Safety Hazard

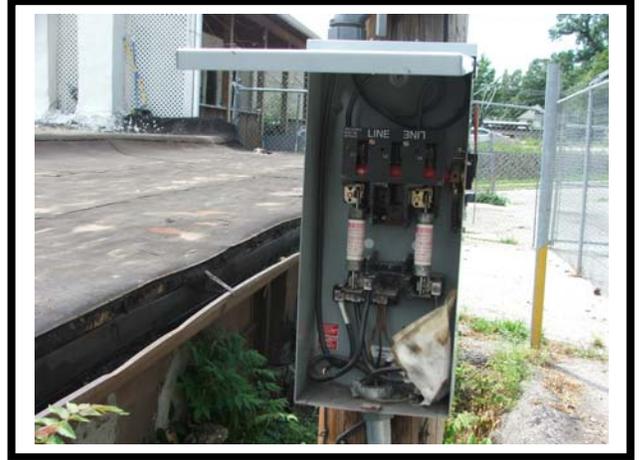
Photo 50 – A Main Electrical Disconnect at Pole Behind the Mexican Restaurant is not Marked as to Who or What it Controls

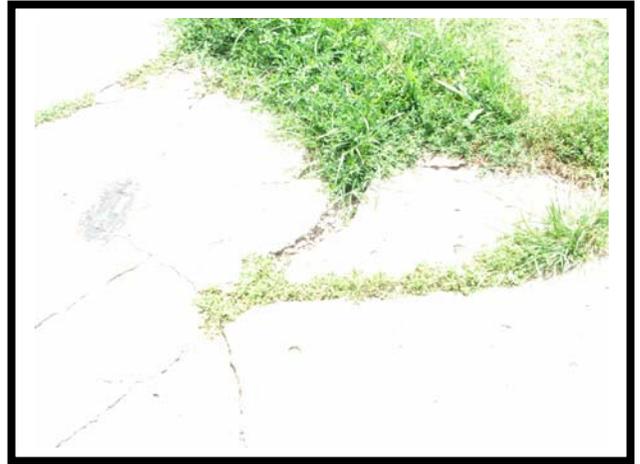
property of the city, but again verify who maintains them). Typical cracks and wear was noted AND large cracks, offset surfaces and trip hazards were noted (**photo #56**) that should be repaired.

Photo 56 – Large Cracks or Gaps at the Walking Surface of Sidewalks or Drives. Trip Hazard for Tenants or Others

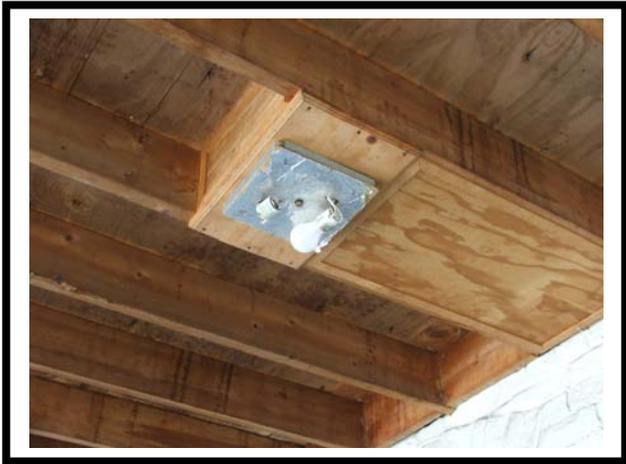
Photo 57 – Lights for Both Apts at Rear Porch are Loose in Ceiling or Damaged

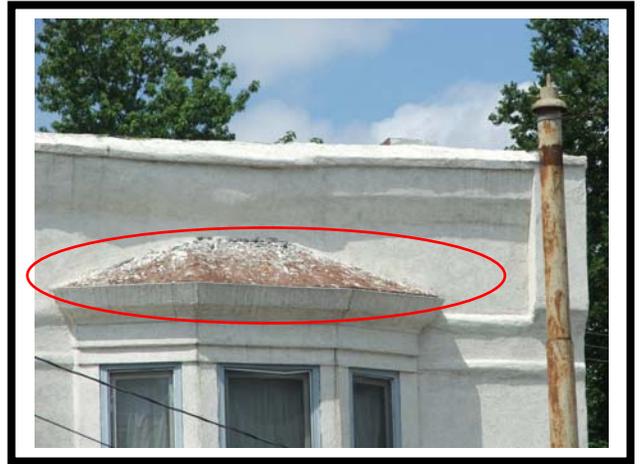
Photo 58 – “Eyebrow” Roofs at Front Wall of 3700 are Covered with Paint or Stucco and What Type and Their Condition is Unknown

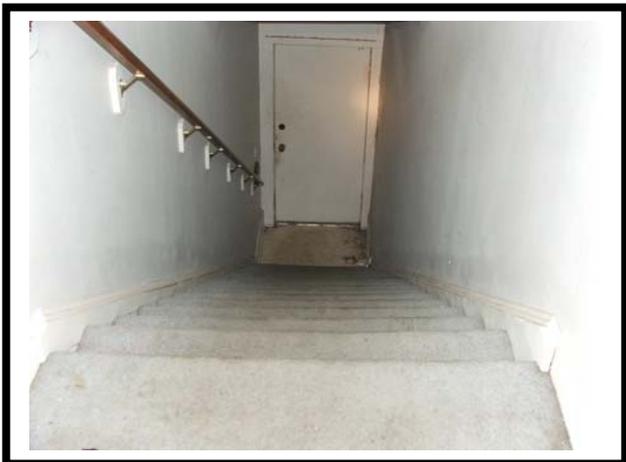
Photo 59 – Common Inside Stairs from 2nd Floor Apts Down to Street Level Door

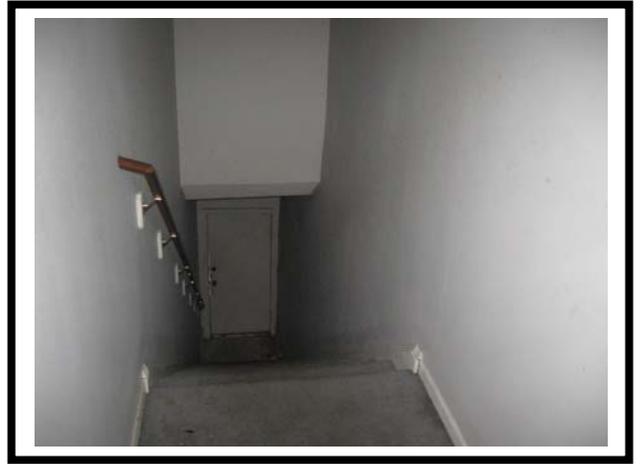
Photo 2 – Unit 3700 #B. No light at stairs to street. Can be a Trip, Fall, Safety hazard.

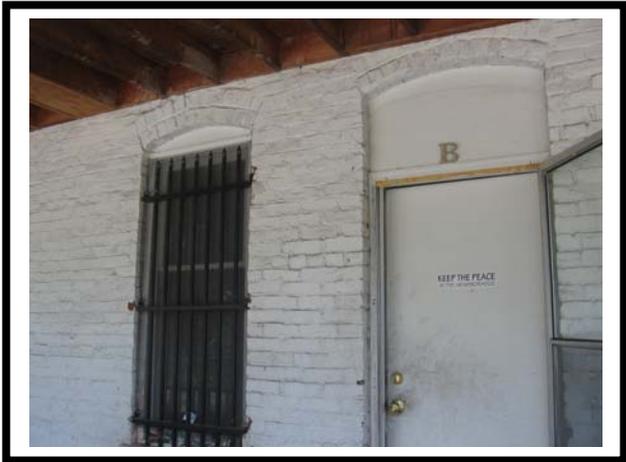
Photo 3 – Burglar Bars Block Emergency Egress. Safety Hazard.

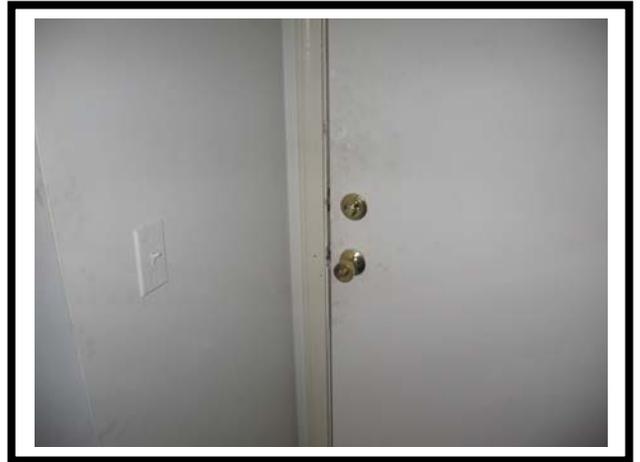
Photo 4 – Deadbolt Not Working. Safety and Security Hazard.

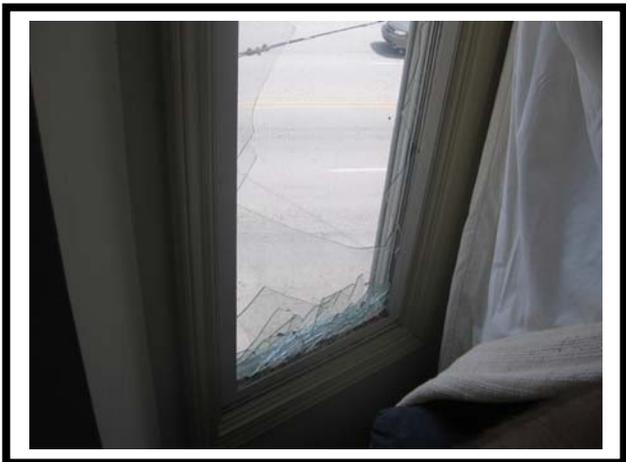
Photo 5 – Broken Window Glass

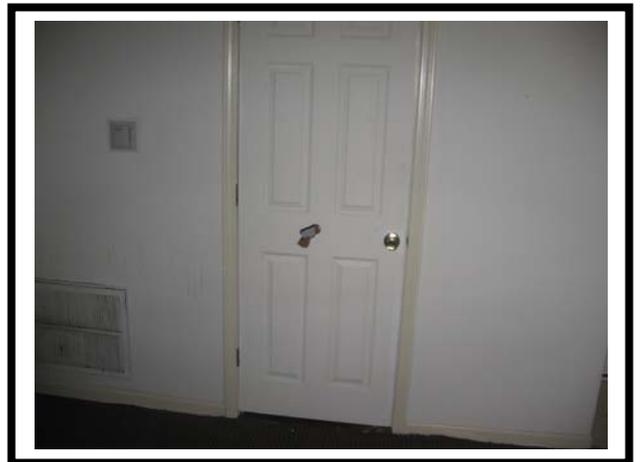
Photo 6 – Hole in Door

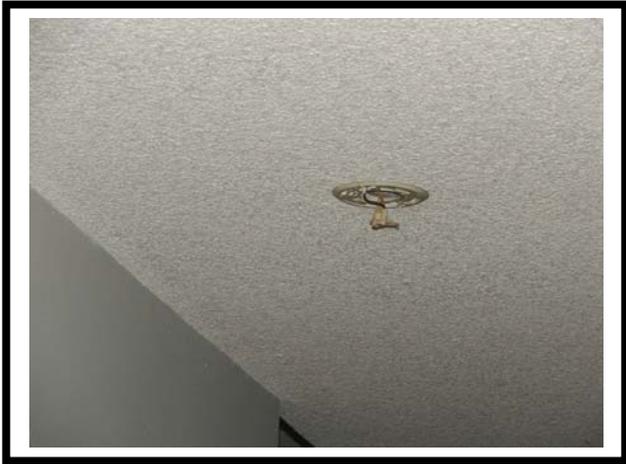
Photo 7 – Missing Smoke Detector. Replace it – safety hazard.

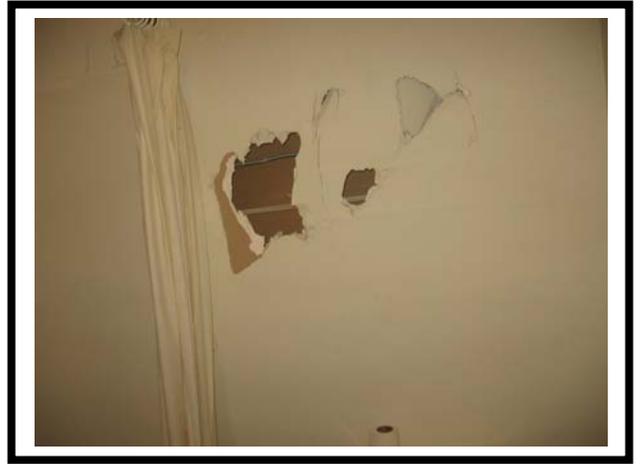
Photo 8 – Damaged Walls.

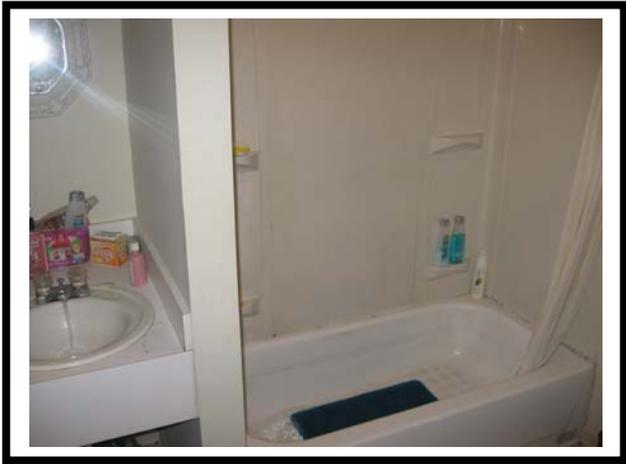
Photo 9 – The toilet was loose at the floor and there was no sink stopper.

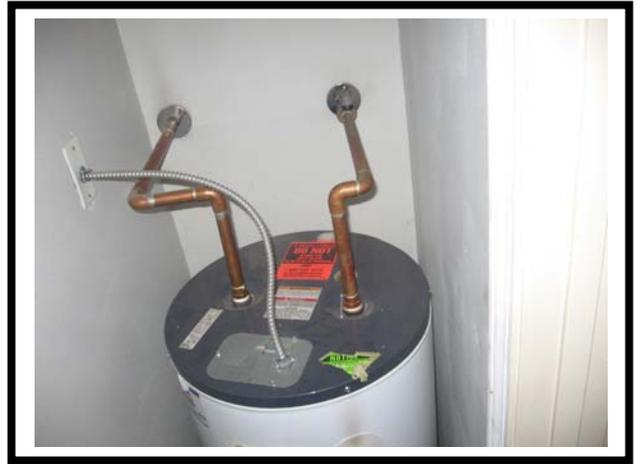
Photo 10 – Electric water heater TPR valve leaking; no water shut-off valve; element cover missing; no drain for drip pan.

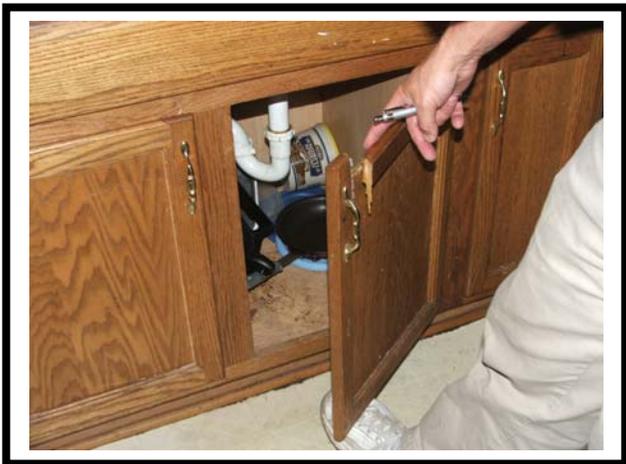
Photo 11 – Kitchen cabinet door broken.

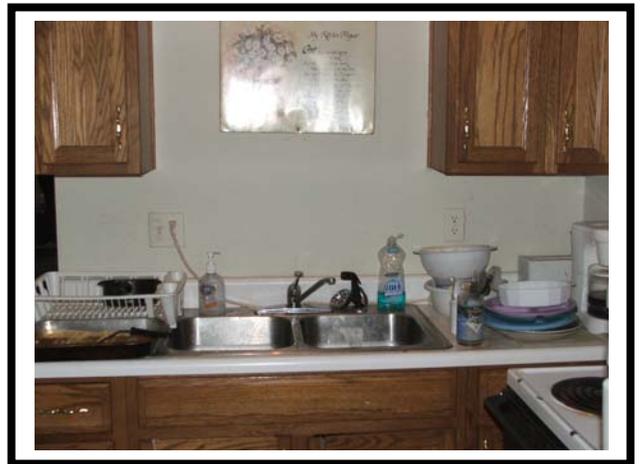
Photo 12 – Outlet to right of sink was dead.

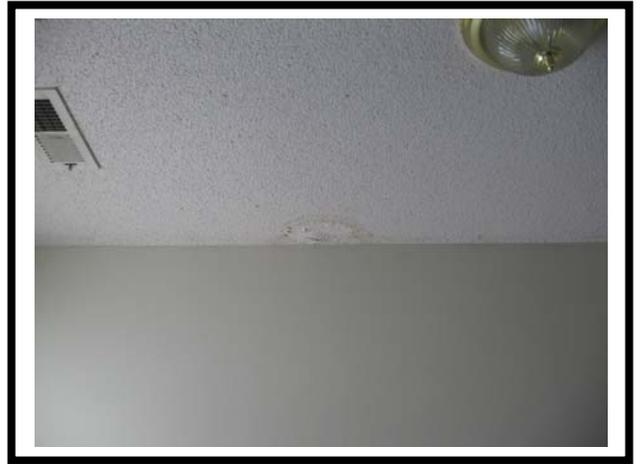
Photo 16 – Stains at bedroom ceiling wet.

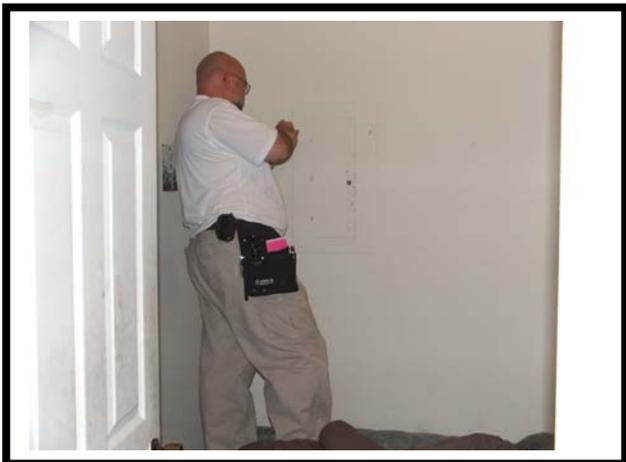
Photo 17 – Water in electrical sub-panel.
Improper mixed grounds and neutral wiring.

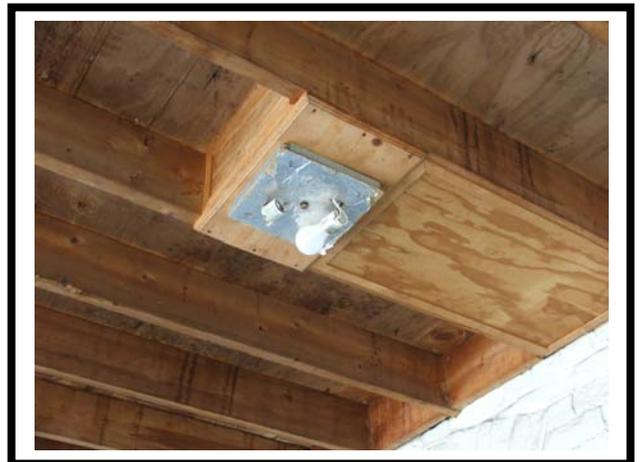
Photo 18 – Rear Deck Lights outside 3700-A
and 3700-B are broken or missing.

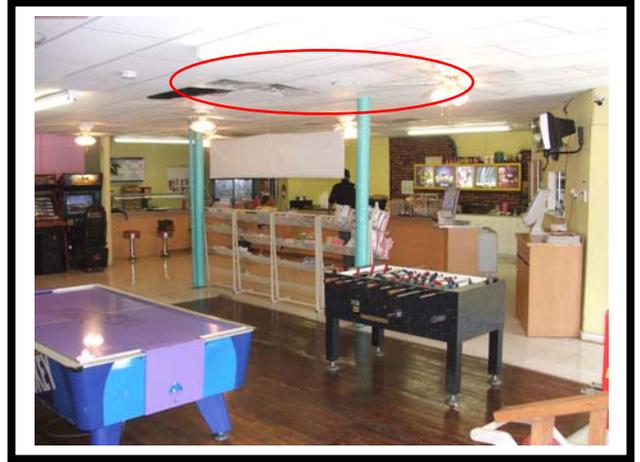
Photo 20 - Bldg 3704/3706. Mexican Shop. Courtesy view of interior. Leak stains and missing tile at ceiling,

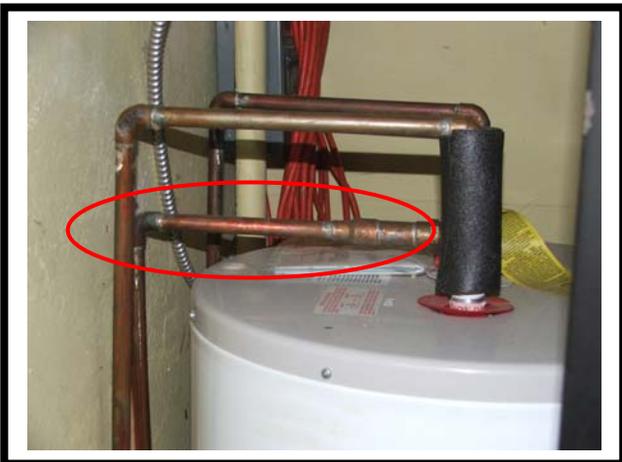
Photo 23 – Water heater TPR drain line has been downsized. Safety hazard – should be $\frac{3}{4}$ " in size – its too small.

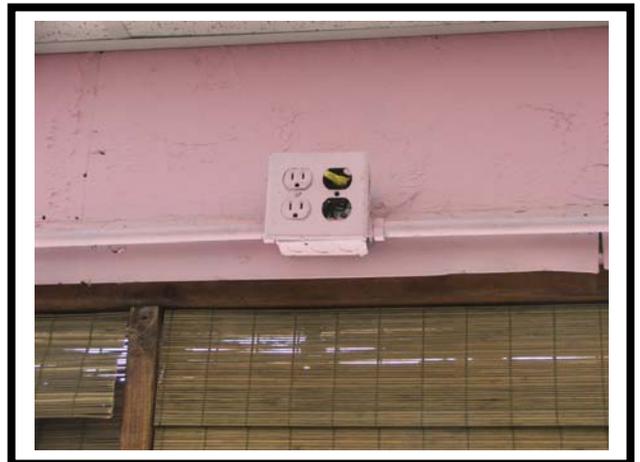
Photo 24 – Ungrounded outlets present and open electrical junction boxes or exposed wire splices.

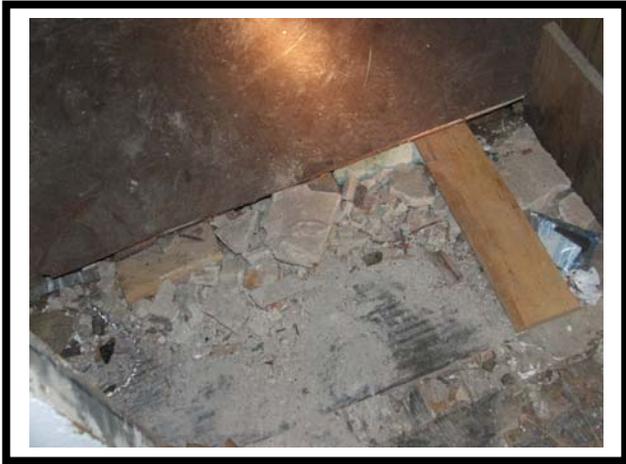
Photo 25 – Broken up, damaged, & sloping floor in rear storeroom. Not fully visible due to heavy storage.

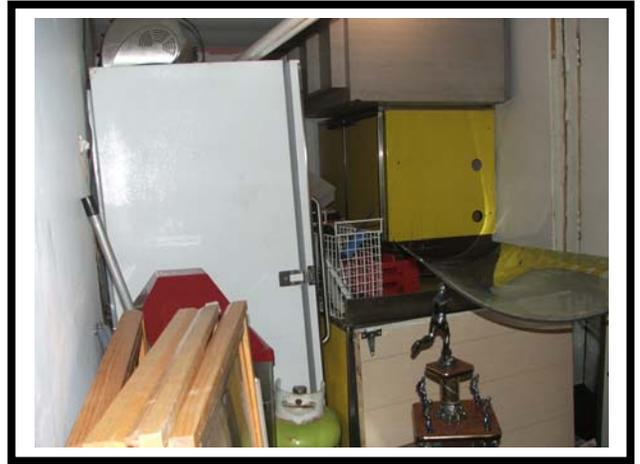
Photo 26 – Rear storeroom. Walls, floor, and much ceiling area not visible for inspection.

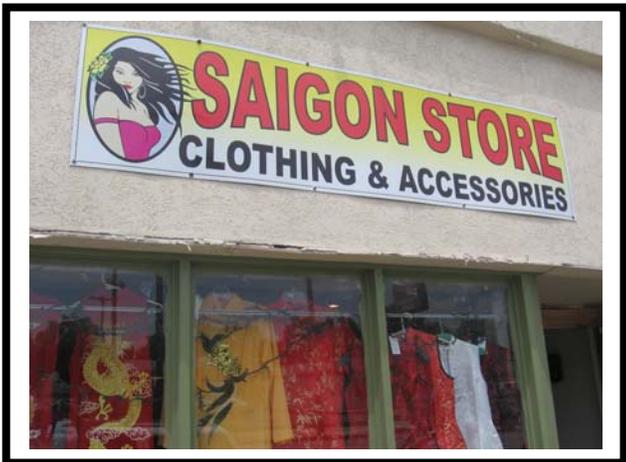
Photo 29 – Saigon Store – Bldg 3708. Wood rot & missing flashing.

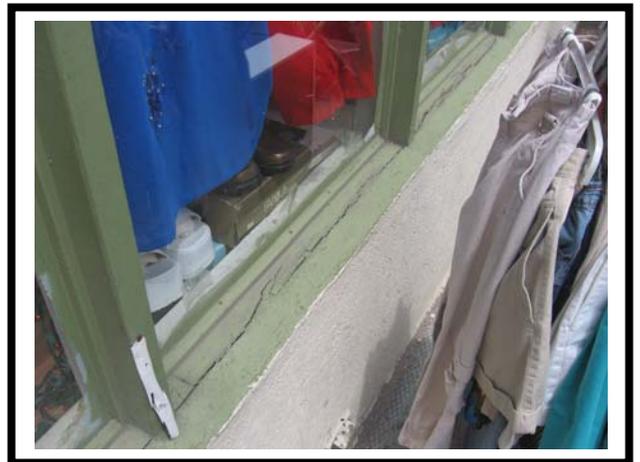
Photo 30 – Wood rot at front window.

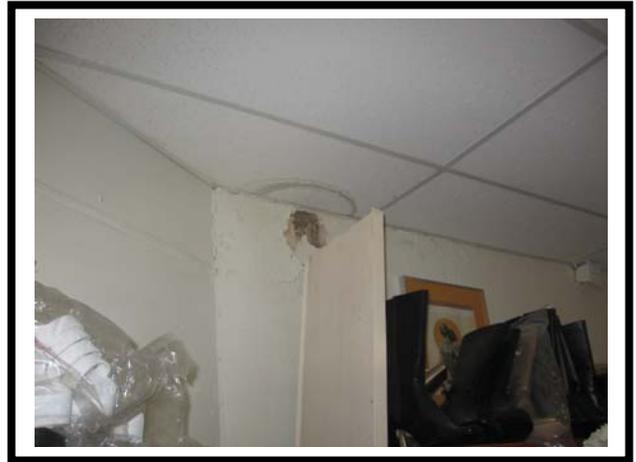
Photo 34 – Water stain at ceiling – moist.

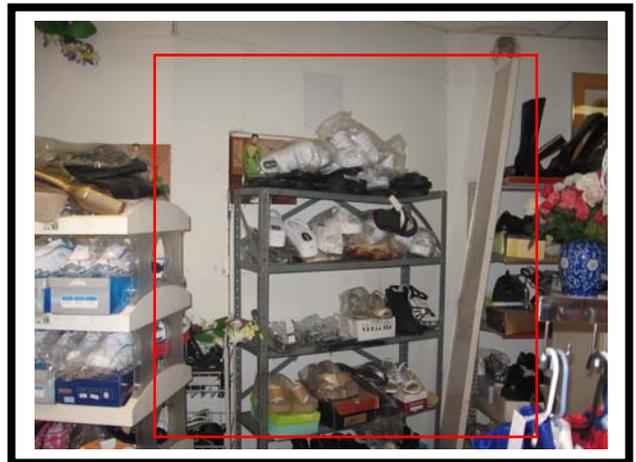
Photo 36 – We believe access to crawlspace is behind clothing racks and its blocked. Crawlspace was not seen or accessed.

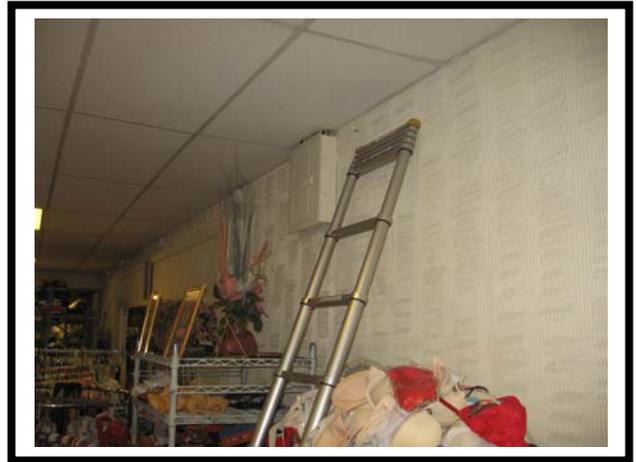
Photo 40 – Electrical panel is mounted too high for a normal person access without use of a ladder – safety hazard.

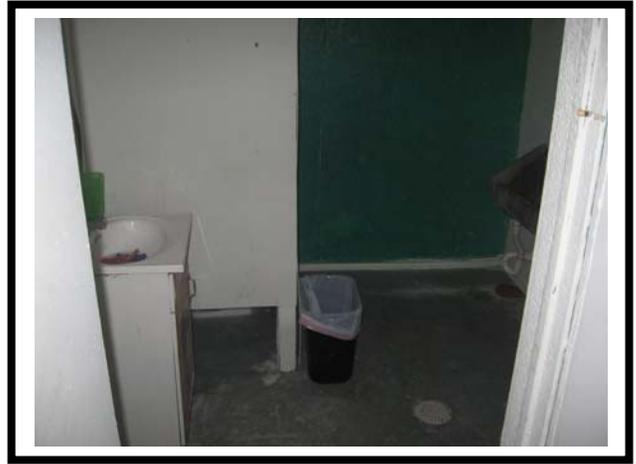
Photo 44 – Latino Servicios – Bldg 3700. Bathroom has no hot water, toilet loose at floor, and no ventilation for room.

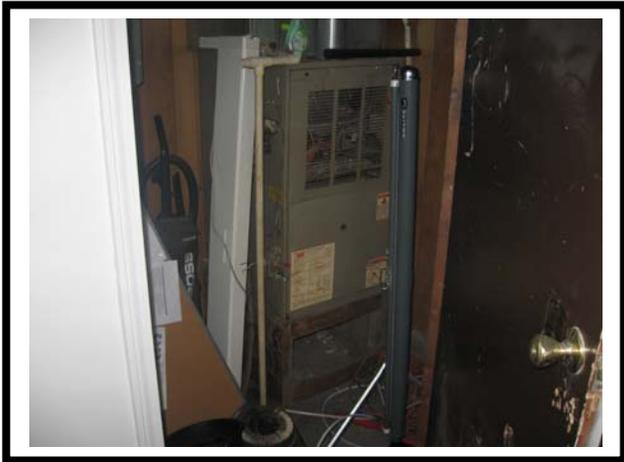
Photo 45 – No gas to furnace, exposed wire splices, water in controls, improper gas line, very rusty, no data tag. Unit not inspected.

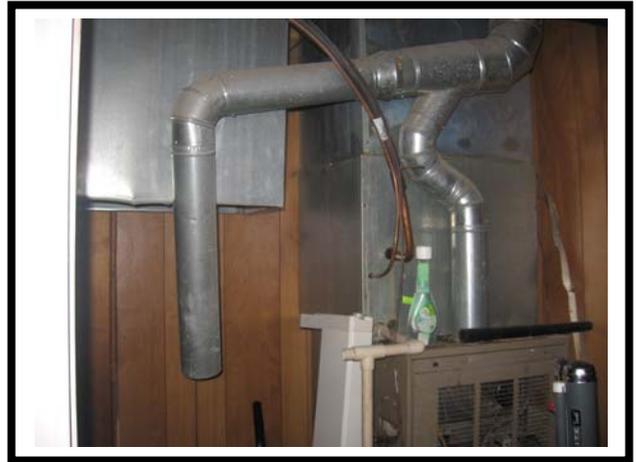
Photo 46 – Open unsealed and unused flue by furnace. Safety hazard (carbon monoxide) if the furnace was actually being used.

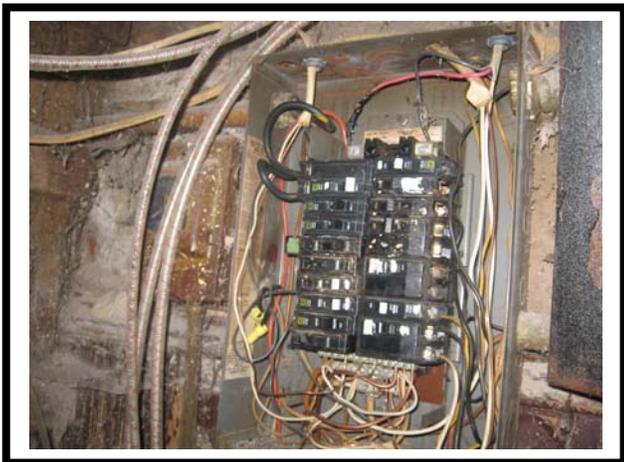
Photo 47 – Panel has oversized breakers, direct tap connections, ground and neutral wiring mixed and its very corroded inside.

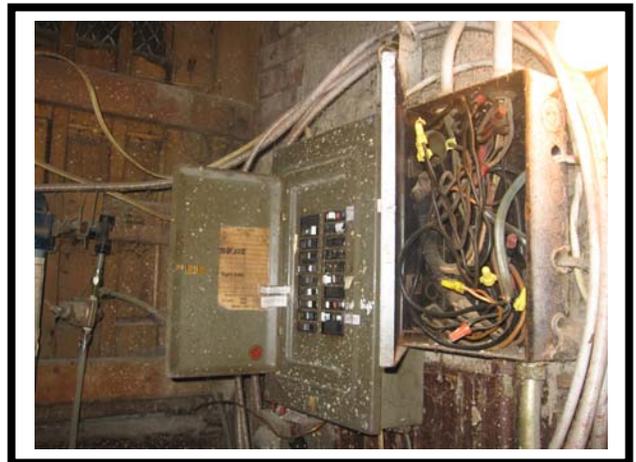
Photo 48 – Electrical defects in Bldg like extension cord wiring, ungrounded outlets, exposed wire splices, junction box too full

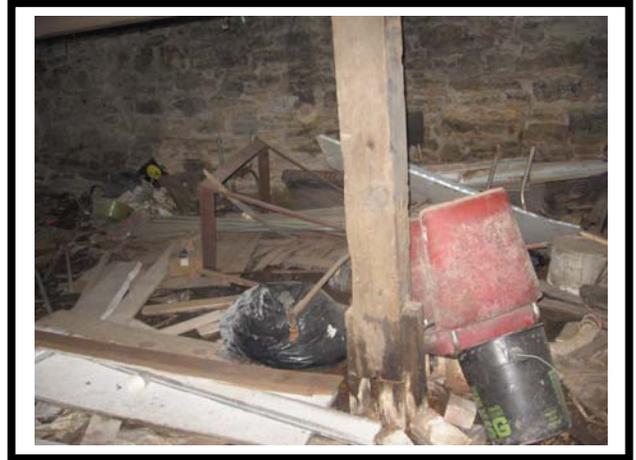
Photo 50 – Crawlspace filled with debris. Potential home for rodents & termites, etc

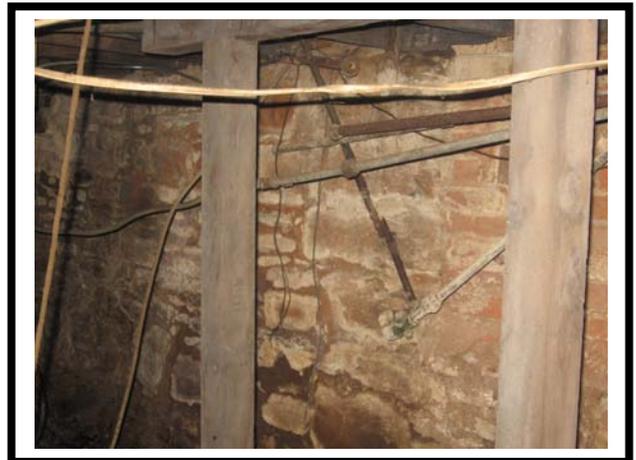
Photo 52 – Loose piping & loose electrical wires in the crawlspace area.

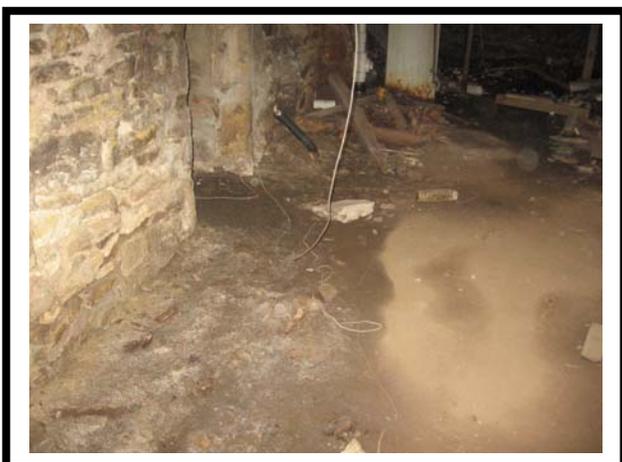
Photo 53 – Crawlspace floor is wet and should have a plastic vapor barrier there.

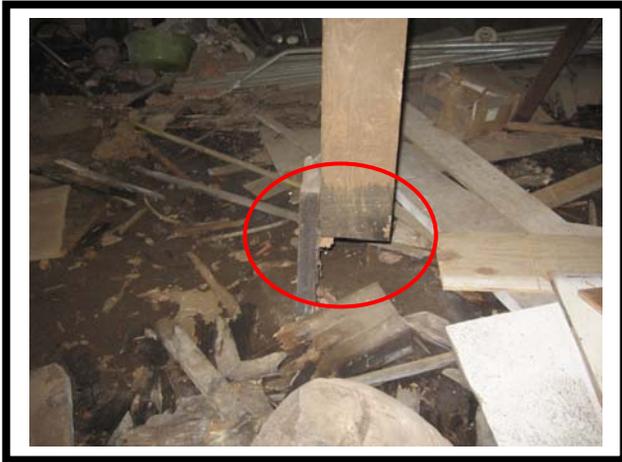
Photo 55 – More wood rot at base of support posts in crawlspace. Inadequate support

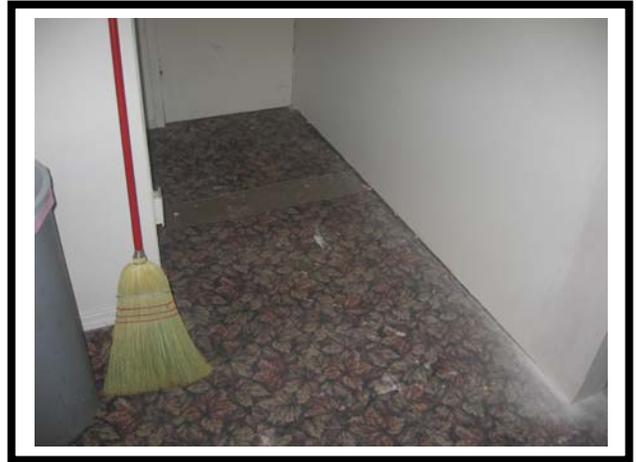
Photo 56 – Floor above crawlspace soft and spongy at spots. Repair as needed.

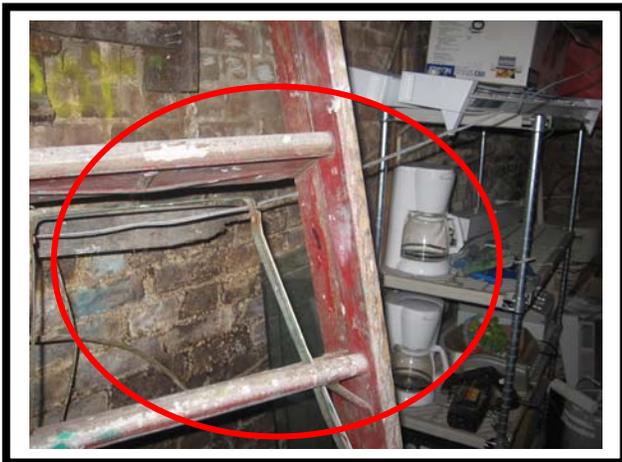
Photo 57 – Sections of brick foundation walls show past moisture penetration.

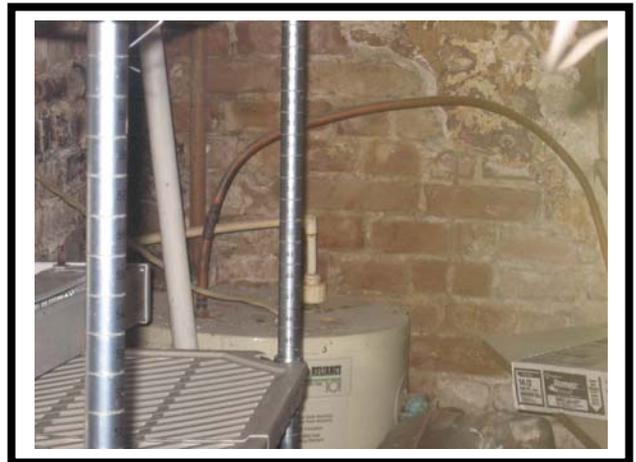
Photo 58 – Access to electric water heater blocked. Wires not in conduit. Plastic piping closer to tank than recommended for safety
