Inspection Report

Property Address:
1567 E. Anywhere Ln
Kansas City MO 64055

Dan Bowers Company

This is a **Property Condition Report "PCR"** generally using the **ASTM E2018** as a starting guideline to describe the condition of building or buildings for the property inspected. **This process involves visual observation of the property by a person or entity.** It's purpose is to help develop an opinion and preparing a PCR of a commercial real estate's current physical condition. At the option of the user and for an additional fee, the PCA may include a higher level of inquiry and due diligence than the baseline scope described within this guide OR at the user's option, it may include a lower level of inquiry or due diligence than the baseline scope described in this guide. If there are such deviations from this guide's scope it should be disclosed here on this page. **A PCR is a written report, prepared in accordance with the recommendations contained in this guide, that outline the consultant's observations and opinions as to the subject property's condition, and opinions of service or repair, etc for material physical deficiencies that were observed.**

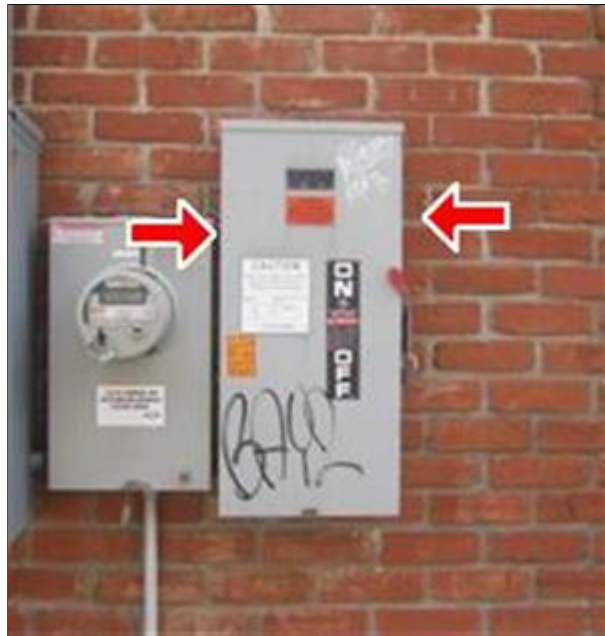
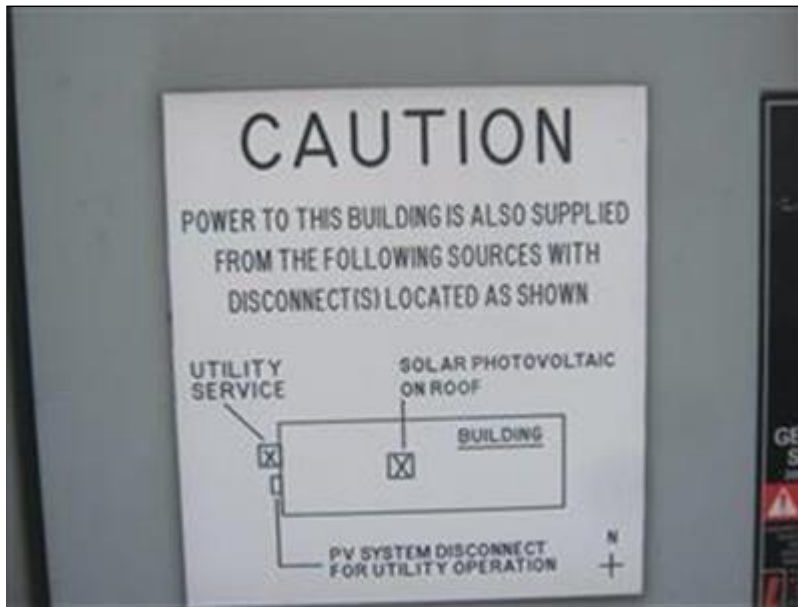
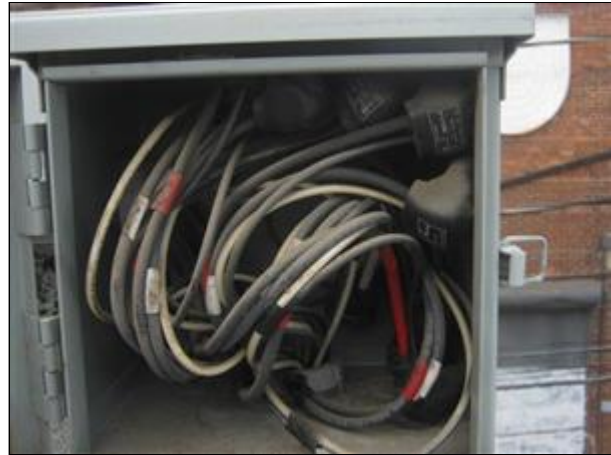
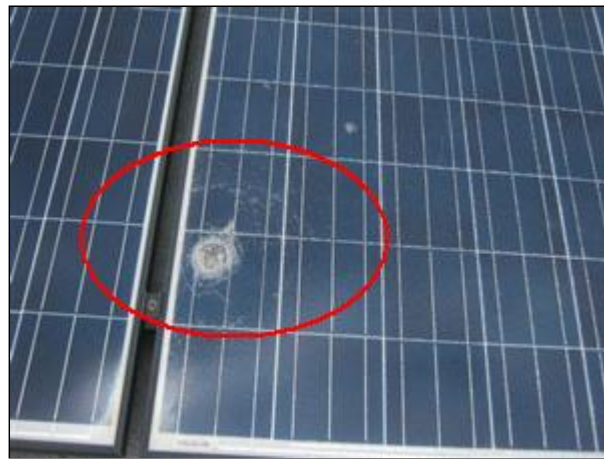
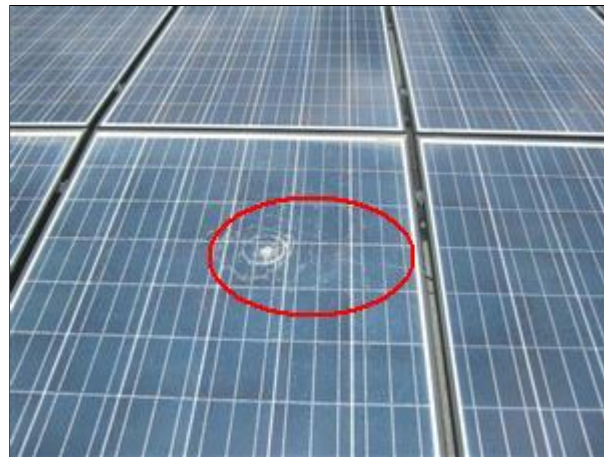
We noted several panels with visible damage, and recommend having a professional Solar Panel contractor Service and **Check these prior to leaving your due diligence period to determine if the damage is just cosmetic and they are functioning properly OR if Repair is Needed**. Several Company's that we understand do this are **Ampray Solar (816) 287-4118** or **KC Energy Solar (816) 268-7810**. Other companies may be found online or in the phone directory.

The damage may be hail related If so there might be insurance coverage for this from the sellers insurance policy.

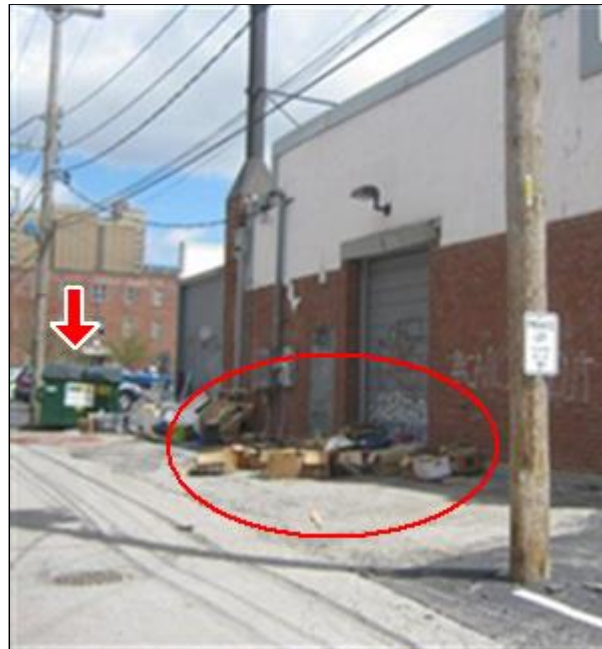
F. Picture 1

Apparently trash pick-up has not been done for awhile as there was a lot of trash / debris accumulating at the rear of the building needing removal.

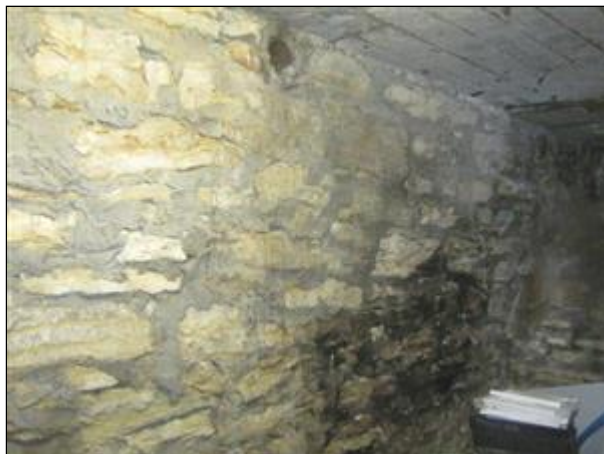
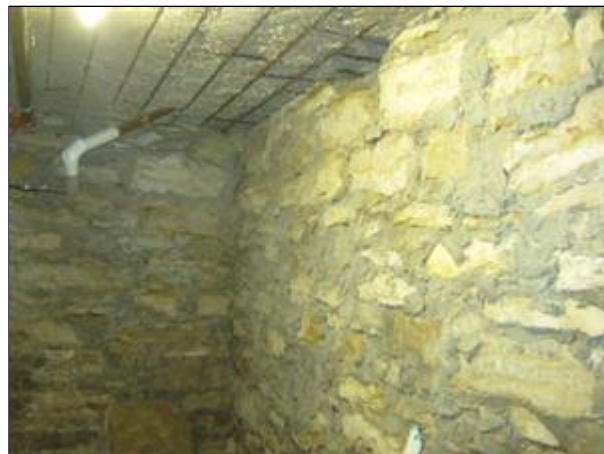
Most of the building is on a slab foundation with a very small basement area. Some parts of the basement had storage or equipment. The slab areas had equipment or shelving at some areas. Due to this and the soil or flatwork level outside, etc not all of the slabs were visible. They look functional where we could see them with small cracks in the concrete.

Many slabs are found to contain small cracks in the concrete. Those less than 1/4" wide and which exhibit no significant vertical or horizontal displacement are not usually regarded as being structurally threatening. They can typically result from concrete shrinkage, but can also be caused by a deficient mixture of concrete, deterioration, seismic activity, expansive soils, downspouts that are clogged or that terminate next to the foundation. If they are not kept sealed they can allow moisture to enter a structure.

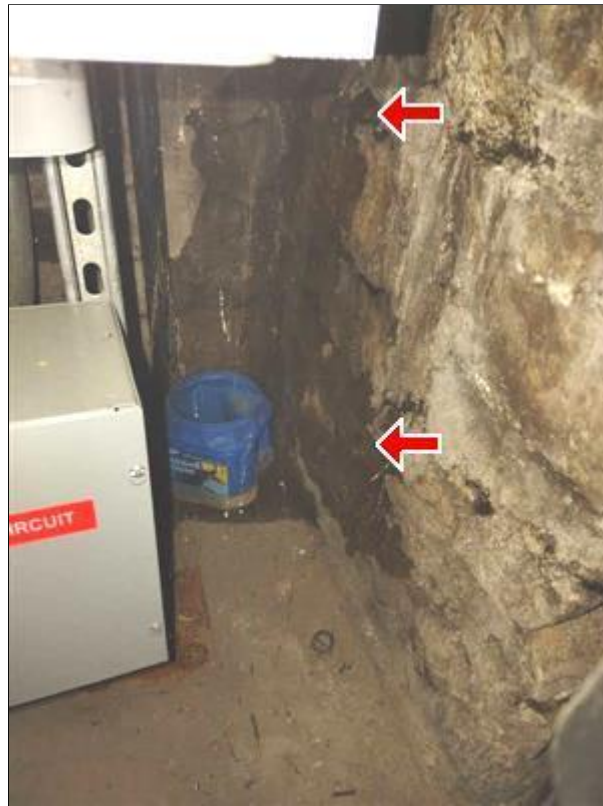
A. Picture 3

(2) We observed signs of current moisture leakage in the basement. **We recommend service and repair by a competent foundation or water proofing contractor**

We did not observe a floor drain or sump pump, etc present in the basement. This was fairly common in buildings of this age. Due to our current building standards and expansive soils, new buildings would have a floor drain and/or sump pump drain system present. There is a lot of expensive equipment in the basement and if used for storage of perishables, **we would recommend installing a drainage system.**

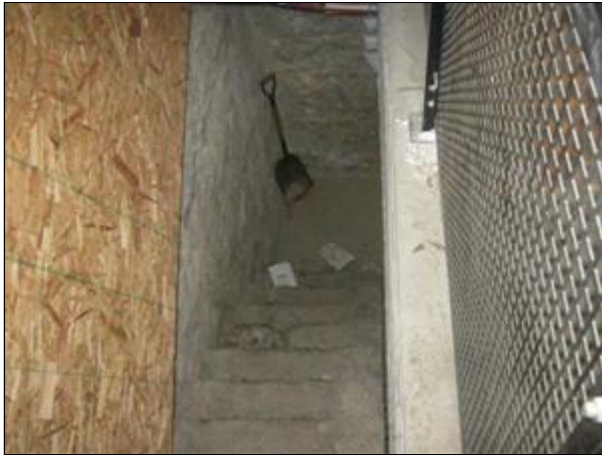
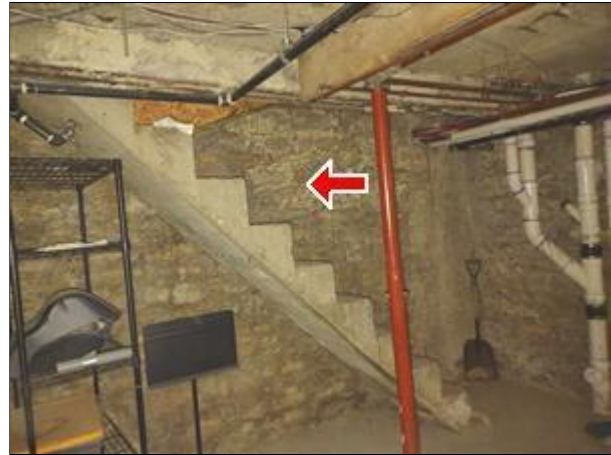
1. The stairs at the basement are steeper and narrower than we typically see (building standards recommend they be 36" or more wide). This can pose a safety concern.
2. No handrail was present at the basement stairs. Any stairway with 4 or more risers should have a handrail on at least 1 side.
3. The guard railing at the basement stairs was missing. For safety, a guardrail is needed at any elevated floor or walk surface, if there is 30" or more of a vertical drop to the floor or ground below.
4. **Service and correction would typically be recommended, however with the stairs being concrete it is doubtful if this can be readily or economically done.**
5. See Examples

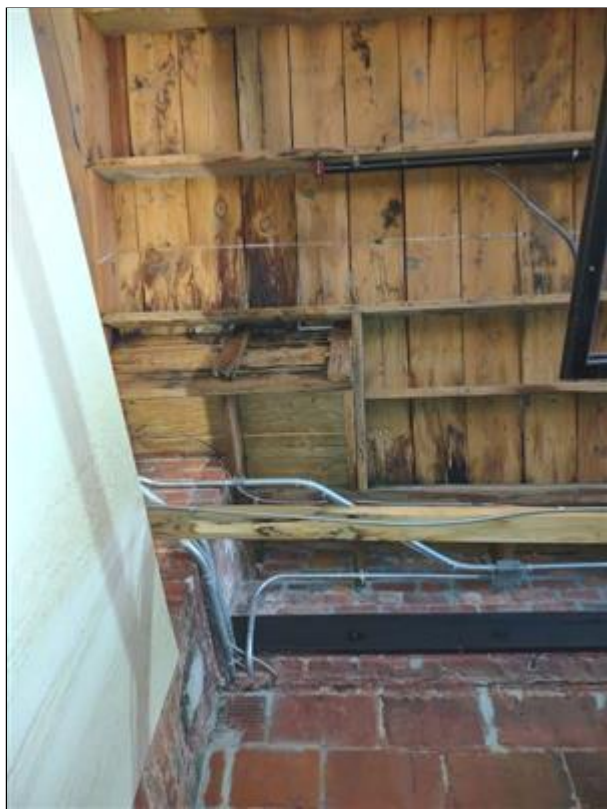
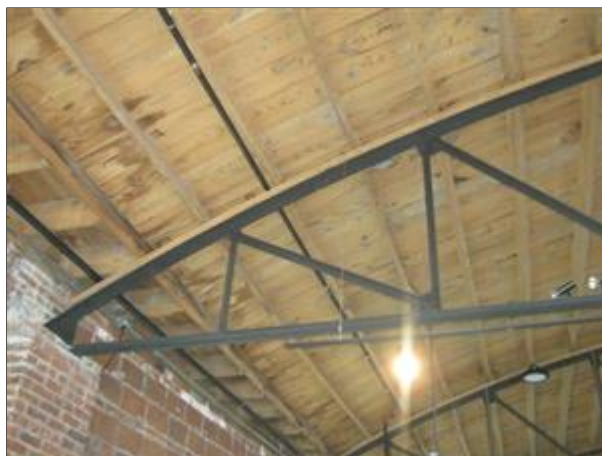
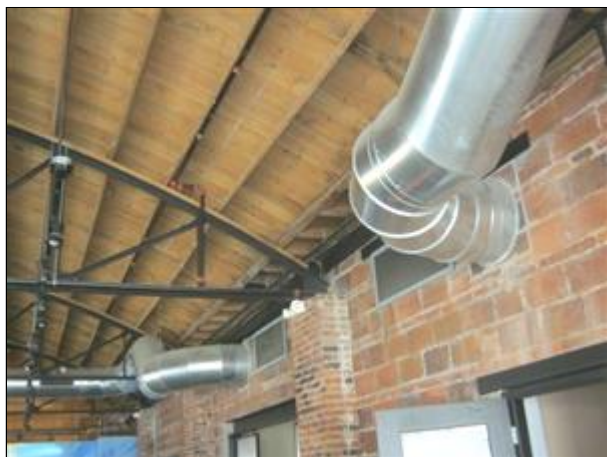
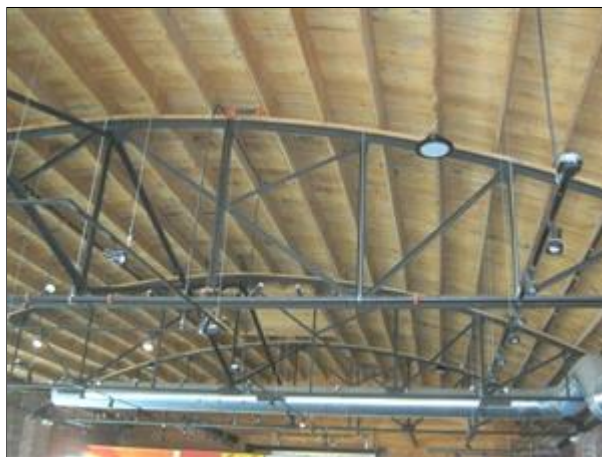
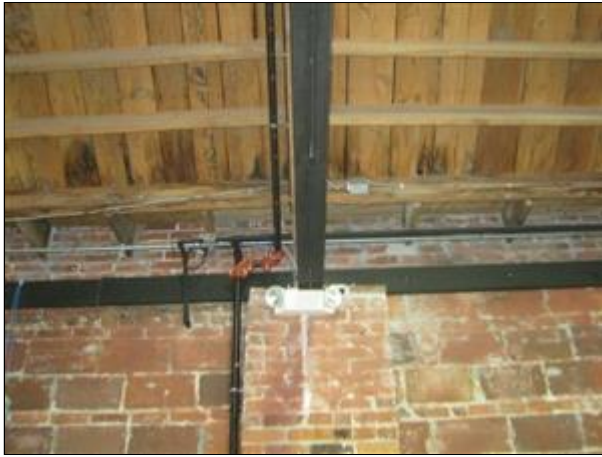
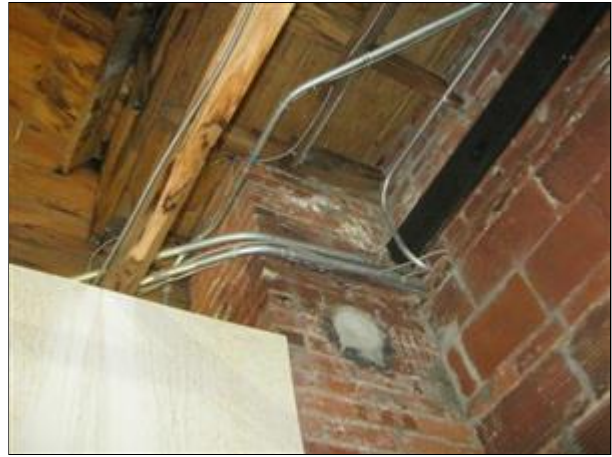
There were moisture stains present. We scanned them with an IR camera and at this time the stains were dry. Monitor them in the future.

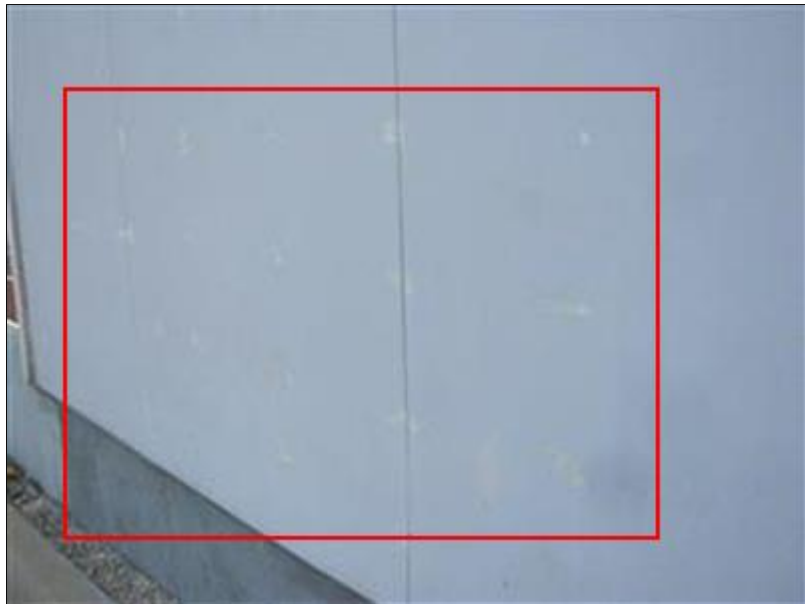
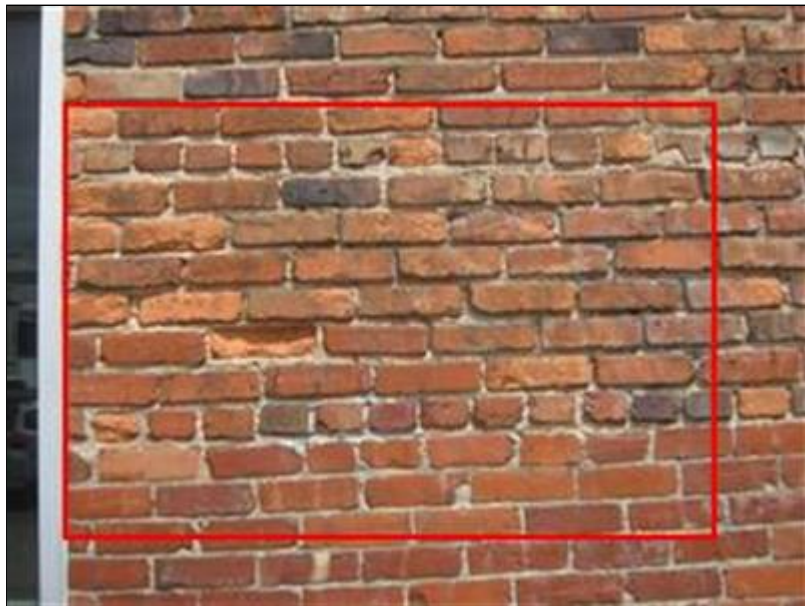
In our opinion the exterior walls (brick, cement panels, etc) appear to be in overall functional condition showing wear and deterioration (such as the spalling brick with some soft mortar, and the cement panels with nails showing through) that are not inconsistent for their type, age and useage.

There were cracks, chipped, spalled and damaged bricks; there were exposed nail heads on the cement panels subject to rusting or leaking; soft mortar or worn caulking and sealants.

Ongoing Service, Tuckpointing, and Maintenance recommended

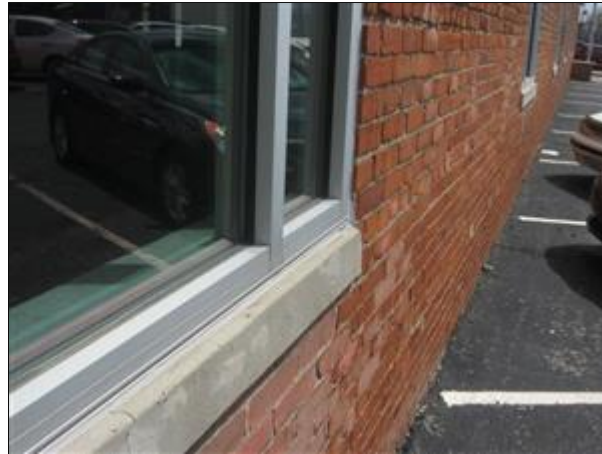
D. Picture 5

In our opinion the exterior metal windows look to be in functional overall condition with wear consistent with their type and usage. Some sealant is worn or split. Have a competent contractor caulk, seal **AND** address any place below the soffit line where they meets another building material, etc.

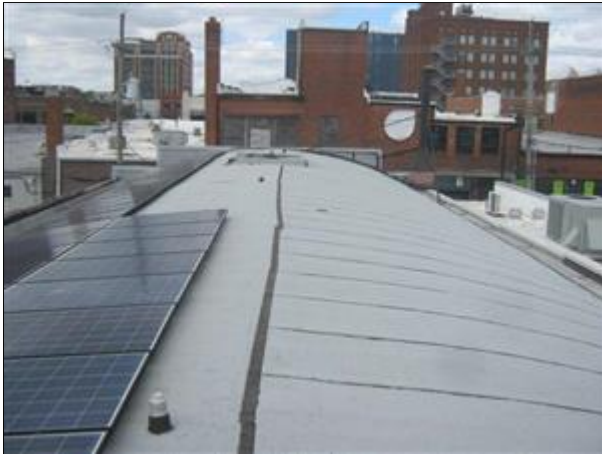
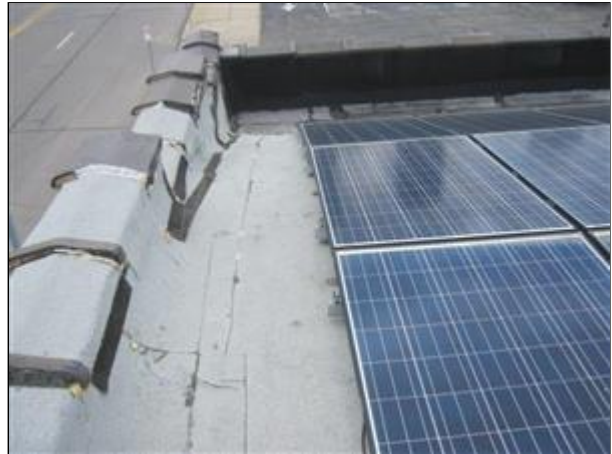
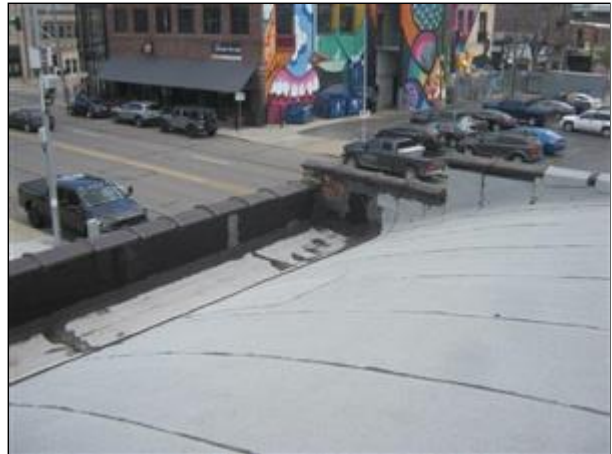
The roof is a combination of flat, low slope and a barrel roll design. The roof was examined by the use of a ladder at the patio area, then mounting and walking the roof. There were stains on the roof at the trough areas that indicated it may have ponded water at some time, but it had rained and snowed in the past few days and it was not ponding at this time.

The general overall condition appears functional with signs of wear, weather, age and prior patching that in our opinion do not look inconsistent for its type, age and useage. Regular maintenance and inspections are advised to achieve continued service.

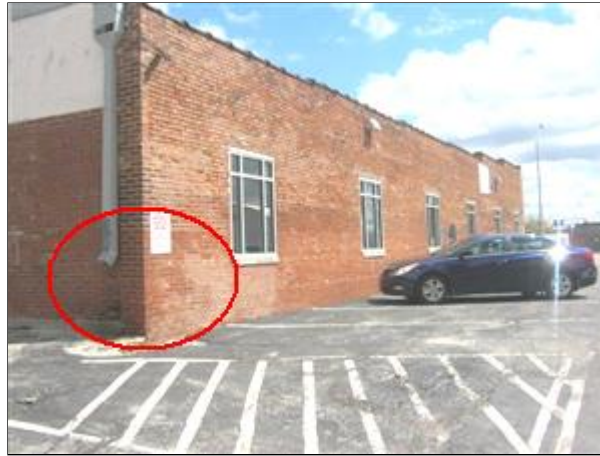
E. Picture 6

We noted some gutters or downspouts improperly depositing the roof run-off water next to the foundation. See Example

This can lead to moisture leaks at the building or foundation. We recommend extending them further away from the building (6' or more) where applicable.

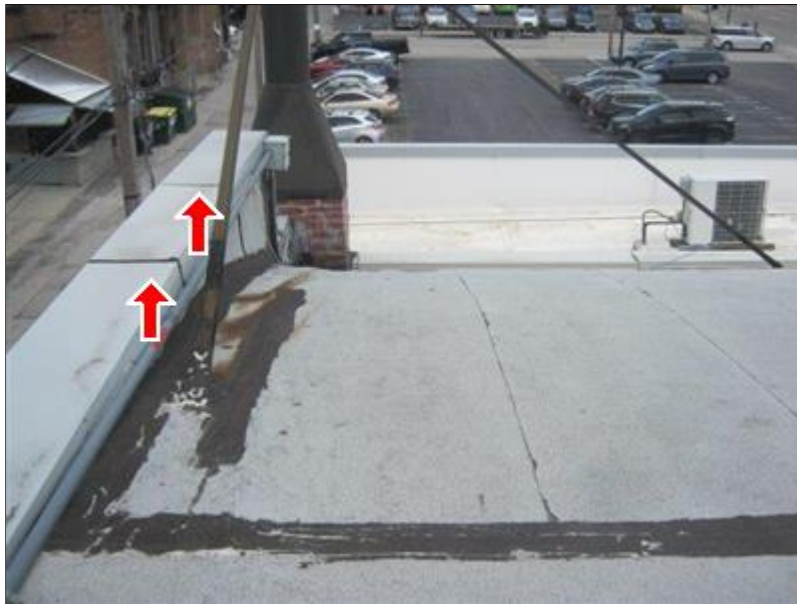
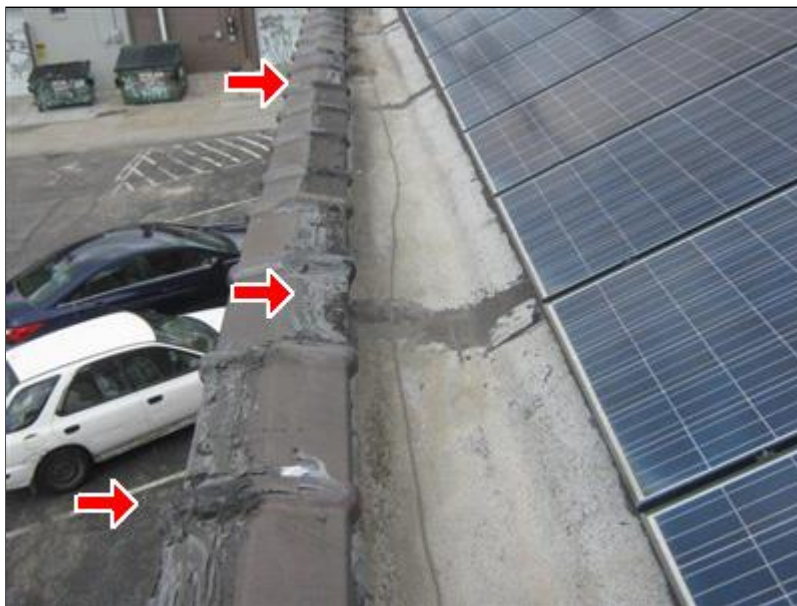
Most caulking or mastic looks like it was good to start, but now has various places where it is worn, separating, split, etc (all of which can allow moisture intrusions). Have a competent contractor caulk **AND/OR** re-seal the flashing and tile.

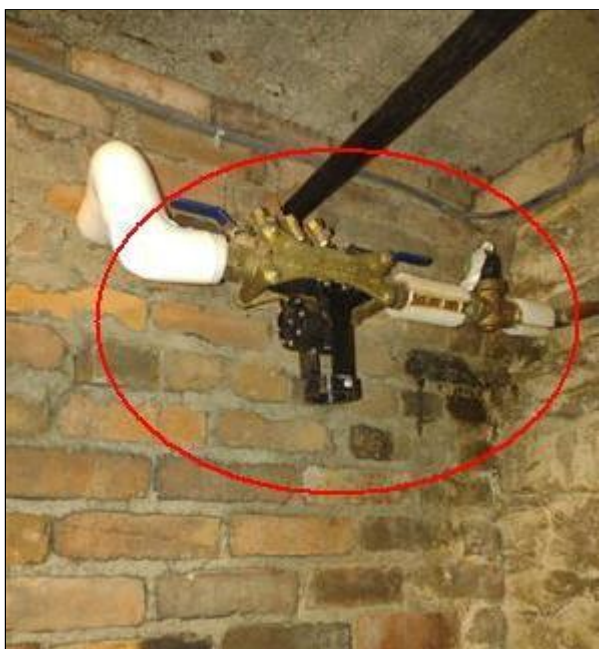
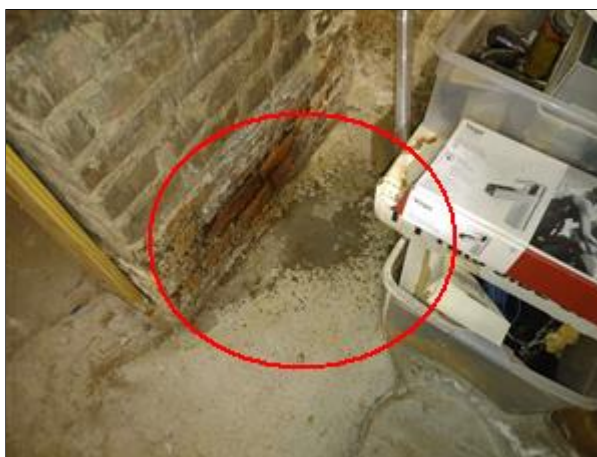
The device and/or fittings were leaking. Service and Repair.

A. Picture 2 Backflow Prevention

A. Picture 3 Leaks

We recommend that a licensed Backblow Specialist or Plumber inspect the system and verify it is functioning properly.

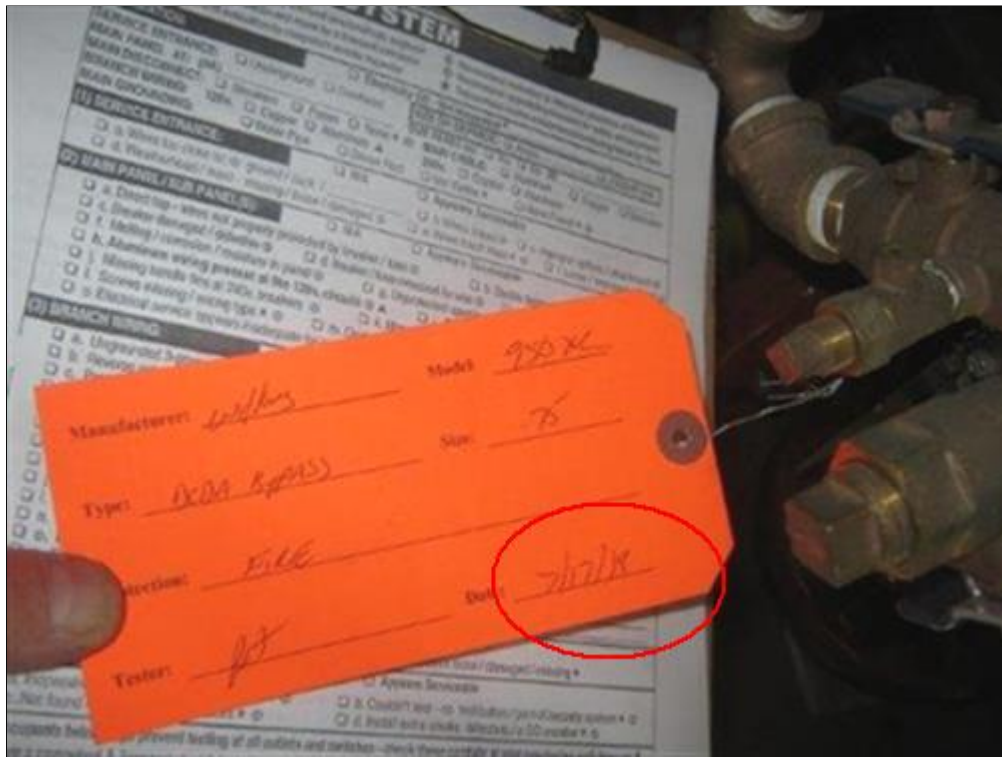
(2) The data tag on the sprinkler system shows the last service / inspection was in 2018. Most cities require periodic (annual or bi-annual) testing by a licensed plumbing **OR** mechanical contractor that specializes in testing of these systems. We are **NOT** licensed plumbers, etc.

B. Picture 8 July 2018

We recommend that a licensed Mechanical Contractor or qualified Plumber service / inspect the system and verify it is functioning properly.

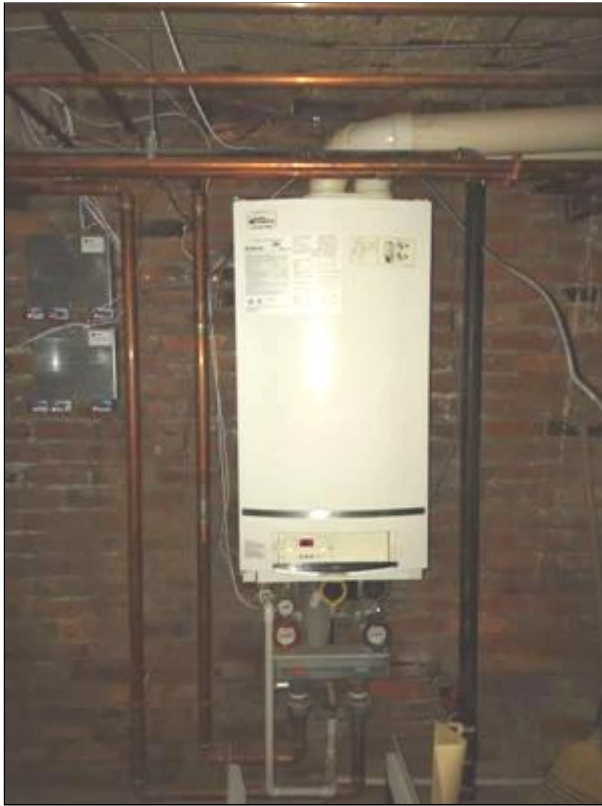
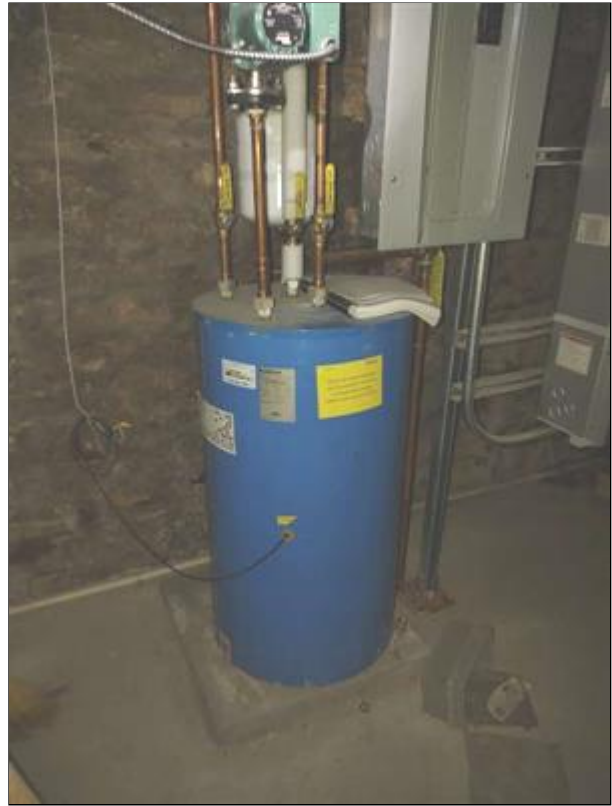
The circulation pump was running but the unit was not producing heated water so we could NOT check the system. Have a competent professional contractor Service and Repair as Needed.

D. Picture 1 Boiler / Instant-Hot Water Heater

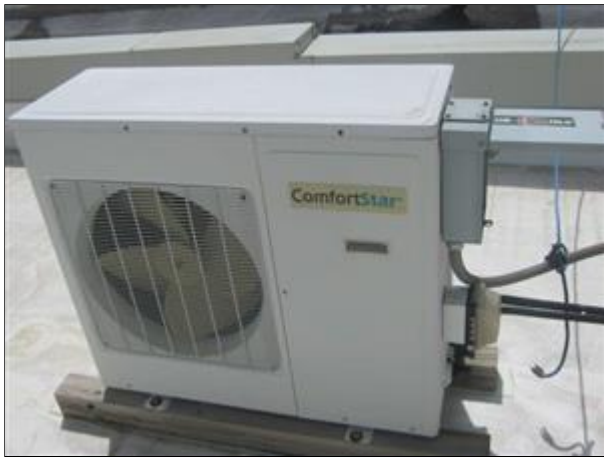
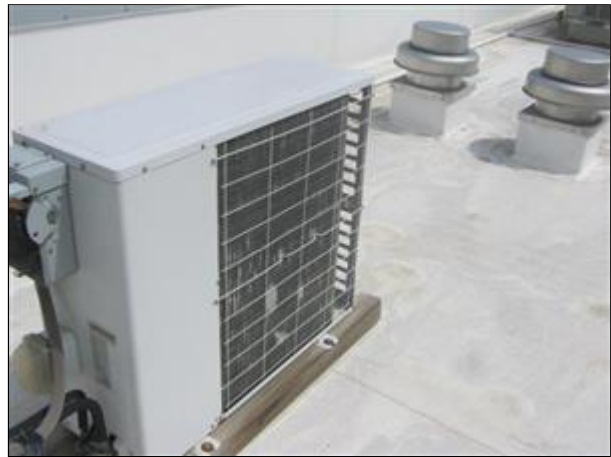
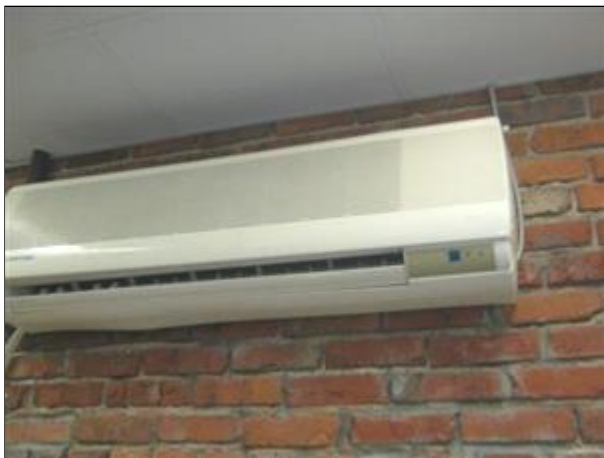
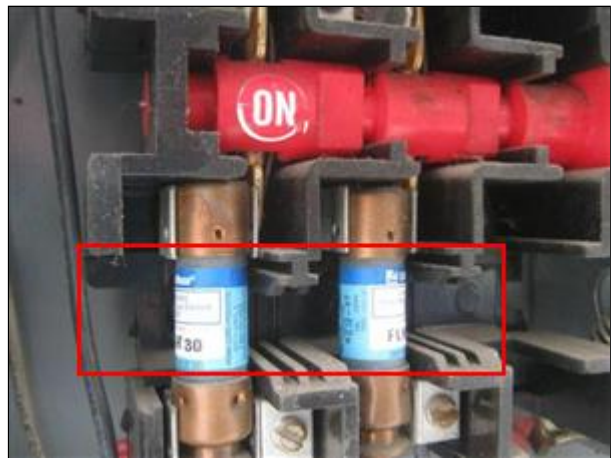
The RTU's use R-410A Refrigerant. The Mini-Split uses R-22 Refrigerant and R-22 production was banned after January of this past year. Most Service Companies have stockpiled R-22, but future repairs may be more expensive as this type refrigerant gradually gets harder to get. Budget for unexpected repairs **AND** continue to use and service the units until replacement is needed. With the current ban on R-22 and newer energy standards, when you have to replace the existing unit it is our opinion you could anticipate replacement costs to be higher, So plan or budget accordingly.

Since we could NOT operate the mini-split and we did NOT see signs of recent service on the units themselves, prior to leaving your due diligence period we recommend Service and a complete system evaluation by a licensed hvac contractor. Such an inspection would involve inspection of the cooling coils (inside and outside), the heat exchangers, controls and areas not readily visible. It will also include leak checking coils; checking freon levels, etc.

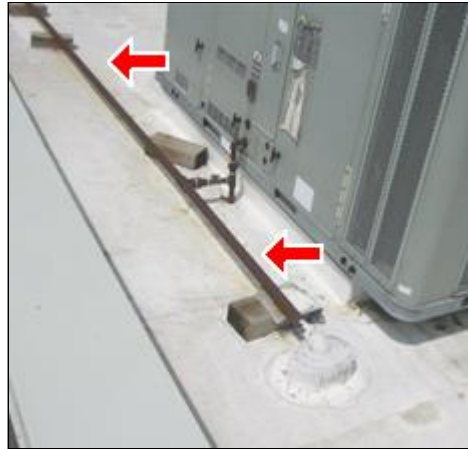
Some gas pipes are rusted or corroded. These have the potential to become unreliable and develop leaks. Correcting this condition typically involves installing a protective coating or sealant on them.

F. Picture 7 Rusty Gas Lines

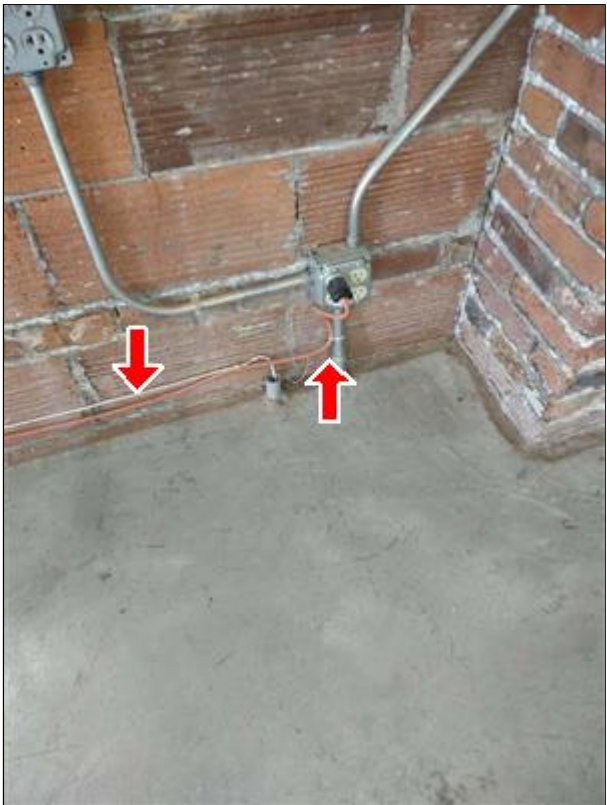
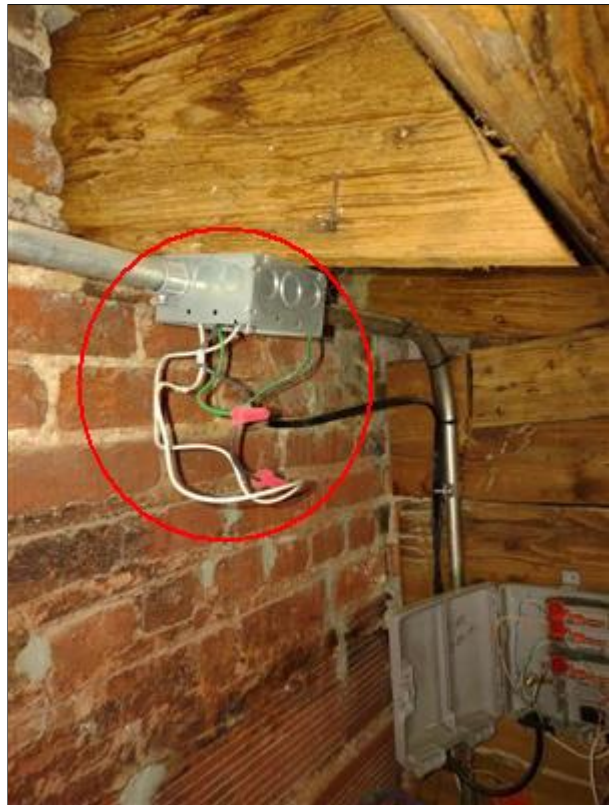
During the examination of the electrical branch circuit we noted deficiencies OR unreliable conditions, such as the following conditions: an open electrical junction boxes with exposed wiring at the loft area; an extension cord used for permanent wiring; lights we could not get to operate (check the bulbs to start with);

Some **"wet areas"** (wet areas are locations like kitchens, restrooms, exterior, unfinished basement areas, etc) did not have GFCI protection. Current safety standards recommend GFCI's at these type areas. We recommend installing a GFCI at any applicable area without one.

Have an electrician or qualified individual service and correct as needed.

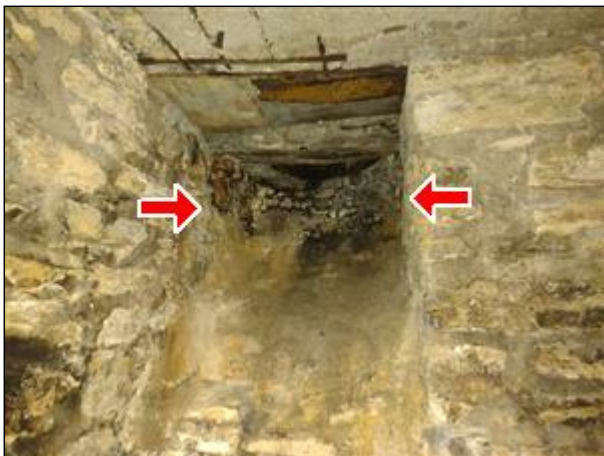
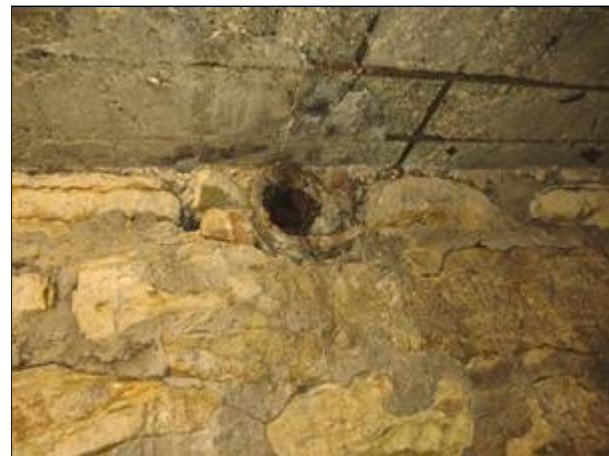
FYI - There was an old unused coal chute and/or chimney flue present with nothing connected to it. This is considered inoperable in its current condition. It was **NOT** inspected as part of the General Inspection. If you ever decide to use it It should not be used until inspected for safety by a qualified chimney sweep.

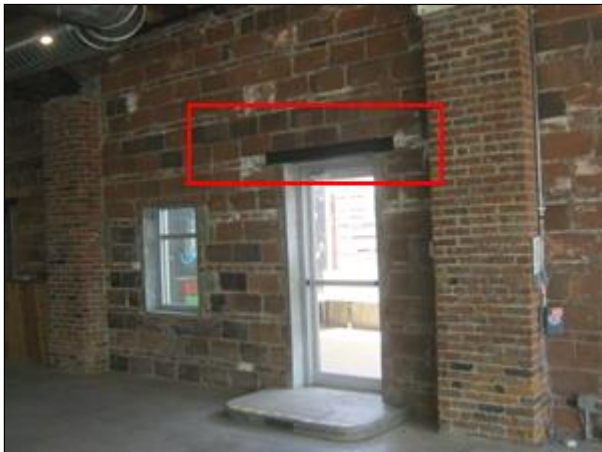
Although Emergency Exit signs were present at many locations, they were not seen at every Exit in the building (door onto patio - recommend adding one). It would also be beneficial if it was of the type that have battery back-up lights that are illuminated / lite up if power goes out See Examples

B. Picture 1 Not Present

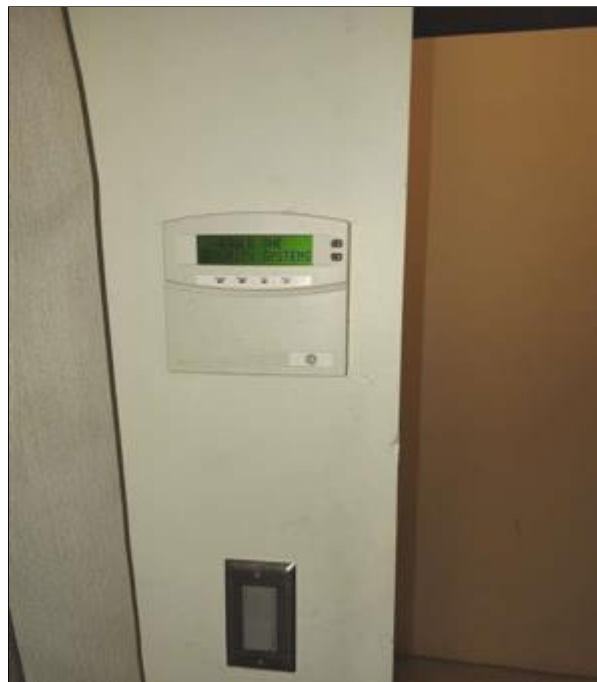
D. Picture 1

A security alarm system was present in the building and look functional, but its control case was open with wires looking loose or disconnected and these are **NOT** activated **NOR** set off as part of the **VISUAL** survey and review. We recommend having an alarm specialist or contractor verify proper function of the alarm system(s) before your due diligence period expires. We recommend you obtain all past alarm inspection and maintenance records from the current owner before your due diligence period expires.
