Inspection Report

Property Address:
4934 S. Happy St
Gladstone MO 64065

Dan Bowers Company

Date: 10/3/2012	Time: 09:30 AM	Report ID: 42676 - 15
Property: 4934 S. Happy St Gladstone MO 64065	Customer: Bobby Mechanic

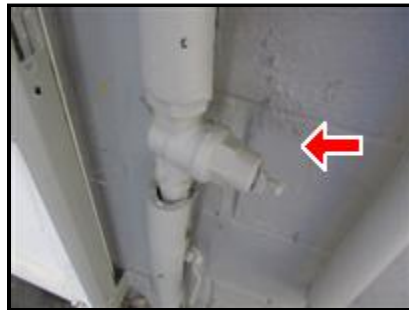
2.0 Picture 2 PRV

(2) **FYI** - The plumbing supply system has a PRV (pressure reducing valve) in the water lines. This typically means you have high water pressure in the building (usually a good feature). In the past PRV's were not always used, however newer plumbing codes, building standards and even some water heater manufacturers recommend that when a PRV (or closed system) is present - you install an expansion tank (these devices function similar to an overflow tank on a cars radiator system). A recent story in the Kansas City Star reported that although expansion devices have not been commonly required in our area in the past, some insurance companies have now started to deny coverage to damaged water heaters or supply lines when this condition exists **AND** there is no expansion tank, etc present.

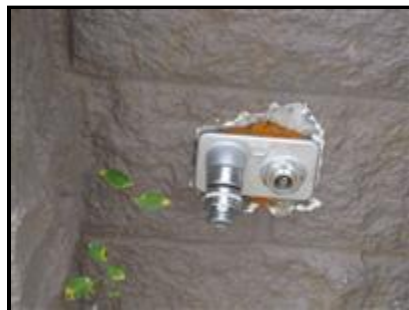
2.3 Picture 1 Example

2.3 Hose bibb handles were missing at all outside locations.

The water was off to the fixture(s); no operational inspection was done.

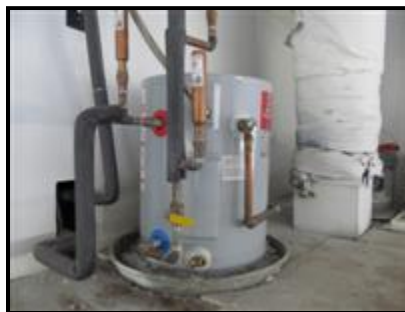
2.5 Picture 1

2.5 Courtesy view of water heater located over the Shop area bath. It has a drain pan under it to catch leakage. The TPRV drain line and drain line for the overflow pan disappear into the walls so we do not know where they terminate.

The water was off to the appliance(s); no operational inspection was done.

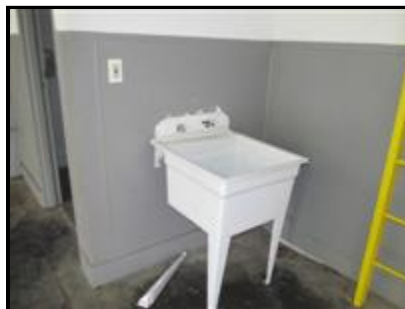
2.6 Picture 1

2.6 (1) The Shop area had a sink that was missing faucets and had a broken leg. Water was off to the fixture so no operational inspection was done. Service and repair as needed.

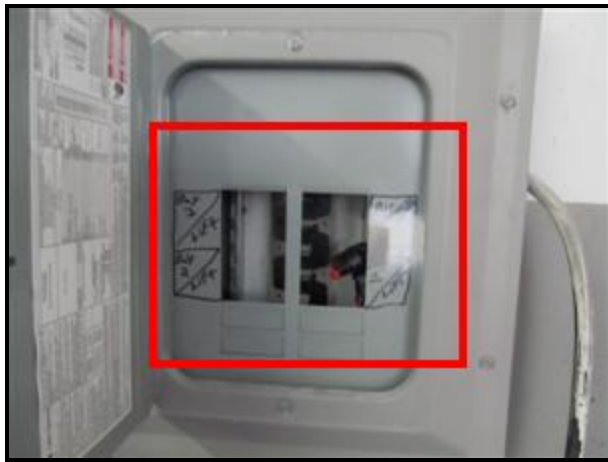
3.1 Picture 2 Open Gaps/No Breakers

(2) During the examination of the electrical main and sub-panels we noted deficiencies needing repair, such as the following conditions:

"Double-tapped" circuits in the main panel; loose OR improperly terminated wiring inside the sub-panels; wires capped or taped together and not protected by a breaker OR fuse present in sub-panels; unprotected openings OR missing wire clamps in the panels; panel screws missing at the electrical panels); the main panel used nuts versus screws to hold the inner panel on and 2 were partly stripped (we could not fully get cover off (viewed from the side); paint overspray on breakers at main panel; various breakers were shut off, wires were capped but not terminated properly, etc (prevents us from activating breakers, etc that are off); breakers were missing at sub-panel; etc. These are samples of unreliable conditions or deficiencies noted.

We recommend having a licensed and competent electrician read **ALL** electrical comments anywhere in the report; review the electrical system conditions present; then service, modify or repair any defects or unreliable conditions as necessary, to properly and safely correct them.

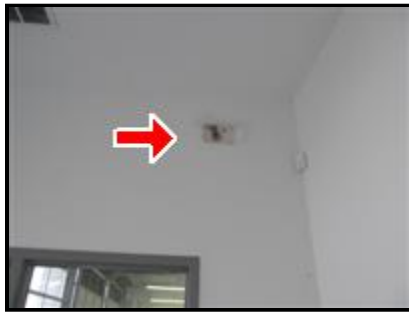
3.2 Picture 1 Missing Fixture/ Office

3.2 During the examination of the electrical branch circuit we noted deficiencies in need of service or repair, such the following conditions:

A missing light or other fixture high on the wall in the customer waiting area; live wires exposed on wall or ceiling surfaces at multiple locations in the shop area (wires are to be inside walls, ceilings or conduit); open electrical junction boxes with exposed wiring in the shop area (cover plates missing); many 220v-240v size wires coiled up, not being used with wire nuts on the ends in the shop area (use or properly terminate them); outlets with no power to them in bath and shop (marked with colored dots); many 110v-120v size wires coiled up, not being used with wire nuts on the ends at the exterior walls of the building (possibly lights or signs) use or properly terminate them); exposed electrical splices noted (electrical splices are to be in a covered junction box or fixture, etc); lights we could not get to operate (check the bulbs to start with); outlets with no power. This is a sample of the branch wiring defects noted at the property. See Samples in Pic's

We recommend having a licensed and competent electrician read **ALL** electrical comments anywhere in the report; review the electrical system conditions present; then service, modify or repair any defects or unreliable conditions as necessary to properly and safely correct them.

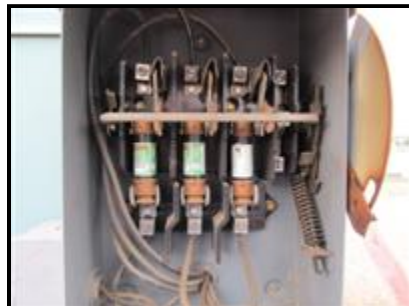
4.0 Picture 1

There is a 110v-120v outlet on the disconnect for the service tech's to use. Its grounded but does not have a GFCI on it. Current safety standards recommend Ground Fault Circuit Interrupters (GFCI's) at electrical outlets in "wet areas". We recommend having an electrician or qualified individual install one.

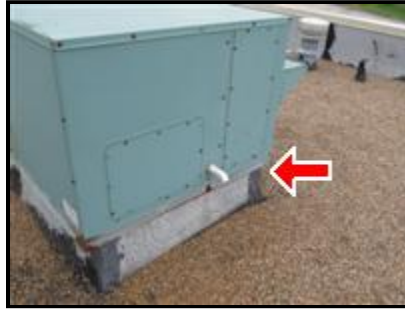
4.1 Picture 7

(2) The AC units condensate drain dumped directly onto the roof. It should be piped to a roof drain OR off the roof to prevent ponding water.

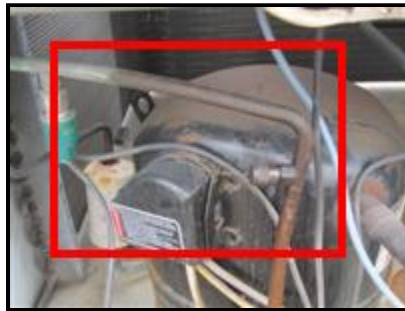
4.1 Picture 8

(3) There was an oil slick on the freon lines in the compressor compartment (possibly from over spray OR could be small leak. Service and check.

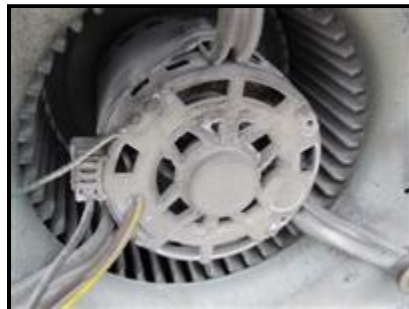
4.1 Picture 9

(4) The blower fan and squirrel cage are getting dirty. This can lead to excess wear, deterioration and reduced efficiency of the furnace and its related components (Clean and service the unit and its related components, such as the cooling coil).

There were loose wires capped off in the blower area. Have the service tech determine if needed OR if a safety device has been removed, etc.

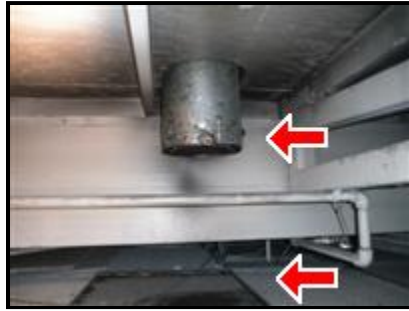
4.2 Picture 1

4.2 There have been 2 ceiling mounted hanging space heaters in the shop. Flues are still present on the roof. and in the attic cavity (the flues are sooted up and show signs of past moisture entry below them - See examples in Pic's). These unit heaters are not present at this time.

A competent HVAC contractor can determine size requirements and replace them as needed.

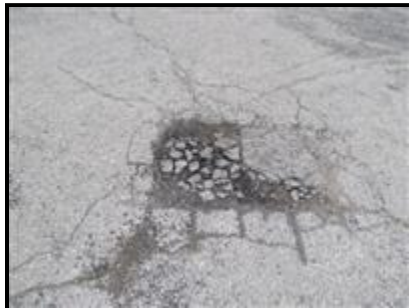
5.0 Picture 1

5.0 Damage or deterioration such as: cracks, movement, or spalling was noted at the surface of the drive and can be a trip hazard

Sections of the drive are low or deteriorated and it appears that they will pond water.

The drive(s) shows movements, cracking or deterioration resulting in an offset surface or other damages at various locations. Repair or replace any applicable areas as needed. This may include sealcoating the surface, sealing the cracks, correcting any surfaces offset by more than 1", and/or restoring the drive to the original position.

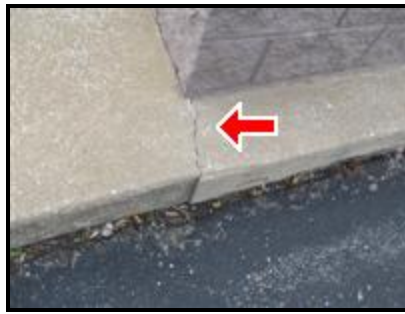
5.1 Picture 1

5.1 Common deterioration such as: cracks, movement, or spalling was noted at the surface of the walk(s).

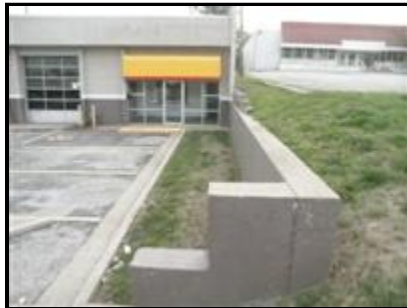
5.2 Picture 1

5.2 Typical cracks, movement or damage were noted at the front concrete retaining wall. Monitor for future movement and repair as needed.

The rear stone retaining wall has collapsed. Repairs recommended.

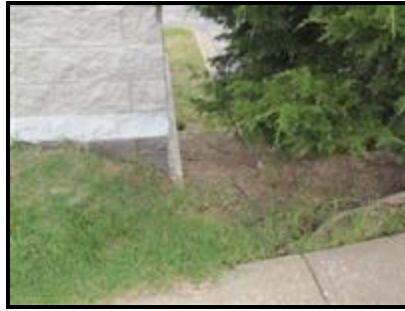
5.3 Picture 1 Example

5.3 There was at least one or more locations around the perimeter of the building where the grading is either flat or slopes backward toward the structure. The drainage should be improved so that the soil slopes away from the foundation at least 6" in the first 10' on all sides.

When the ground next to the foundation is flat or slopes back to the structure, it causes the soil to stay moist. Wet soil can double or triple the stress on a foundation wall. This combined with expansive or heaving sub-soils can lead to cracks, movement, and potential leakage. The grading and/or drainage should be modified to prevent this.

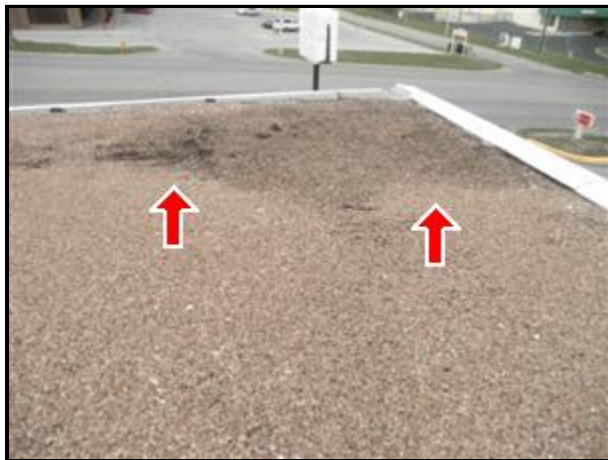
6.0 Picture 5

We noted split or gaping seams in metal or roll roofing; nails driven through the top of parapet metal cap flashing, then caulked (caulking dried out or nail heads protruding); we noted areas with exposed tar, etc (aggregate missing or thin); we noted areas that look like they will pond water; we noted areas around scuppers that look like they may be leaking. These type conditions can lead to moisture intrusion. There are water stains below these areas at several places in the applicable business.

Have a competent and licensed roofing contractor read the report: review the roofing system, its accessories and the conditions; and then service, repair, modify or replace any deficiencies as needed to properly correct them.

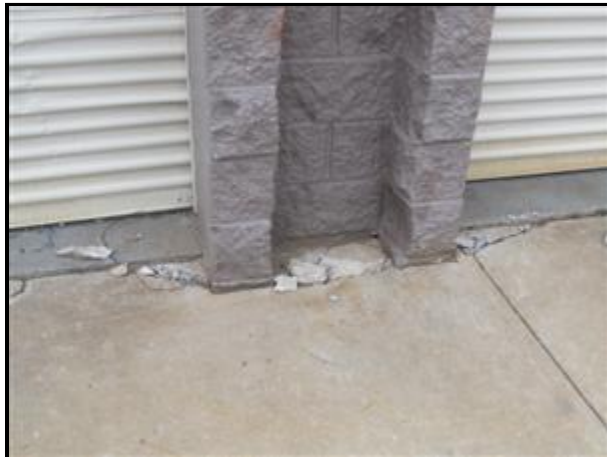
7.0 Picture 1

7.0 Foundation or wall movements noted, mainly along north wall. Review by competent contractor or engineer recommended. This type of movement is usually caused by settlement movements and expansive soils. The amount of movement did not appear structurally significant, however the movement may have affected roof drainage, etc. It would be prudent to have review by competent contractor or engineer.

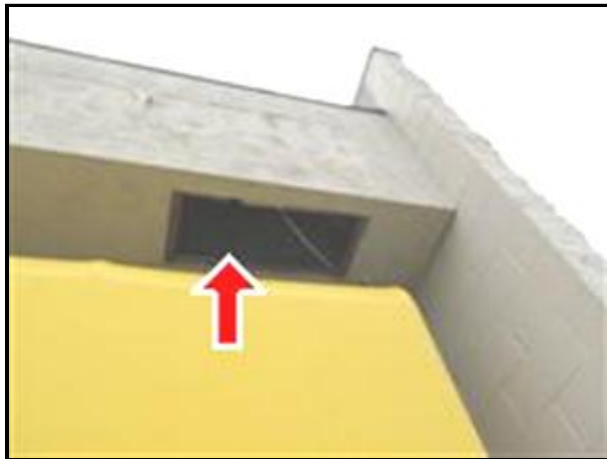
7.1 Picture 1

7.1 An examination of exposed and readily accessible portions of the exterior walls revealed them to be in overall functional condition with some cracks or gaps noted at noted at the wall joints. This type of movement is usually caused by settlement movements and expansive soils. Common scaling of paint or rust noted. The amount of movement or crack size did not appear structurally significant. In our opinion the walls are performing their intended function at this time, however the movement may have affected roof drainage.

We also noted a missing piece of soffit at the front of the building and holes in siding where signs were probably mounted. Service and correct.

Tuckpoint or seal any cracks to prevent leaks and future deterioration, and them monitor them in the future. Water should never be allowed to pond or flow toward the building. The exterior walls, cladding, are in overall functional condition.

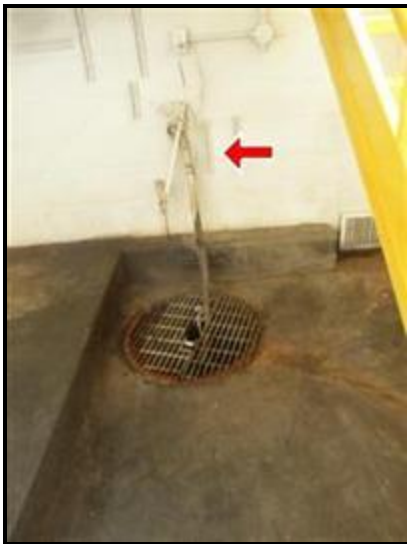
8.3 Picture 1

8.3 The sump pump was functional but the float did not go off until raised VERY high. Adjust the float valve to operate at a lower fluid level. We noted water and oil in the pit and the sump pump exterior drain pipe goes underground. We did not see where it comes out. We suggest verifying with the owner where this is, so you can determine there is a proper drainage through the pipe, etc and that its proper.

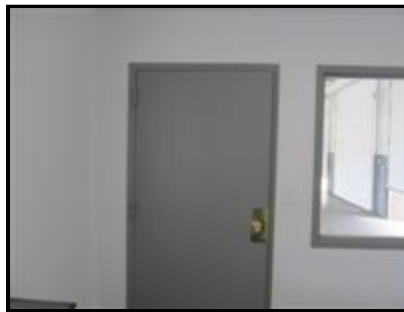
9.1 Picture 1

9.1 We noted several interior door(s) that rub or did not latch correctly (bath and office). Service and adjustment recommended.

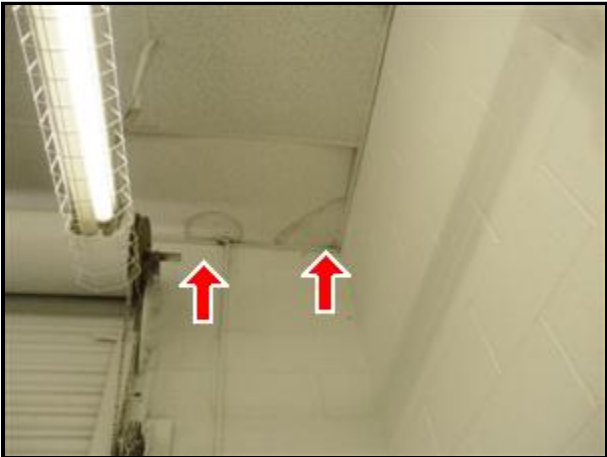
9.3 Picture 1

9.3 There is evidence of past moisture stains at the garage and at ceiling tiles.

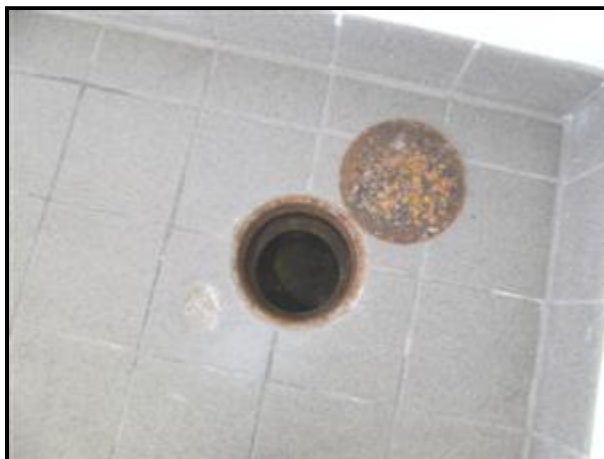
9.6 Picture 1

9.6 We noted what looked at first like a floor drain in the reception office which we felt was an unusual place for a drain. It was dry inside. We also wondered if the opening could be used for a small floor safe. Its purpose is unknown (verify use with seller).

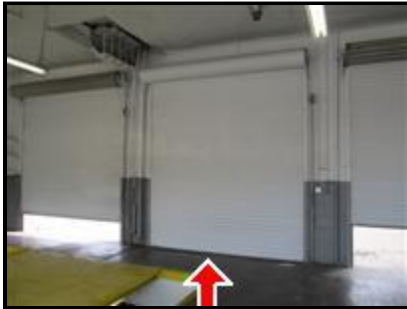
10.2 Picture 1

- 1) The overhead door by the mail slot has a cut in it.
- 2) Several doors on the North side have rust on the door or lintel, OR have minor damage (warping, etc).

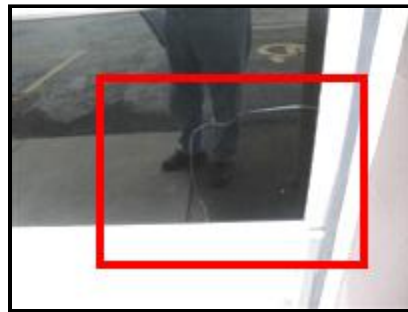
10.2 Picture 5 Cracked Glass

- 1) On the west side, the south overhead door would not stay up.
- 2) On the east side, the south overhead door would not go up.
- 3) The 1st overhead door to the left of the office has cracked glass.

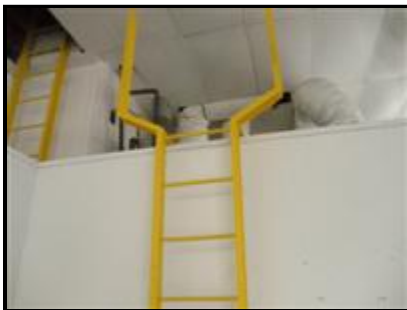
10.3 Picture 1

There were minor moisture stains in attic that were dry at this time. Monitor this in the future.

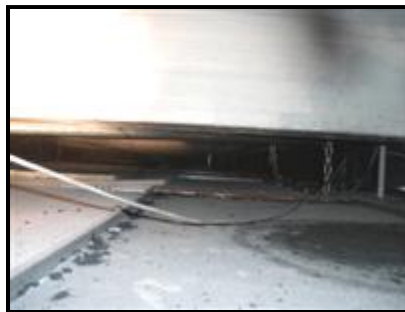
10.3 Picture 5

(3) There was minimal **OR** no insulation installed. We recommend adding more insulation.

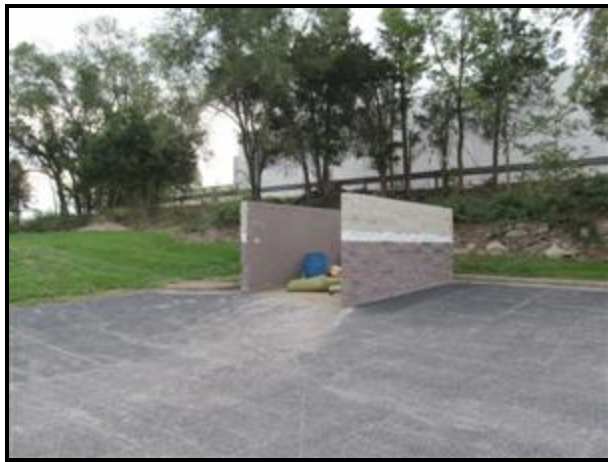
11.3 Picture 1

11.3 The trash dumpster area is at the rear of the parking lot. Its doors are missing. Replace as needed.
