Inspection Report

Saint Jefferson Parrish

Property Address:
6235 Missouri Blvd
Jefferson City MO 65109

Date: 1/17/2019	Time: 09:30 AM	Report ID: 011719 - Church
Property: 6235 Missouri Blvd Jefferson City MO 65109	Customer: Saint Jefferson Parrish

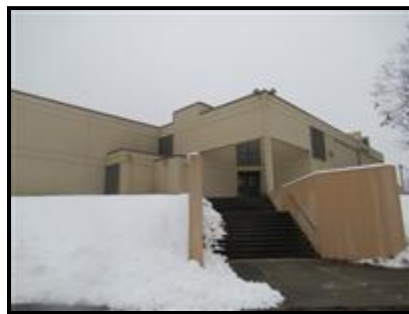
F. Picture 1

The stone retaining walls at the south side of the building has deteriorated or loose mortar and stone that does not look uncommon for the type and age in our opinion. It looks like a contractor may have been repairing it (see sign on top of the wall). Verify with seller if the repairs have been done; if soare they complete and paid for.

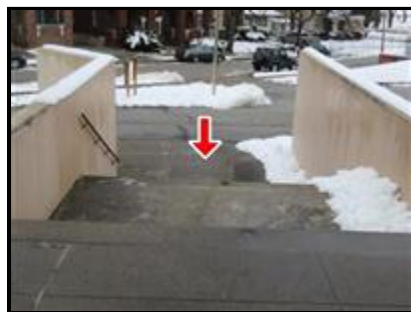
G. Picture 1

G. The front landing stoop and/or steps have had excessive movement (over1"-2" +/- that in our opinion looks like heaving movements) resulting in uneven step heights or other damage that can be a trip hazard. Repair or replace any applicable areas as needed. This may include sealcoating the surface, correcting any surfaces offset by more than 1", and/or restoring the component to its original position.

Have a competent concrete contractor or similar read the report; evaluate the conditions present; then service, modify or repair any deficiencies or unreliable conditions as needed to safely and properly correct them.

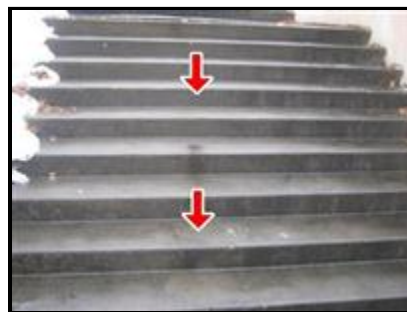
At one time there has been a middle "grab rail at the front steps down toward the street. Its missing / Replace it.

G. Picture 3 Missing Rail

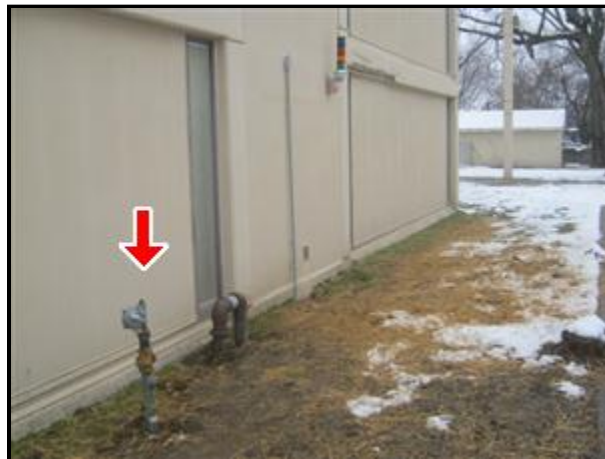
C. Picture 1

However on the exterior of the building the gas meter was gone ???

Have seller or utility company verify how / where gas enters building and where your gas meter is located. Then have utility company or plumbing contractor verify the condition and installation is safe and proper.

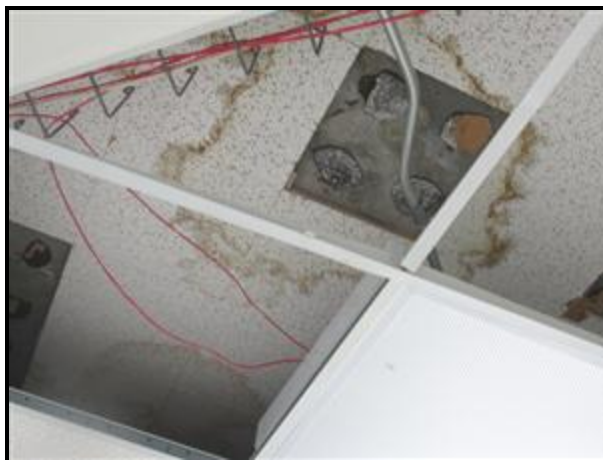
The ceilings were solid at some areas, unfinished at other areas and had "suspended ceiling tiles" at other areas. Several places where ceiling tiles were missing indicated there were 2 layers of ceiling tiles that were just about a foot or so apart (double layers of ceiling tiles suspended ceiling tiles with lay-in tiles above them). With that small a space above them, there was no viable attic space that we observed.

C. Picture 1 2 Layers of Ceiling Tiles

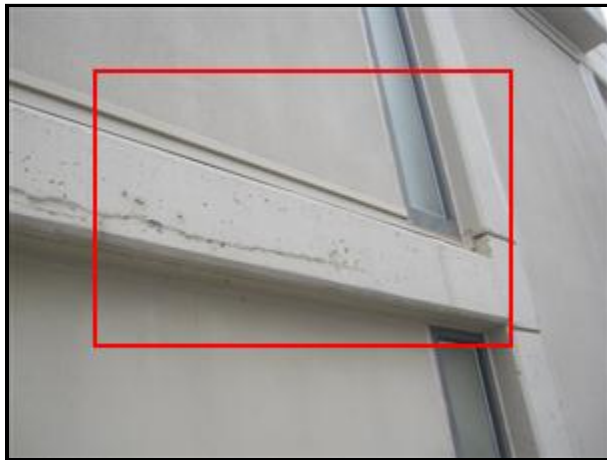
D. Picture 1

We observed cracks, rebar pops, moisture damage, concrete damage, a tilt in beam on areas like the south, east and west walls, the dumpster, etc. Although in our opinion they do not look structurally significant, they should be repaired to help prevent moisture damage, moisture intrusion to the building and to help prevent further damage to the building itself.

Exterior repair, sealing, and water-proofing of concrete and walls, etc recommended.

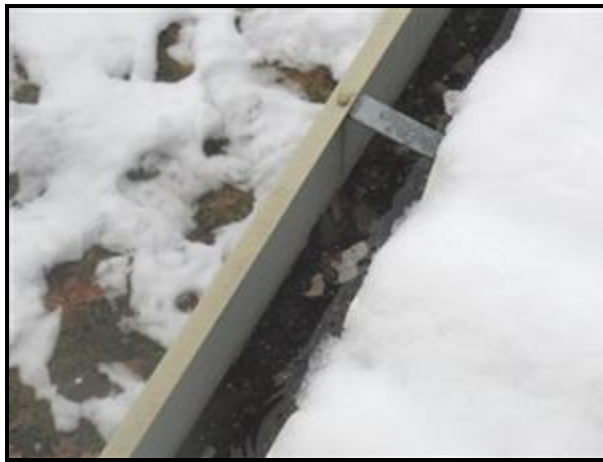
Gutters were snow covered and **NOT** visible **OR** stopped up and holding frozen water most areas. We observed at least one or more scupper damaged outside the building top. Service and Repair as needed.

E. Picture 7 Standing Water

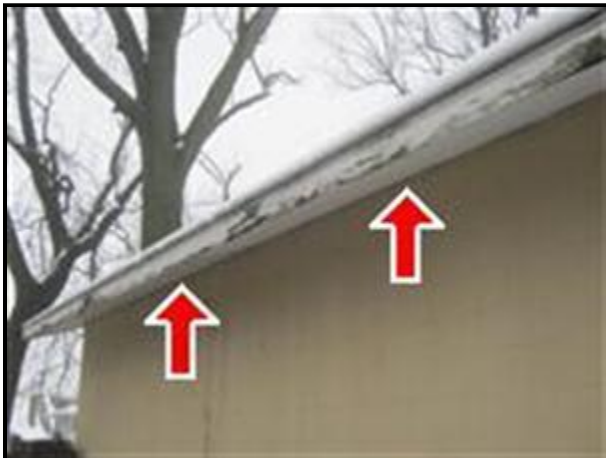
F. Picture 5

1. There was moisture damage and/or wood rot at the soffit, fascia and door areas.
2. There was also bare wood and peeling or deteriorating paint at wood areas.
3. The concrete ramp entering the garage is broken, split and is a trip hazard.
4. Service and Repair Recommended.

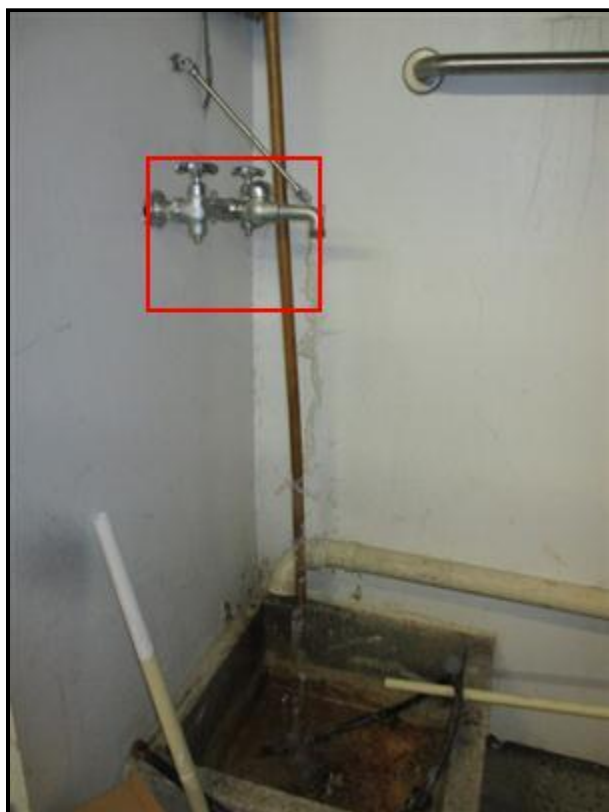
1st floor mop sink leaks;

E. Picture 1 Mop Sink Leaks

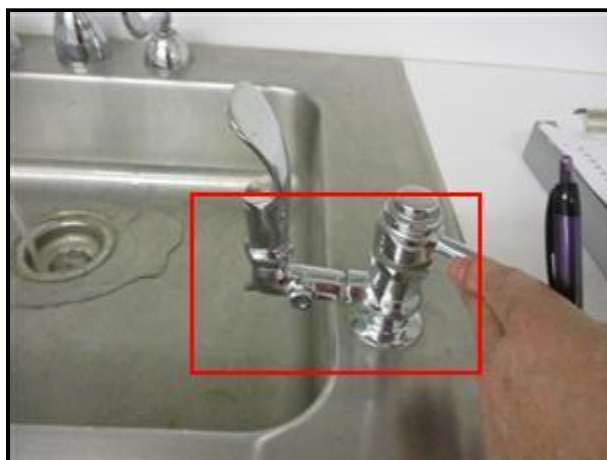
E. Picture 2 Classroom Fountain Leaks

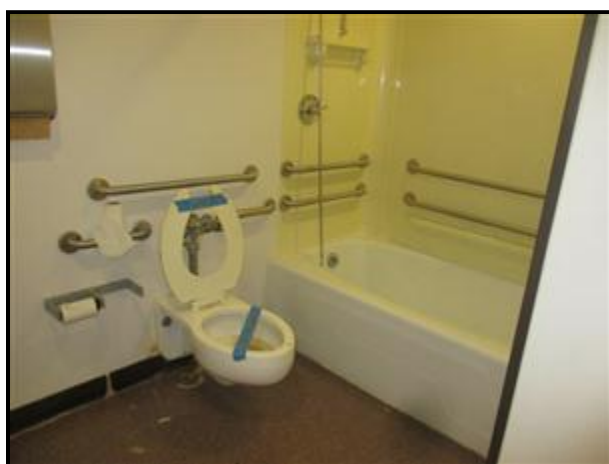
E. Picture 3 Tub Room / Leak / Broken Seat

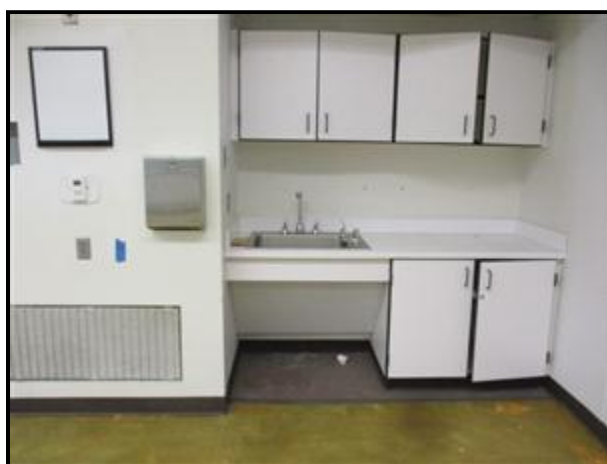
E. Picture 4 Sink Leaks

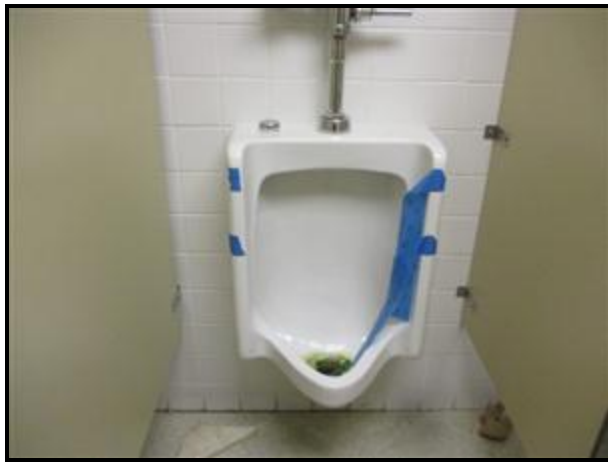
E. Picture 5 Not Working

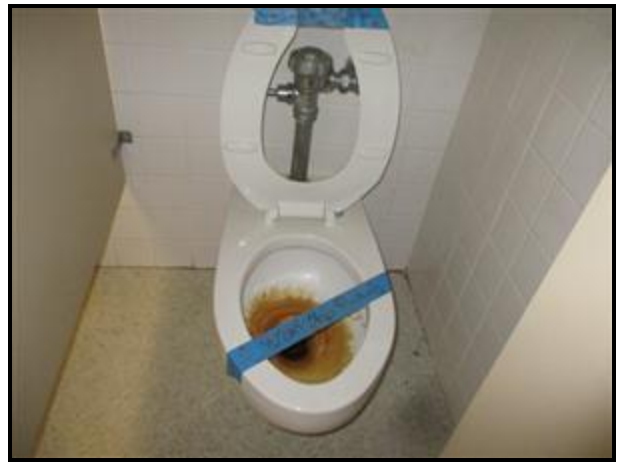
E. Picture 6 Leaks / Broken

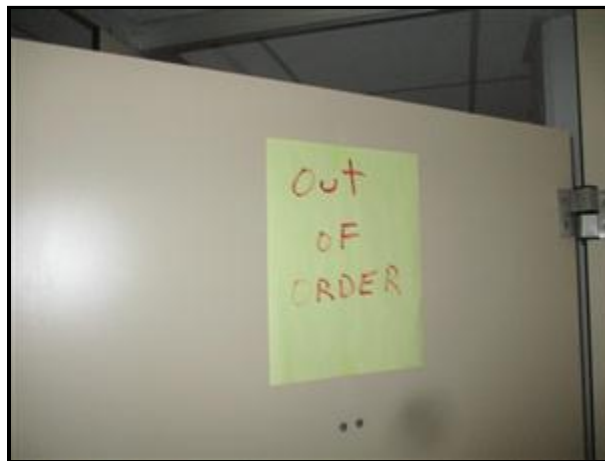
E. Picture 7 Out of Order Toilet Stall

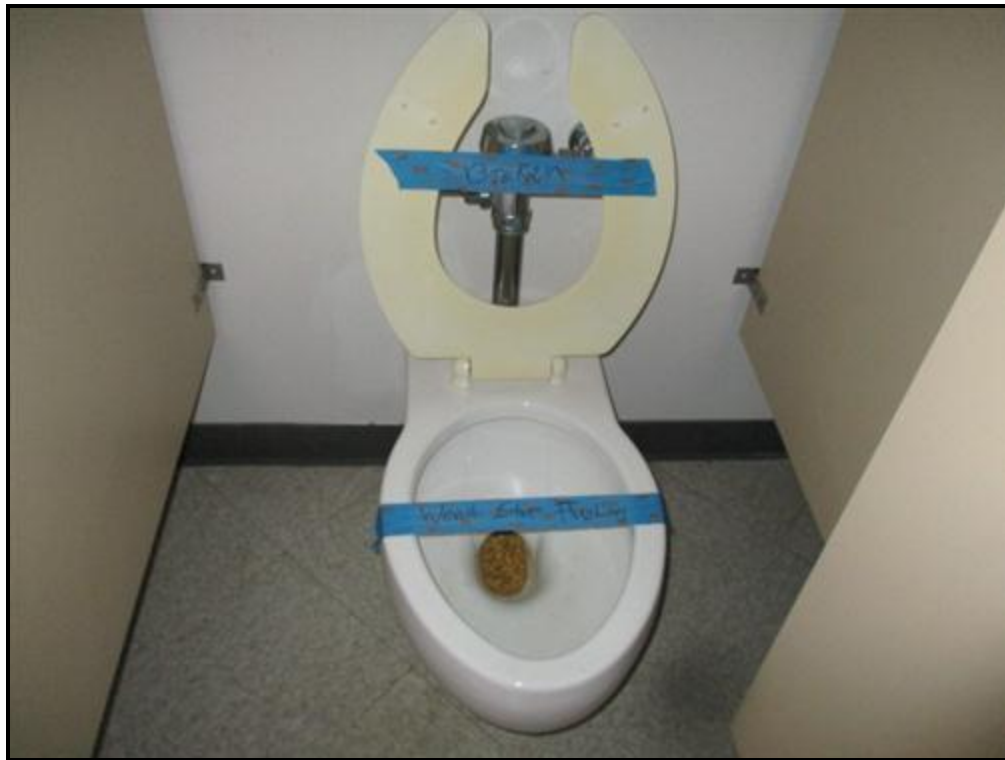
E. Picture 8 Won't Stop Flushing / Broken Seat

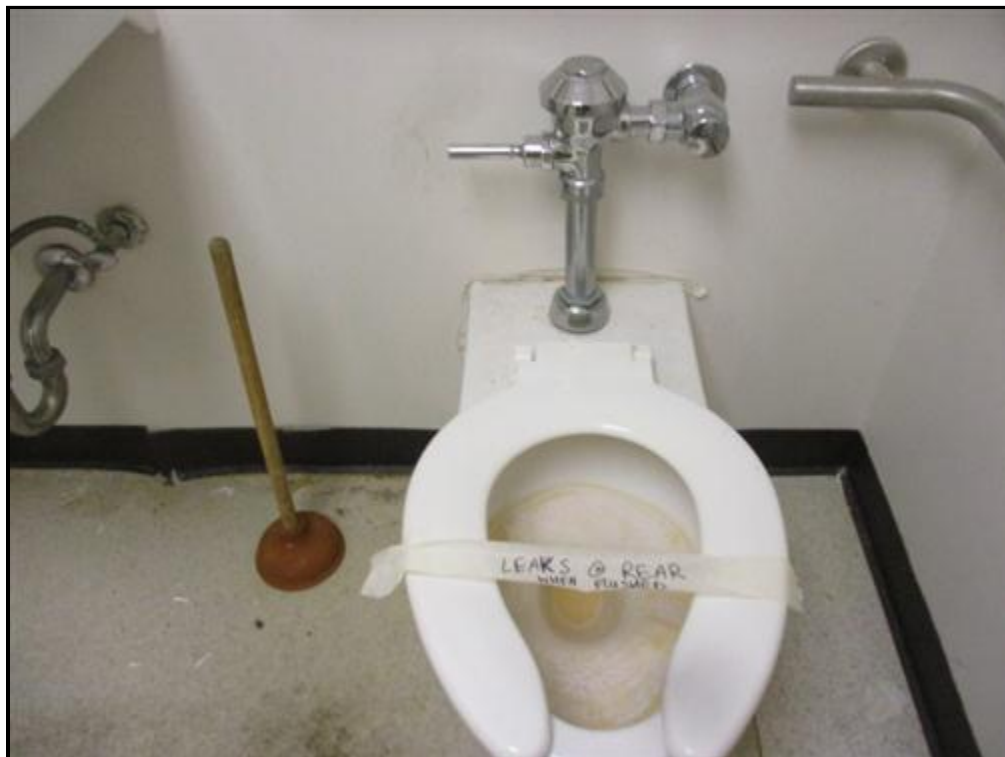
E. Picture 9 Leaks at Rear

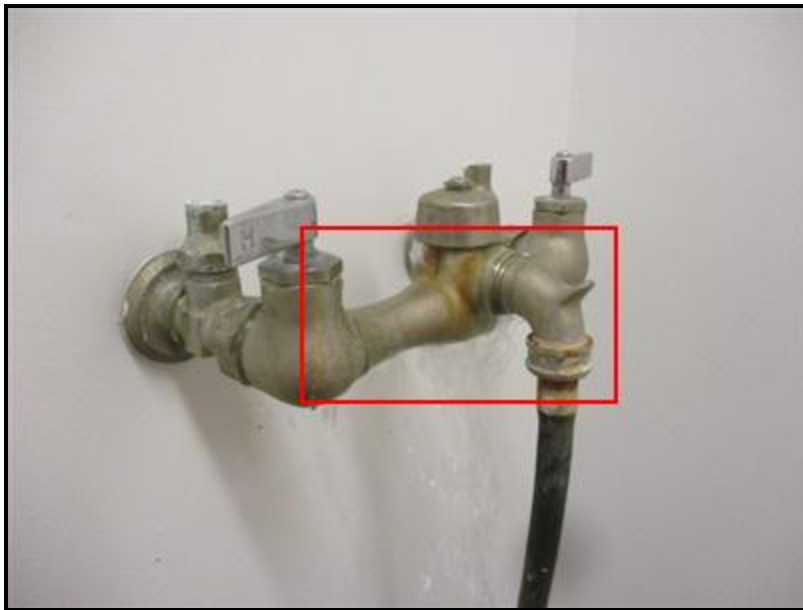
E. Picture 10 Leaks

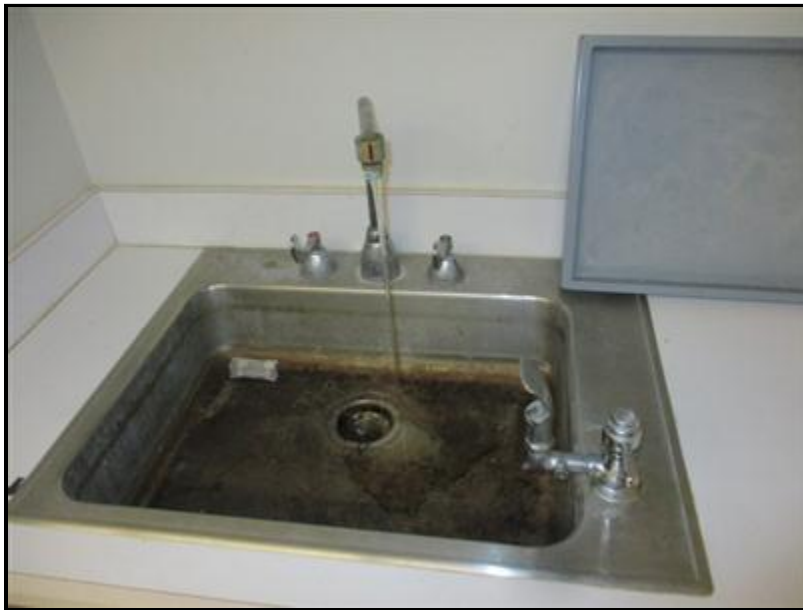
E. Picture 11 Faucet Leaks / Sink Heavily Corroded

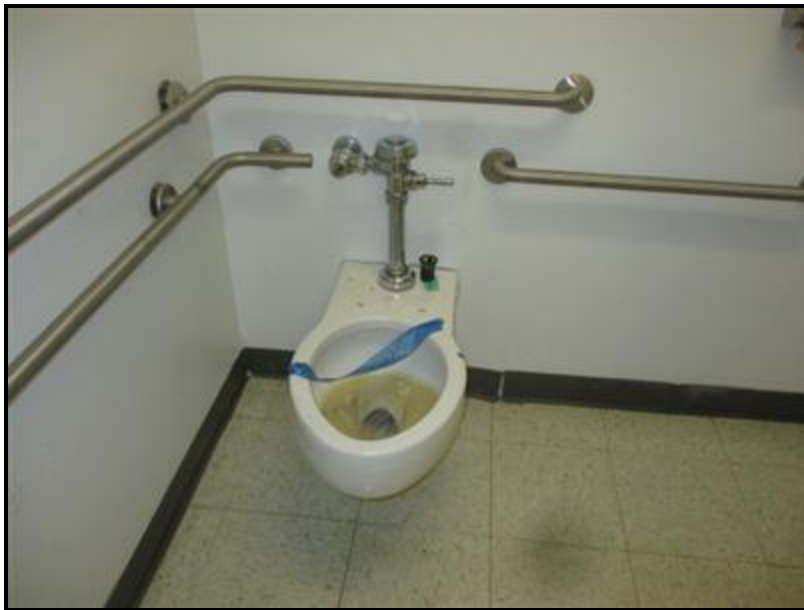
E. Picture 12 Leaks / No Seat

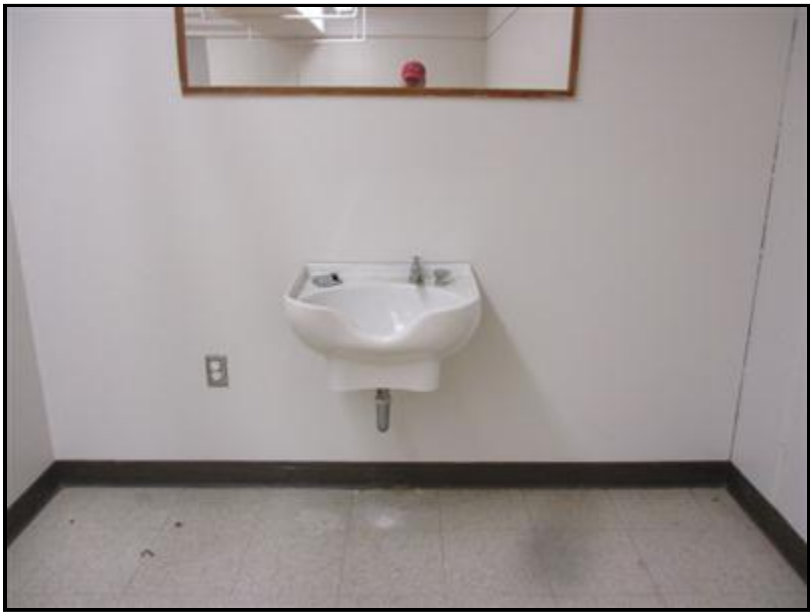
E. Picture 15 Leaks

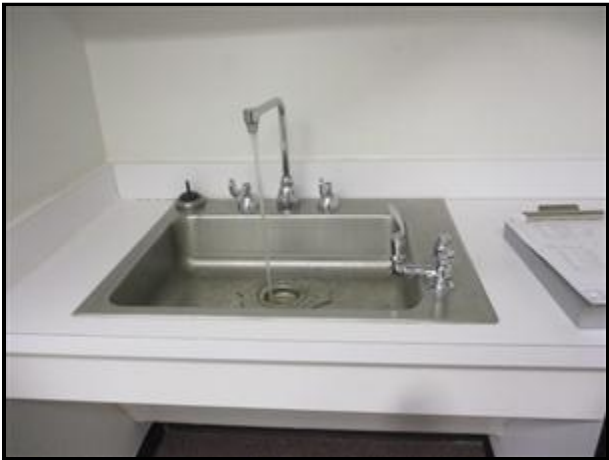
E. Picture 16 Leaks

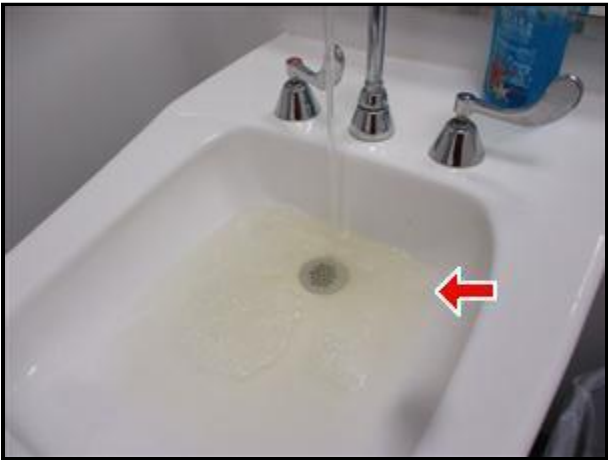
E. Picture 17 Clogged / Slow Draining

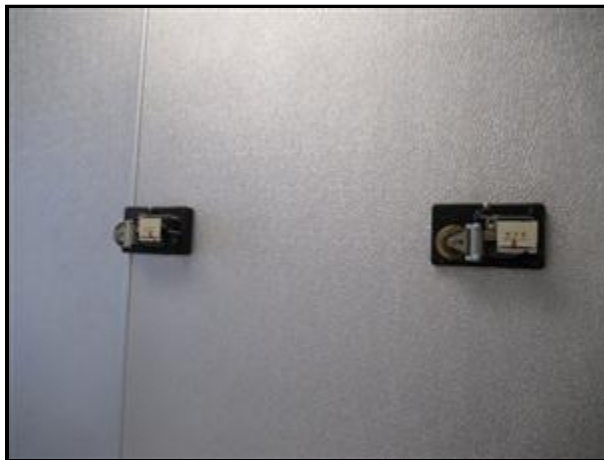
F. Picture 12 Missing Tstat Covers

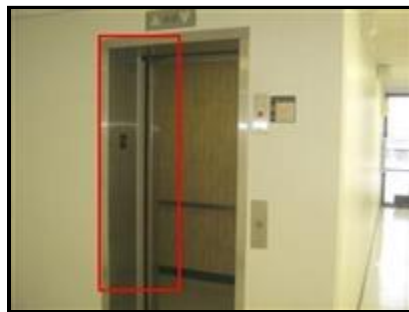
J. Picture 1 Stuck

Service, Inspection and Repair by a competent elevator specialist recommended.

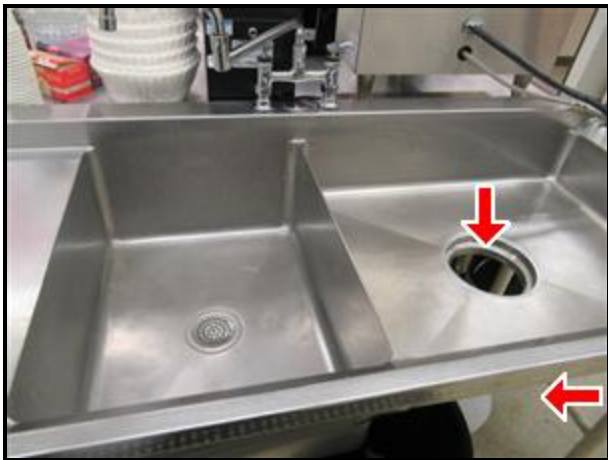
K. Picture 5 Opening / Disposal Missing

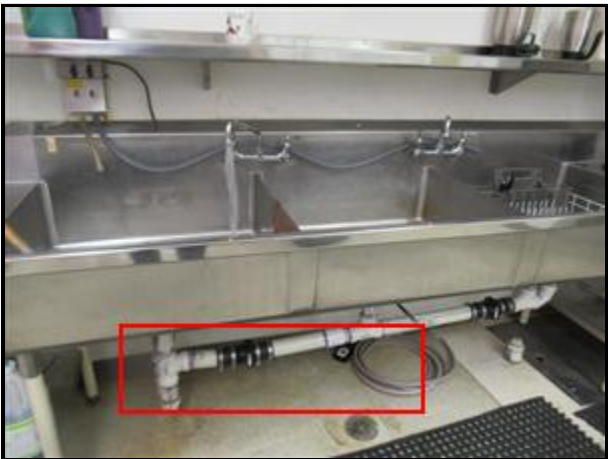
K. Picture 8 Leak Under Sink

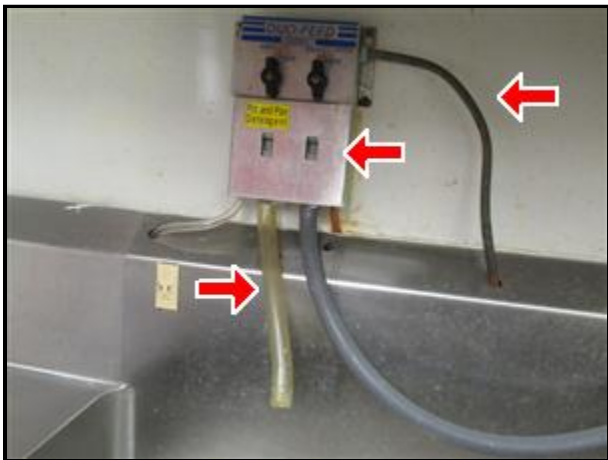
K. Picture 9 Not Working

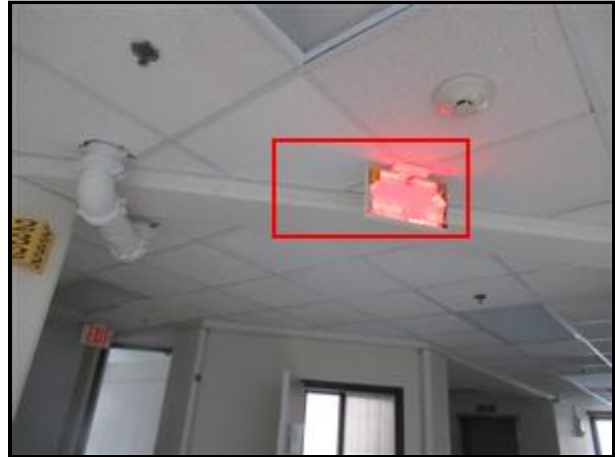
B. Picture 2 Broken

Service and Repair or Correction recommended. We are told these can cost \$50 to \$125 or more apiece, with installation extra. Servicing them as needed could cost several hundred dollars each.

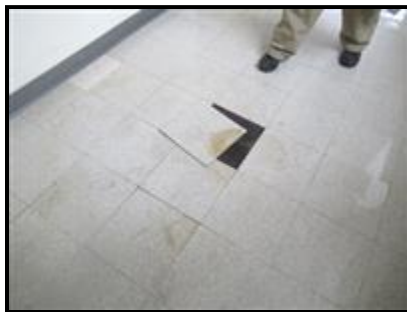
A. Picture 11 2nd Floor Loose Tile

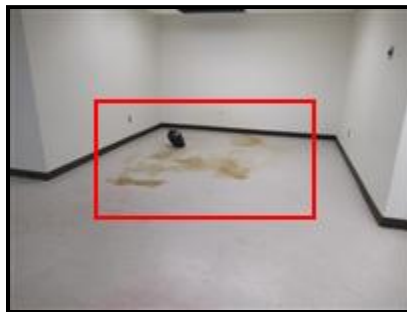
A. Picture 12 2nd Floor Water Stained

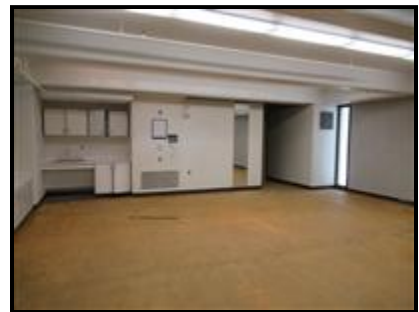
A. Picture 13 2nd Floor Missing Floor Covering

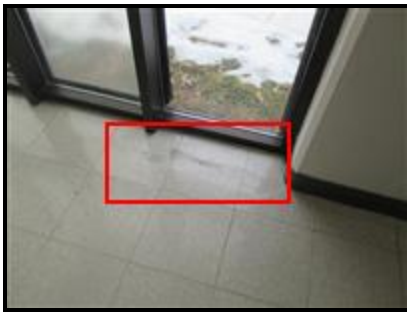
A. Picture 14 Cracked Tiles - 1st Floor

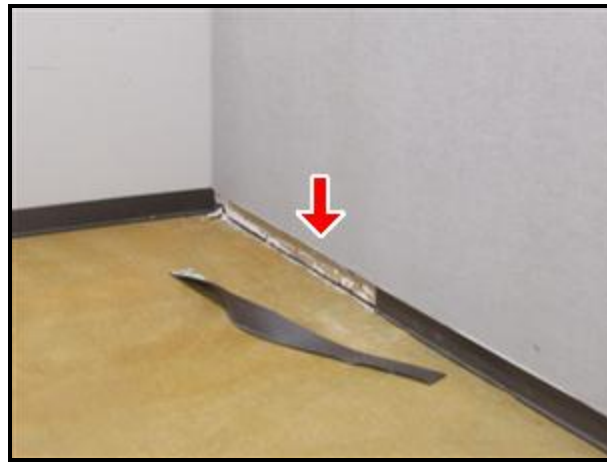
A. Picture 15 Loose Trim Missing Carpet

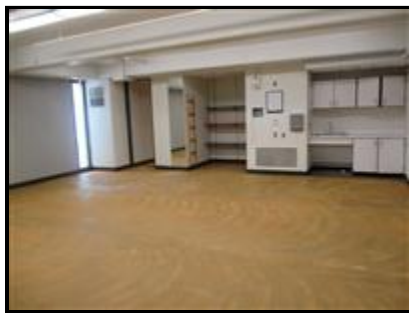
A. Picture 16 2nd Floor No Carpet

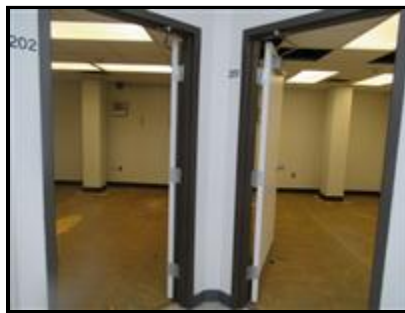
A. Picture 17 2nd Level - Missing Floor Covering

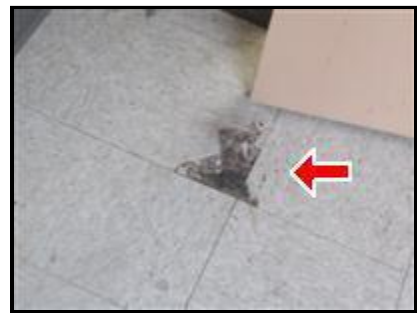
A. Picture 18 2nd Floor Damage Flooring

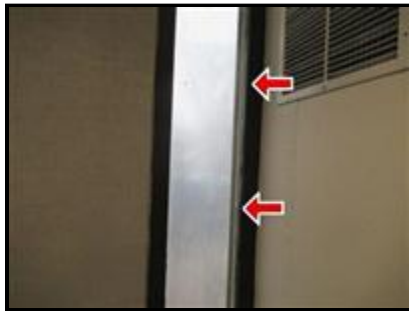
B. Picture 1 Seals ??

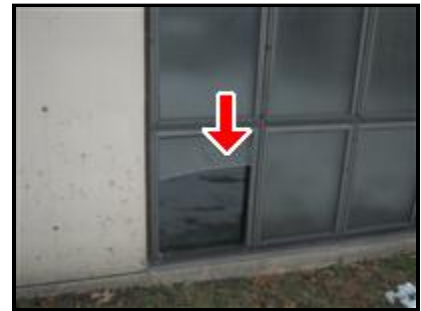
B. Picture 3 Broken Glass

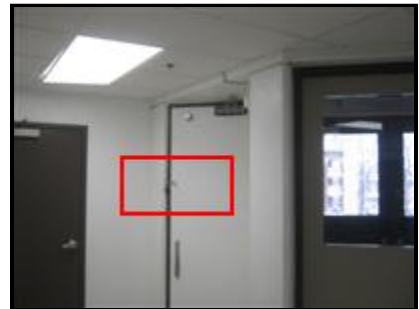
- We observed several stairwell doors with padlocks on them. For fire safety, etc these should be removed.
 - See Examples in Pics
 - **Service and Repair as Needed.**

B. Picture 11 Padlock on Hall Stairwell

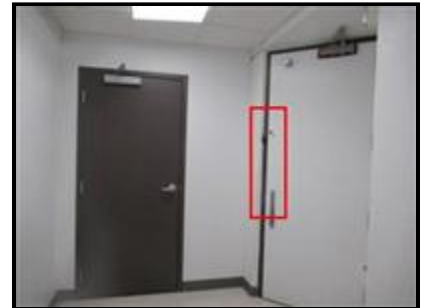
D. Picture 3 Padlocked Door
