# Inspection Report

**Property Address:**  
8027 E. Shamrock Lane  
Topeka KS 66612

<b>Date:</b> 1/8/2016	<b>Time:</b> 09:30 AM	<b>Report ID:</b> 59013 - Sample
<b>Property:</b> 8027 E. Shamrock Lane Topeka KS 66612	<b>Customer:</b> Jack Thomson

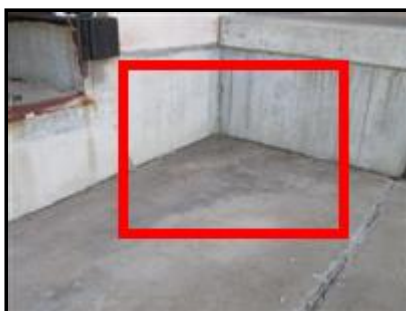
C. Picture 1

(1) Storm water run-off is disposed of through the municipal drains in the parking area and at the street. There was evidence to suggest poor drainage that may pond water at the parking lot near the loading dock. We recommend observing this in a strong rain to see if the drainage is acceptable or not, and if a repair is needed.

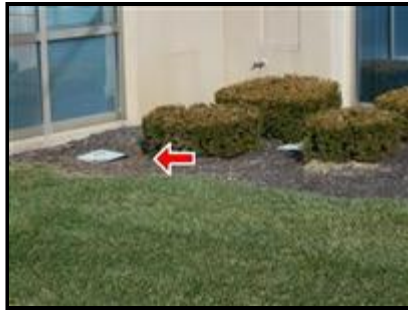
C. Picture 2

(2) Several "Area Surface Drains" were noted at the perimeter of the building. We believe some are necessary for the collection of roof "run-off water" coming off the standing seam roof. Underground drains are **NOT** tested as part of a visual survey. We recommend observing them in a strong rain to see if the drainage is acceptable or not **AND** verifying functionality with the maintenance department or facility manager.

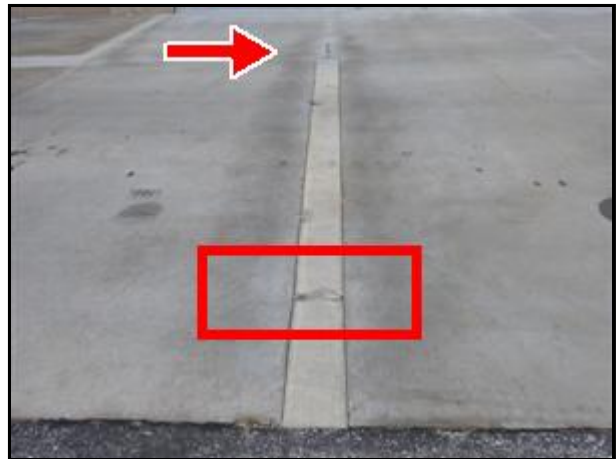
E. Picture 4

Significant damage or offsets in surfaces enough to be trip hazards noted at several areas, such as in concrete pad by rear dock and at asphalt parking area for Test / Visitors noted. **See Examples in Pics 3 and 4.** Repair or Replace any damaged area(s) recommended.

**These type concerns are a tripping hazard and any applicable areas should be replaced or repaired. The cost of doing this service is unknown to us, so you should consult with a contractor to determine the costs prior to ending your due diligence period. If out-sourced, you should expect costs to exceed \$1,500 (verify with contractor).**

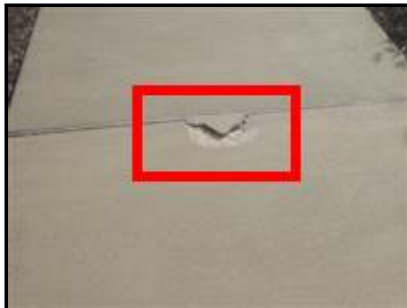
(2) Significant cracks, damage or offsets in the surface in the walking surfaces noted at some areas around the building (front, rear and sides). See the Example in Pics of what we consider significant.

F. Picture 5 Front Walk

**These are a tripping hazard and any applicable areas should be replaced or repaired. You should expect costs to range from \$1,000 to \$2,000 (verify with contractor).**

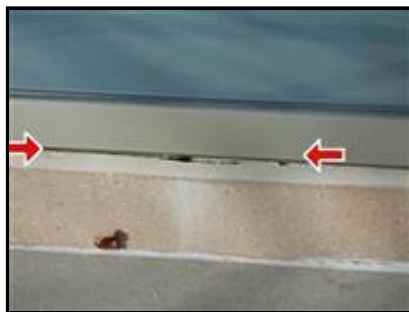
(2) The caulking is failing at various locations and is showing wear typical for its age. This type of caulking typically lasts 10-15 Years. Short term maintenance / service repair is recommended now to help keep building envelope weather tight. See Examples of Worn Caulking.

D. Picture 1 Worn Caulk

(3) This type of caulking typically lasts 10-15 Years. **Budget for a competent professional contractor to do recaulking of all window frames, door frames, joints where 1 building material meets another, utility penetrations, etc in the next 1-5 years to help assure a water tight and durable exterior.**

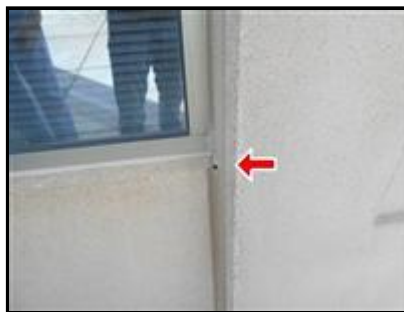
D. Picture 2 Worn Caulk

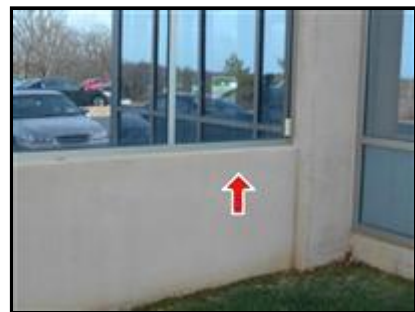
We observed a window at the west side near the stairwell enclosure that had the weep hole caulked over. This can trap water inside the wall. Open as needed. Have maintenance personnel verify all window weeps are open and clear flowing.

D. Picture 3 Weeps Caulked Over

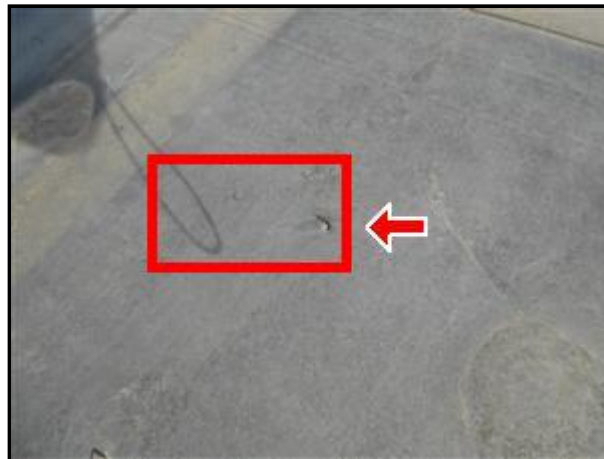
G. Picture 5

(3) A few cuts and/ or tears were noted in the single ply EDPM roofing at varied locations. They are minor at this time. Seal and patch to help prevent any major damage from occurring. See Example in Pic

Although minor repair or service this is recommended to help prevent moisture intrusion and help assure a water tight roof. We believe minor maintenance service like this would be done by building personnel. If out-sourced we do not believe costs should exceed \$1,000.

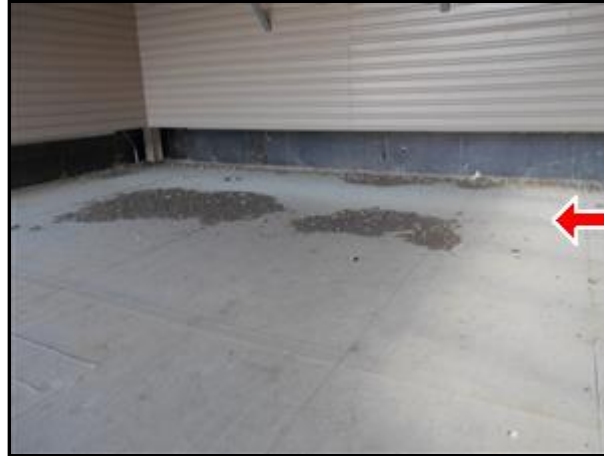
G. Picture 6

(4) Some debris and dead birds were noted at the roof. Clean and monitor bird activity for damage to roofing or blockage of drain paths.

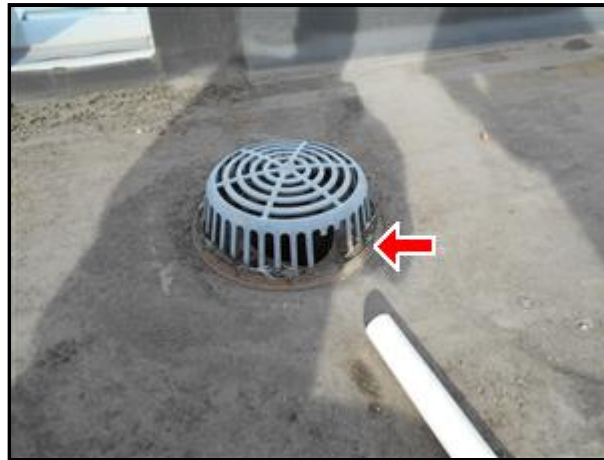
G. Picture 7

(5) The broken grates at roof drains need replacement (several noted). **See Example in Pic.**

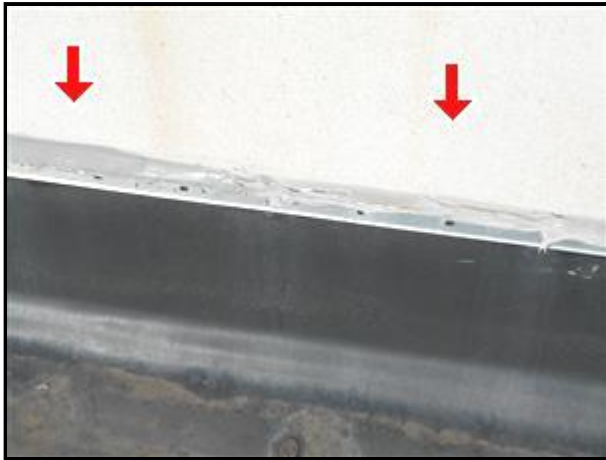
G. Picture 10

(7) Some recaulking was needed at the termination bars at the EDPM roofing/wall juncture. Caulking failure was noted at several locations. The caulking used has a typical life span of 10-15 years, Re-caulking should be budgeted into your maintenance plans by a roofing professional.

**The cost of doing this service is unknown to us. We would expect costs to be about \$1,000 +/-, but for budgeting figures you should consult with a contractor to determine the costs prior to the end of your due diligence period.**

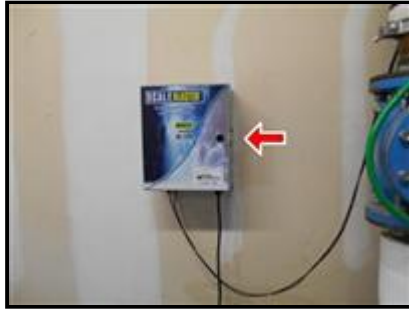
A. Picture 2

Pipe insulation was **NOT** re-installed after the "Scale Busters" were installed. Recommend re-installing this as normal maintenance/service.

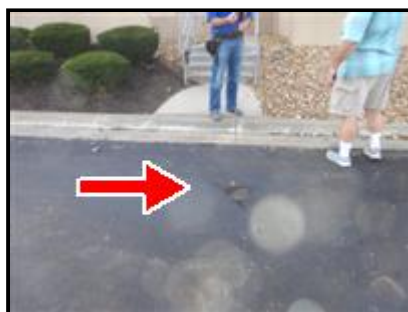
A. Picture 15

(9) It looks like there may be a main water shut off at the rear parking lot drive in a valve box. In our opinion this valve box has been repeatedly run over and looks like it has shifted and may be broken, which would impede use of the valve. **Have a competent plumbing contractor Evaluate and Repair as needed. Costs are unknown ... Verify with contractor,**

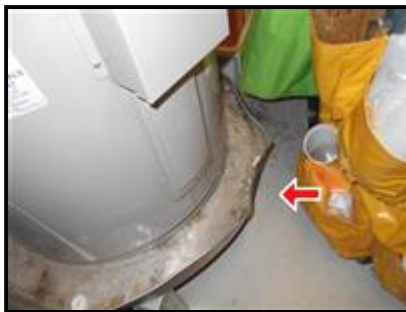
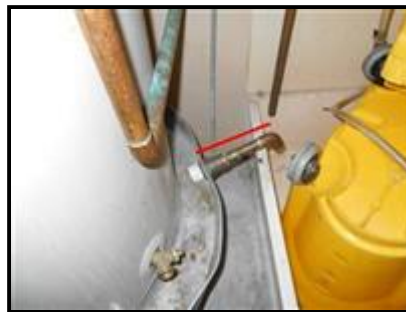
(11) **Second floor water heater overflow pan is damaged and will not function as intended. Repair as needed.**

**You should expect repair costs to be under \$1,000.**

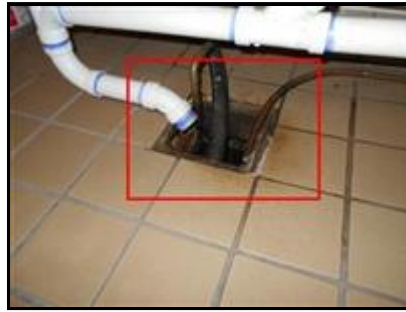
B. Picture 1

**Two potential cross connections**, (potable water mixing with drain water) were noted at the Dishwasher and Ice Maker area in the main level kitchen. **A one inch (1") air gap at the fixture drain to floor drain is normally required. Service and correct.**

We would anticipate this type service to be handled by in-house maintenance personnel.

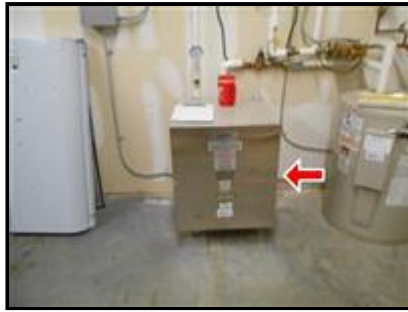
C. Picture 3

A temperature gauge was not present on inlet side of the unit for safety. **Recommend contractor installing one.**

**You should not expect costs of a temperature gauge installation to not exceed \$1,000.**

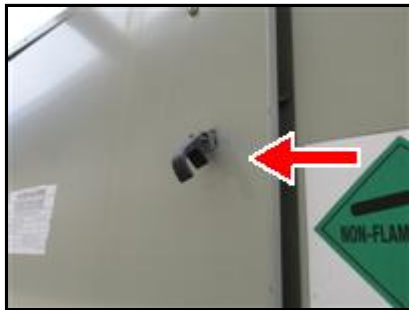
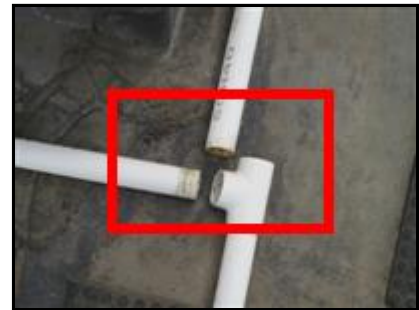
(2) While on the roof we noted one unit (Trane 40 ton unit on center 3-story roof) had broken or damaged latches on the filter rack door and the door did not latch fully. In high winds this could allow the door to be pulled open or further damaged and let excess outside air into a sealed compartment. Service and repair recommended.

We also noted several condensate lines on the flat roofs separated or not getting into the roof top drains. This allows condensate water to stand on the flat roofs. Service and correction recommended.

**In our opinion these are most likely in-house maintenance personnel service or repair functions.**

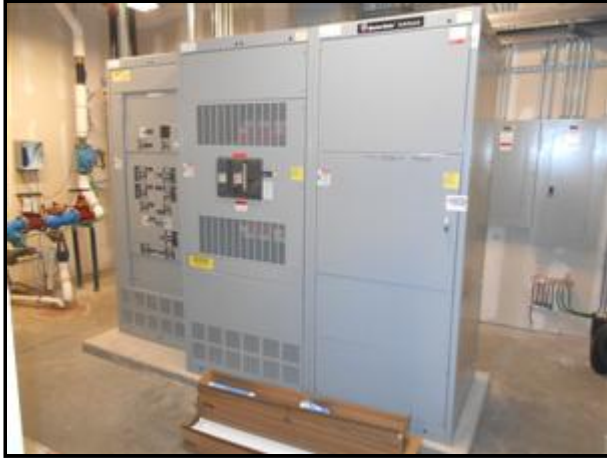
F. Picture 8 Main Panel Housing

He noted electrical circuits not labeled as to their usage in various panels throughout the building (like at the server room). Besides being inconvenient, this prevents one from determining if the circuit, wire, etc being used is correctly sized for its purpose. **Service and correction recommended. In our opinion these are typically in-house tasks performed by maintenance personnel.**

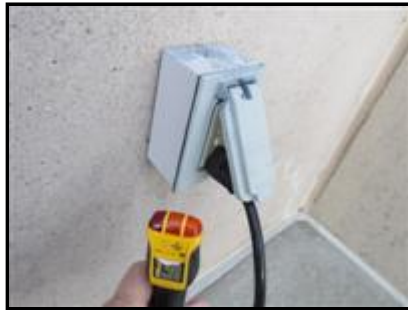
These include **ALL** exterior GFCI outlets we observed were defective. Either tripped and would not reset OR would not trip.

G. Picture 1 Defective Outside GFCI

**Service and repair recommended. In our opinion these are typically in-house tasks performed by maintenance personnel.**

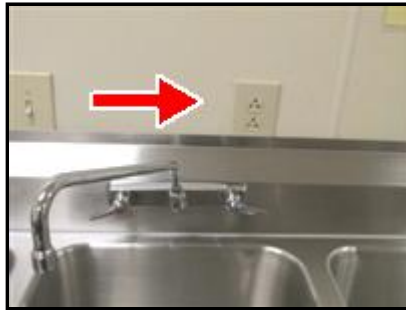
G. Picture 2 Not GFCI
