# Inspection Report

**Property Address:**  
8737 Taco Street  
Columbia MO 65203

**Dan Bowers Company**

<b>Date:</b> 7/8/2015	<b>Time:</b>	<b>Report ID:</b> 142876 - Sample
<b>Property:</b> 8737 Taco Street Columbia MO 65203	<b>Customer:</b> Larry Buyer

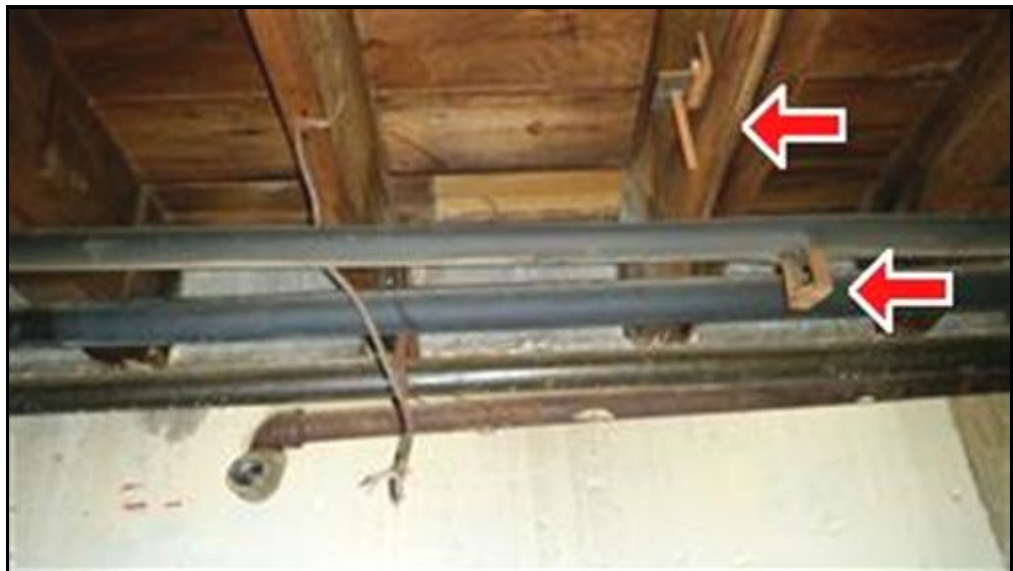
2.1 Picture 1

(1) The supply pipe supports were loose and/or disconnected and should have additional support at some areas in the basement

The supply lines have typical rust or corrosion.

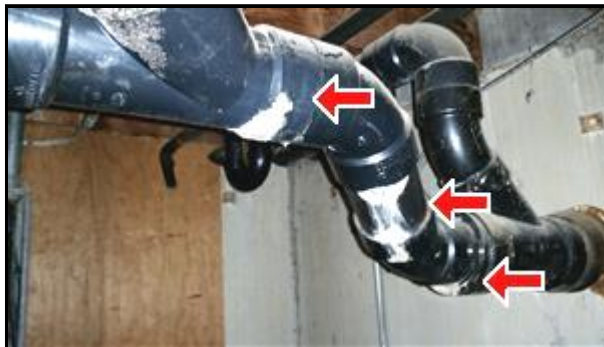
2.2 Picture 1

(1) Signs of active minor leaks noted at the basement. Service and correct.

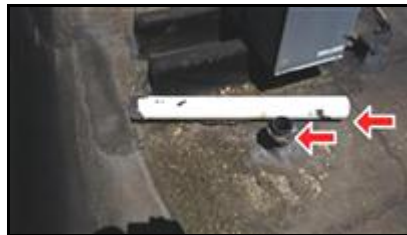
2.2 Picture 2

(2) We noted some vents were loose and others broken on the roof. Service and repair.

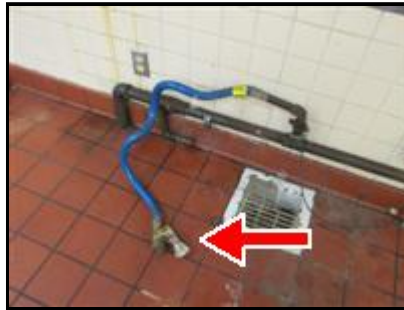
2.4 Picture 1

- Some gas pipes are rusted or corroded. These have the potential to become unreliable or develop leaks. The local gas company may service and correct this condition (this will typically involve installing a protective coating or sealant on them OR replacing applicable piping). A competent plumber can also service the pipes.
- We noted various gas pipes disconnected, with no gas flow BUT they were not capped (mainly in the kitchen area).
- See Example in Pic

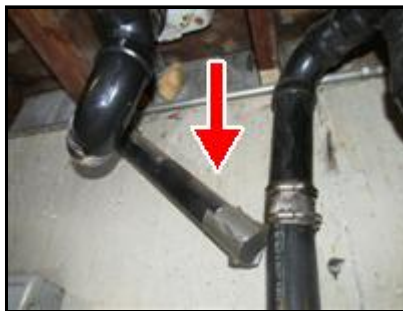
2.7 Picture 1

(1) We noted many supply lines or drain pipes in the plumbing system disconnected, some capped and/or abandoned and not in use. Therefore, these were not checked or operated by us. A plumber can determine if any service is needed on them.

Have a competent and licensed plumbing contractor review the system conditions; then service, modify, or repair any deficiencies or unreliable conditions as needed to safely and properly correct them.

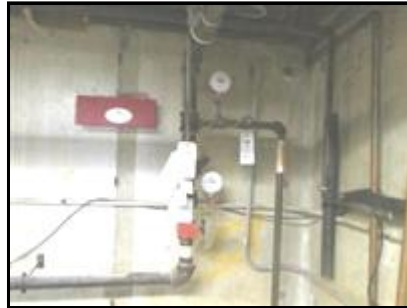
2.7 Picture 2

(3) We noted various pipes, controls, and a motorized pump in the water lines in the basement that had recent inspection tags from a company in Lenexa, Kansas called "Cintas". But they were not in operation at this time. We believe these are part of the sprinkler and/or fire prevention system. To verify their purpose and operation we suggest contacting Cintas OR have your plumber check these.

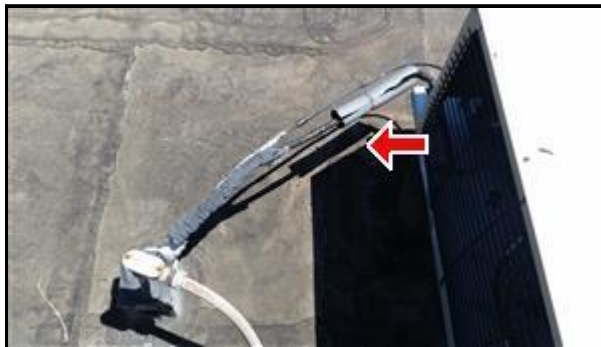
3.3 Picture 5 Missing Insulation

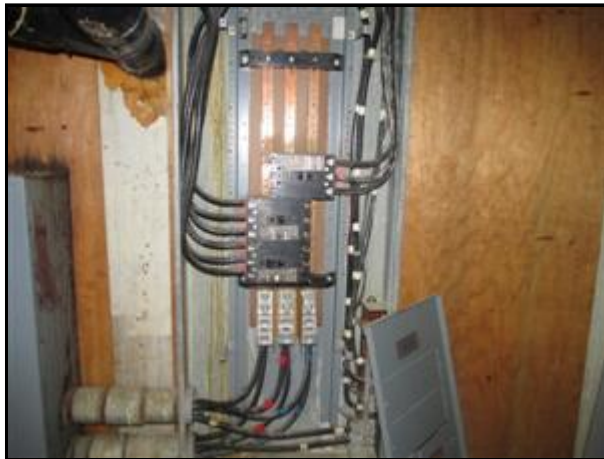
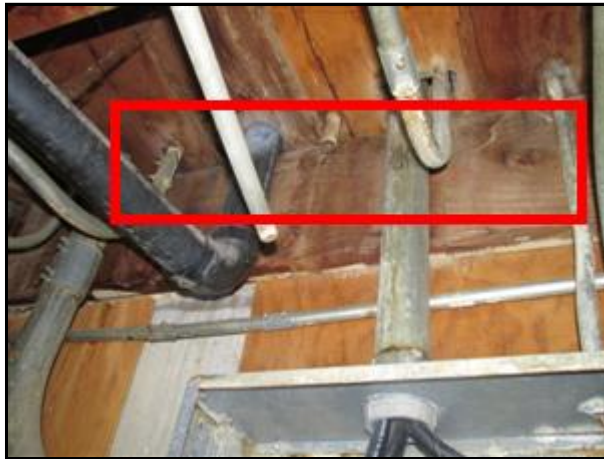
There were signs of water leak stains at the ceiling above ..... Possibly from roof leaks or old plumbing pipes above it. The stains were dry today..

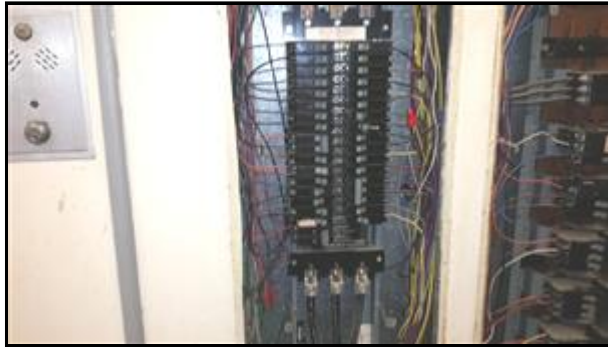
4.2 Picture 1

The left panel board (# B) had at least 9 breakers turned off. Both panels had missing cover front screws.

At least one or more breaker is oversized or mismatched for the wiring it controls. Electrician to evaluate, service and correct.

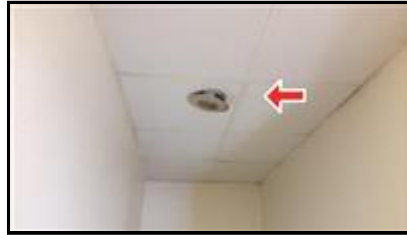
4.3 Picture 3 Loose Can Lights

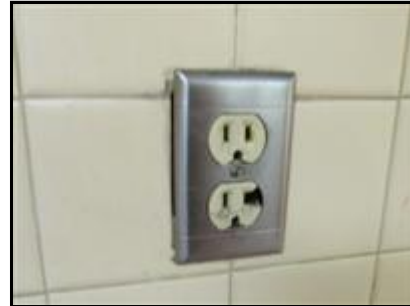
4.3 Picture 4 Sample Damaged Outlets

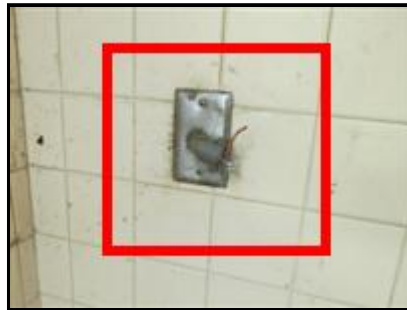
4.3 Picture 5 Bare Exposed Wire Ends

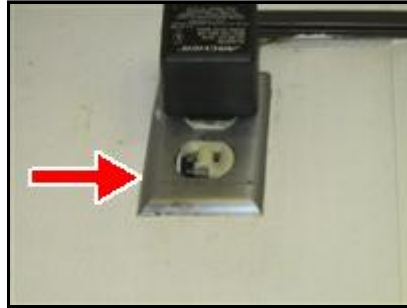
4.3 Picture 9 Damaged Outlet

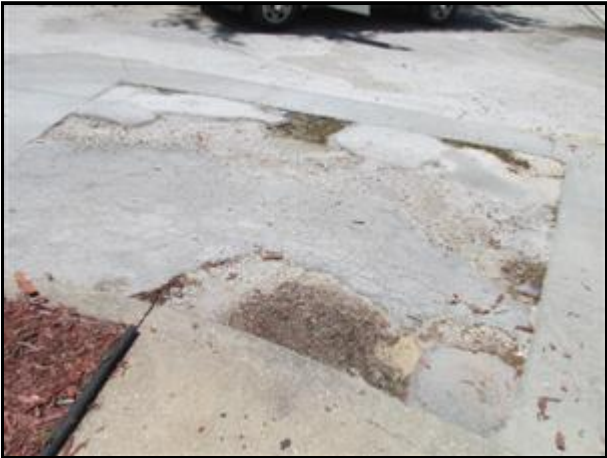
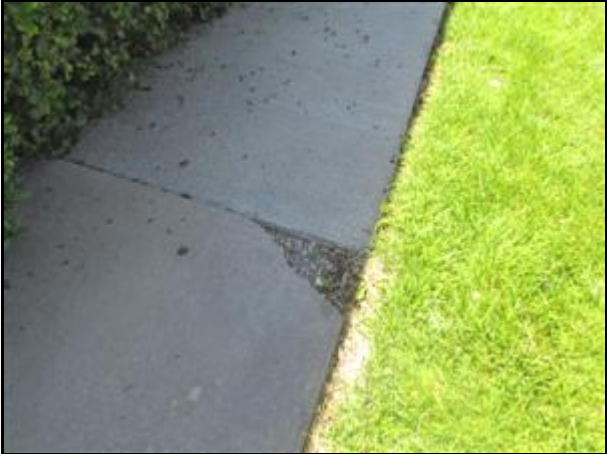
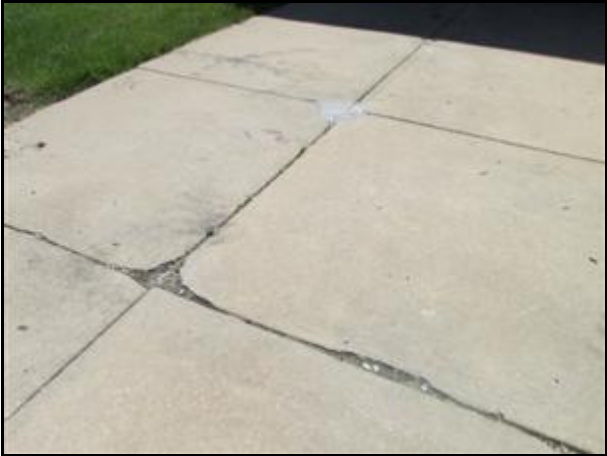
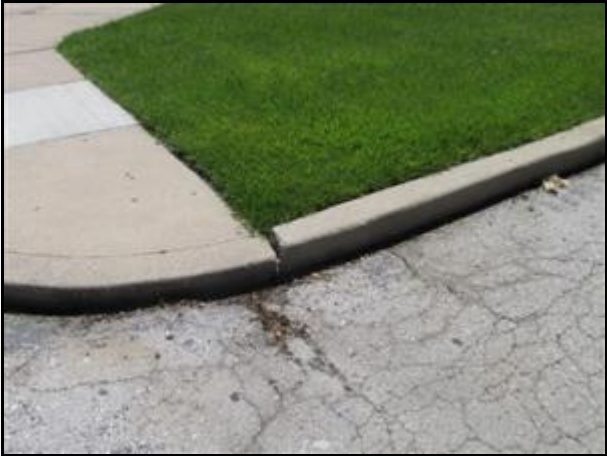
The hard surface flatwork was usable at the time of the inspection, however there are multiple areas at the sidewalks, parking lots, driveway, etc that show signs of cracks, chips, spalling, offset movements of over 1" (**trip or tire hazards**), etc in the flatwork. Although in our opinion these are not considered uncommon, and found at the majority of commercial properties of this age in this area (due mostly to shrinkage, traffic, a lack of ongoing maintenance and curing or expansive soils) **Ongoing** service and maintenance includes sealing gaps or cracks to help prevent future deterioration or a trip potential, etc.

Repair or replace any applicable areas as needed. This may include sealcoating the surfaces, sealing the cracks, repairing and correcting any hard surfaces offset by more than 1", filling in potholes or ponded spots and/or restoring the hard surfaces to the original position.

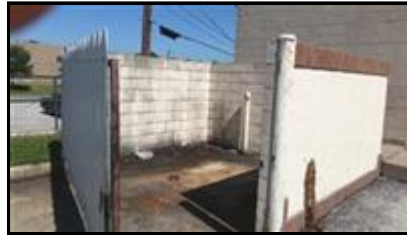
6.1 Picture 1

Courtesy view of Dumpster Corral. No dumpster(s) present. Clean up of area recommended.

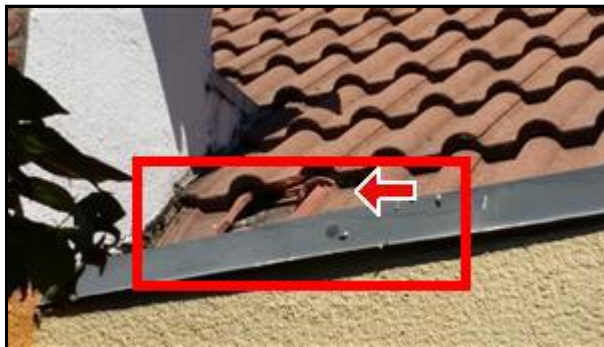
7.0 Picture 1 Example

- There were holes and felt showing thru at the tile sloped roof covering at a few locations.
- There were separations of flashing at the roof / wall junction and drip edge at one or more areas.
- Service and repair by a competent / licensed roof contractor dealing with tile roofs.

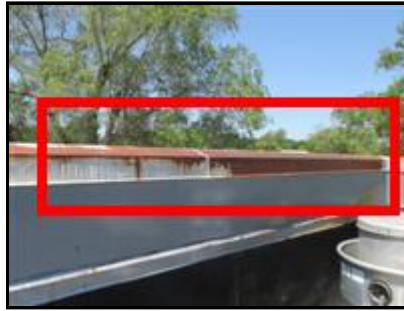
7.1 Picture 1 Example

The metal parapet wall flashing is getting rusted and corroded. That can be unreliable. Seal or coat as needed.

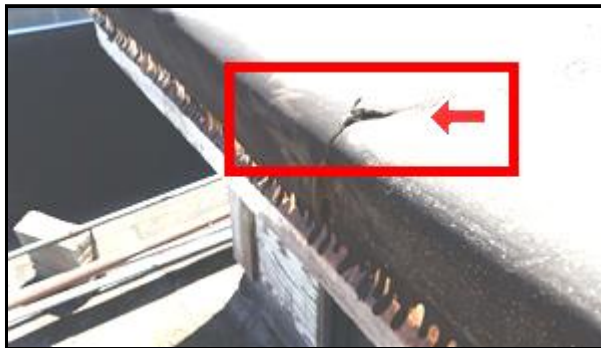
7.2 Picture 1

In our opinion, the general overall condition of the low slope / membrane roof looks functional with common signs of wear, weather or age. Regular maintenance and inspections are advised to achieve continued service. Typical maintenance is recommended for the low slope roll or membrane roof. This usually consists of the repair of open cracks in the flashings or roof coverings; open seams; deteriorated coverings etc. This should help ensure the water tightness of the structure and should be done on a regular basis.

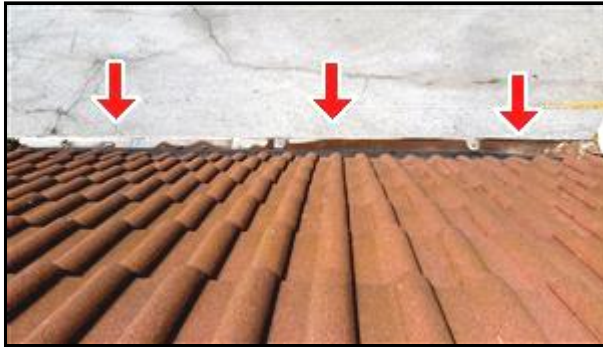
7.3 Picture 1 From Flat Roof Looking Down

(1) There was damage to the internal gutters on the building. There were separations at the edges. Service and repair.

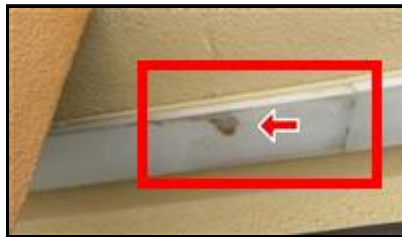
7.3 Picture 2

(2) We noted signs of leaking under various gutters by exterior lights. Service and correct.

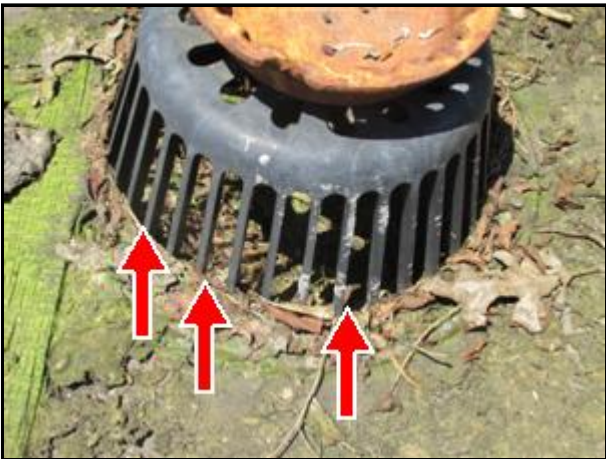
7.3 Picture 4

1. Drains / Scuppers were clogged at almost all locations at the low slope / flat roof. Service and clear.
2. No overflow drains were present on the flat / low sloped roof. These should be added.
3. Signs of ponding water / poor drainage was noted at several spots on the roof. It may be due to clogged drains, etc BUT until the drains and/or scuppers, etc are cleared and free-flowing that can NOT be fully determined.
4. Have a competent contractor service, correct and repair as needed.

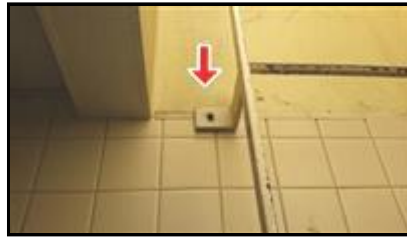
7.4 Picture 1

There was an internal steel ladder bolted to the wall leading to the roof access hatch . A few of the internal roof access ladder bolts were getting loose at the wall and/or had missing hardware. Secure them

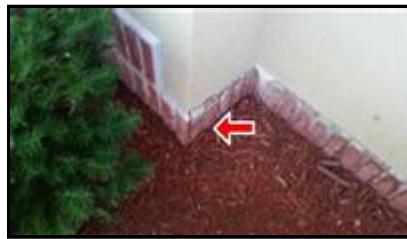
8.0 Picture 1

There were damaged masonry, concrete, brick walls at the exterior foundation. They were damaged. We recommend further evaluation and repair by a licensed and competent foundation and stucco contractor.

The soil level was too high at the foundation (this can lead to moisture intrusion, wood rot and pest entry (like termites or others).

Service and repair as needed.

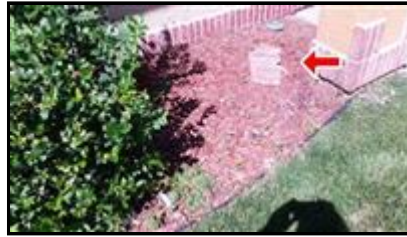
8.1 Picture 1

(1) The masonry wall covering had damaged masonry units pulling loose or off from the walls of building structure. Repair needed.

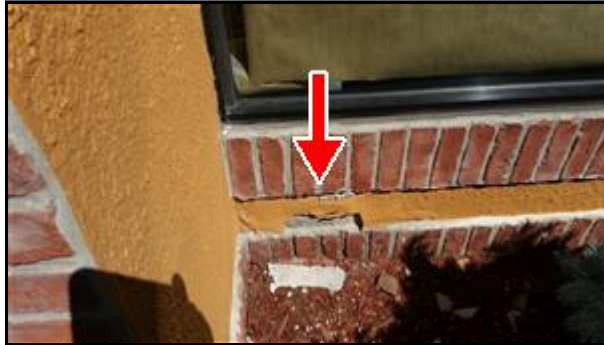
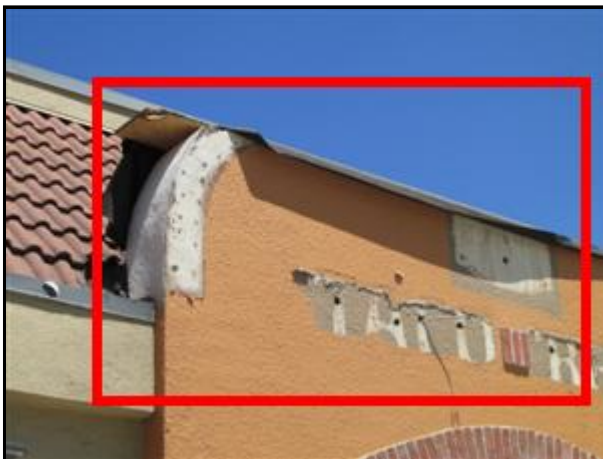
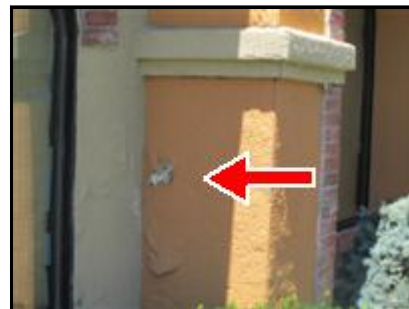
(2) The hardcoat stucco wall covering, was pulling loose from the wall; had large gaps, cracks, openings or missing sections needing repair at many locations around the exterior of the building. Service and repair by stucco contractor. See Examples in Pics

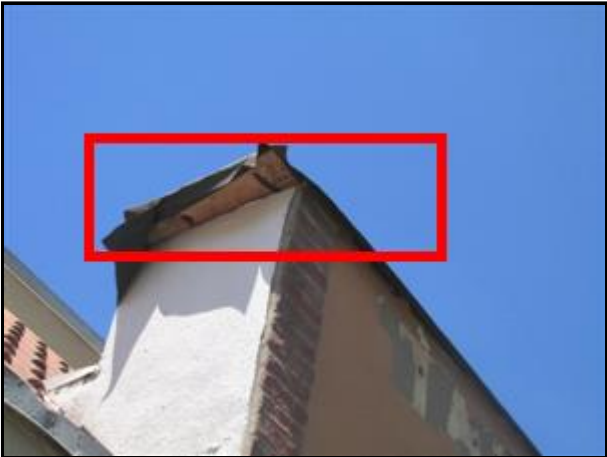
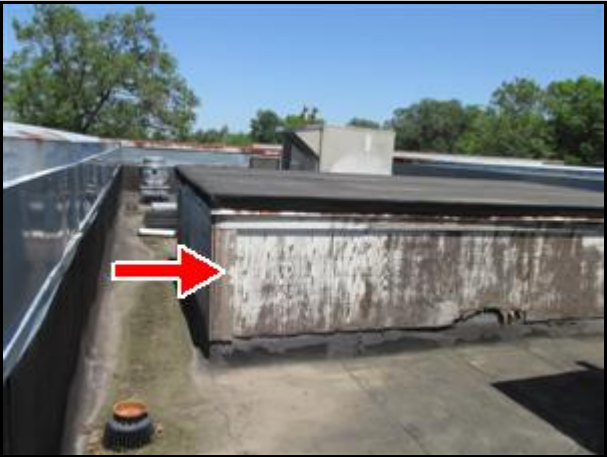
(3) Damage noted at wood siding OR wood trim pieces at walls on top of roof OR at trim at roof level. Service and repair.

Deteriorated / deferred painting at raised wall sections on roof. Service needed.

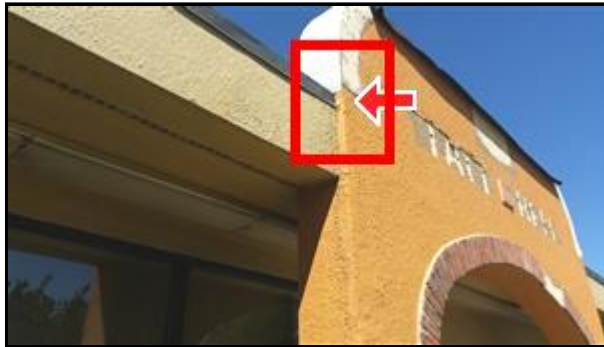
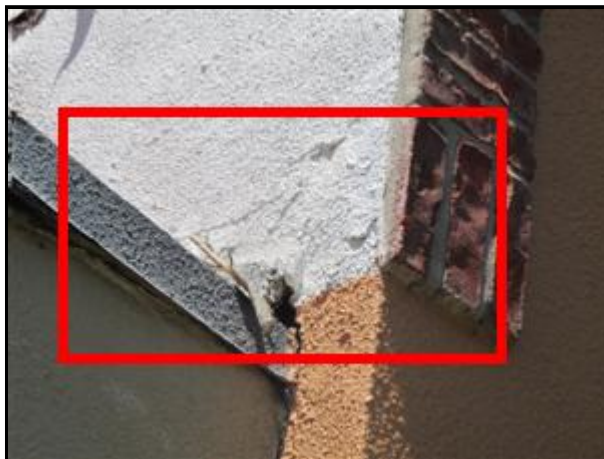
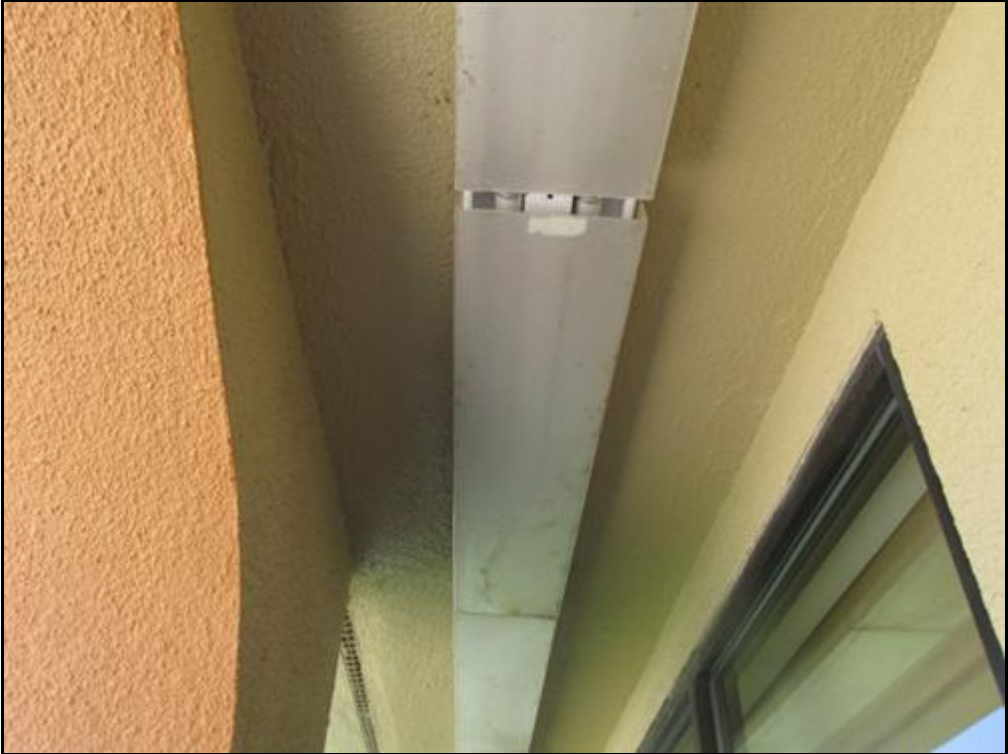
A properly sized, designed and sealed "Kick-out Flashing" should be installed at any roof-to-wall intersection to help divert water away from the structure (this can help prevent moisture damage to the building). We recommend service and correction by a qualified and licensed stucco OR roofing contractor (see location or pics of typical detail locations)

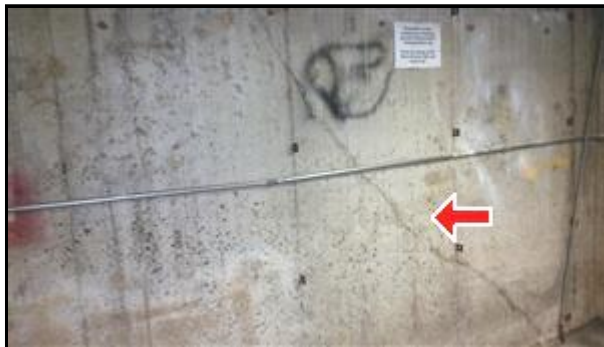
9.0 Picture 1

(1) There was diagonal pressure bowing cracks and movement at foundation walls (often caused by hydrostatic pressure of soil and poor drainage).

Due to the issues we observed outside and inside at the foundation wall(s), we recommend evaluation by a competent and licensed foundation contractor. Then have any recommended repairs or modifications performed.

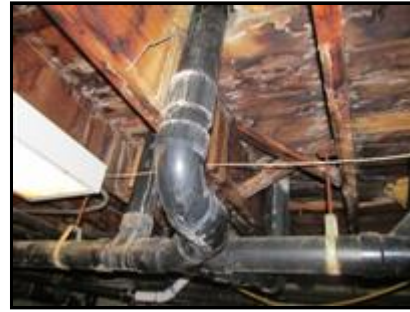
9.0 Picture 3

(2) Wood rot to sub-floor and framing at rear of basement, due to what looks like leaking from floor drains.

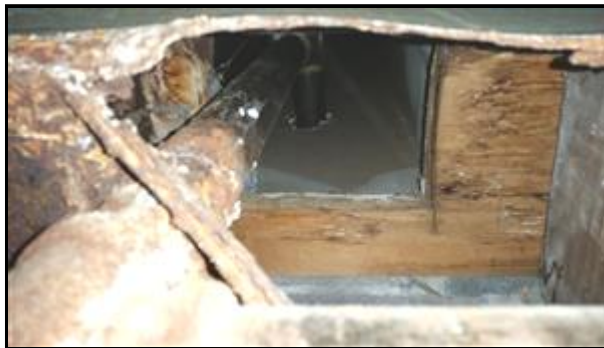
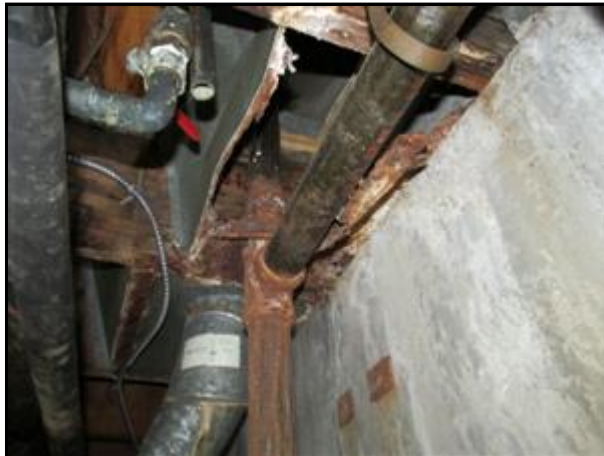
(3) Rusted out metal fire blocking is missing. Service, repair, replace.

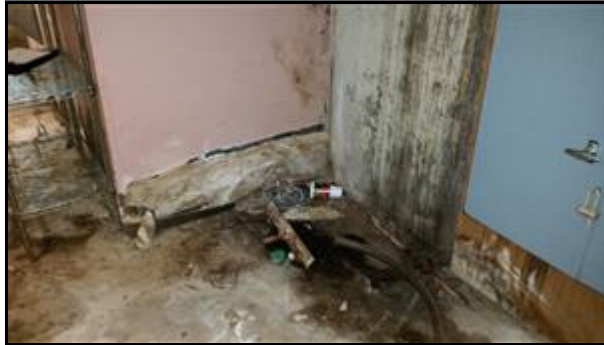
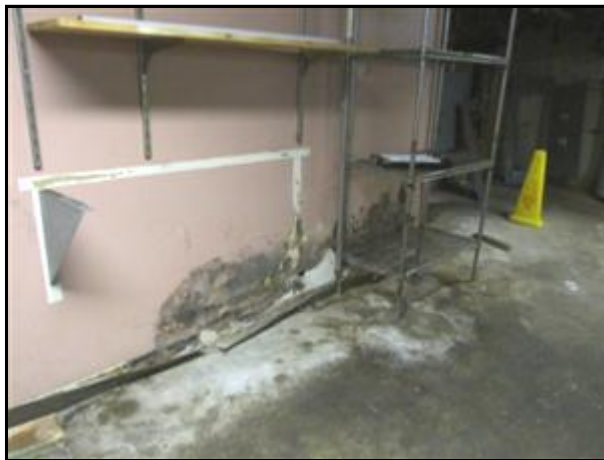
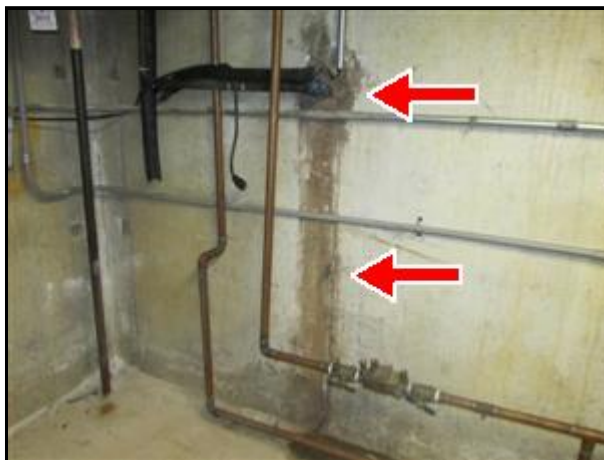
There is evidence of past and recent moisture leakage at the basement at both concrete walls and drywall resulting in damage to drywall, wood and it looks like its developed mold at base of stairwell and inside basement.

We recommend further evaluation by a competent and licensed water proofing contractor. Then have any recommended repairs or modifications performed.

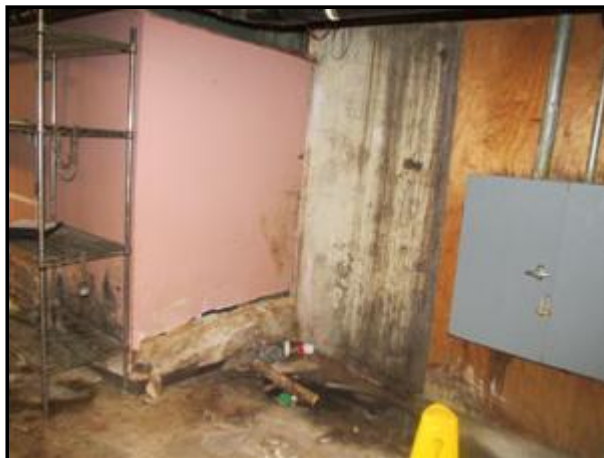
11.2 Picture 1

A competent mold specialist can provide further information, testing or evaluation. We **DID NOT** perform any mold tests or mold / air sampling evaluations at this property. A visual inspection alone can not verify the absence or presence of mold. Almost all buildings have some form of mold spores present, most of which are not harmful. Mold however, can cause health or respiratory problems for some people.

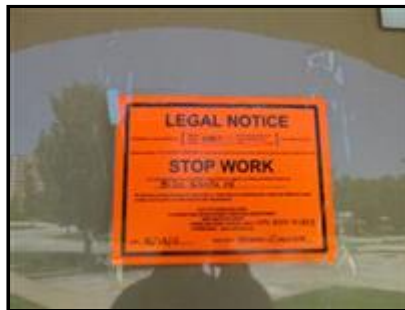
11.5 Picture 1

Some type of repair / renovation was apparently underway but has been stopped. There is a stop work order on the building's front door issued by the City of Overland Park Kansas at this time. We suggest verifying with the tenant and local code authority to determine if this work was done properly and conforms to the applicable city building standards, etc. What was being done, why stopped, etc.
