Inspection Report

Kris Kringle Enterprises

Property Address:
6732 W. Anywhere Ave
Wichita KS 67234

Date: 7/31/2017	Time: 09:00 AM	Report ID: DB73117 - Retirement
Property: 6732 W. Anywhere Ave Wichita KS 67234	Customer: Kris Kringle Enterprises

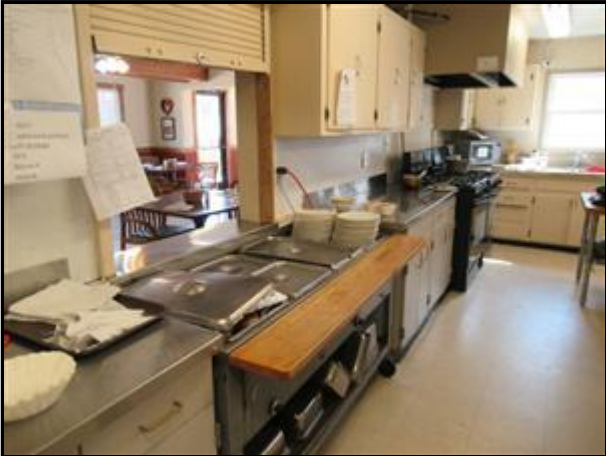
1.0 Picture 1 Steam Table

- 9) On the Steam Table , 2 sides work OK but the 3rd side has missing control knobs (not operated)
- 10) The Exhaust Hood was noisy but worked. Its lites did not come on

Have a competent appliance repair contractor read the report; evaluate the appliance conditions; their connections; then service, modify or make any necessary repairs as needed to safely and properly correct the issue(s).

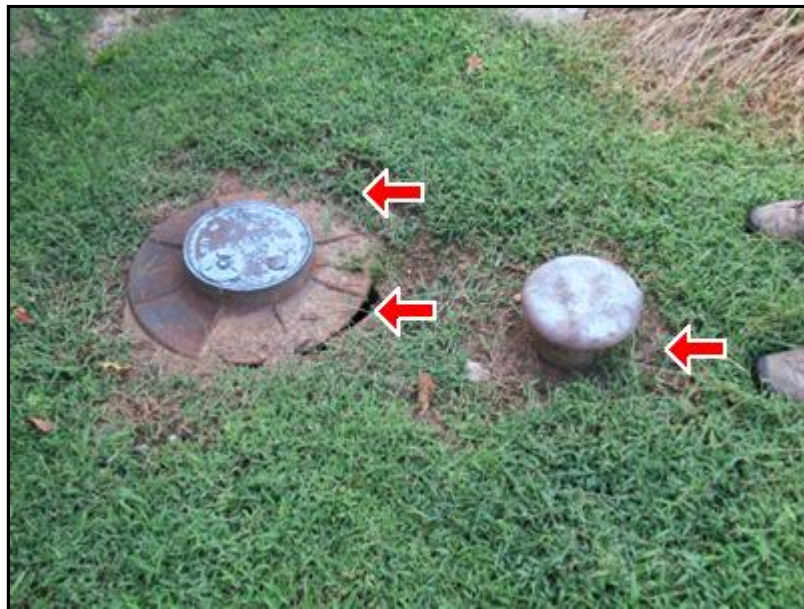
3.0 Picture 1

(1) Large Gaps by in-ground water shut-off access AND deep hole. Trip Concern. City or Contractor to Service and Correct.

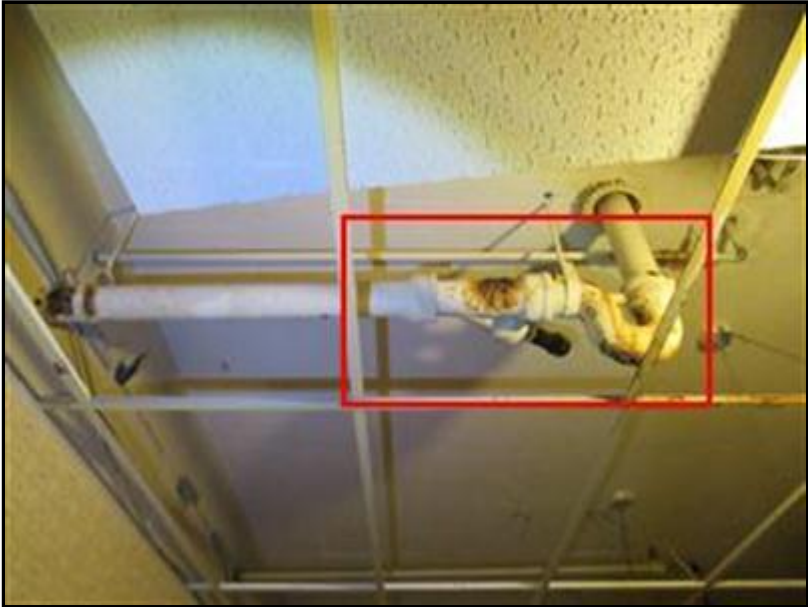
3.2 Picture 1

Cast Iron drain pipes were present and typically indicate an older system (in this area cast iron was commonly used from around 1920 till about 1980). At that time many contractors started switching to Ductile Iron pipe OR plastics like PVC. Cast iron is subject to deterioration from the inside out. These types of pipe can clog or fail at any time. In the **basement where much was exposed** we saw indications of small cracks and leaks starting. See Examples

Some Repairs / Replacement recommended now. Budget for other replacement and/or unexpected repairs now, OR upgrade it now, OR continue to use and service this until replacement is mandatory. Repair OR Replacement of cast iron pipe can get expensive quickly.

The cost of doing this service is unknown to us, so you should consult with a plumbing contractor to determine the exact costs prior to the end of your due diligence period. In our opinion however, based on the current areas we could see at the basement you can anticipate costs to exceed \$3,000.

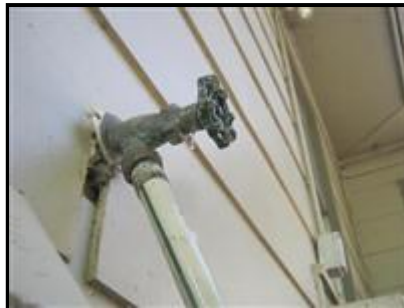
3.3 Picture 1

The faucet leaks at the east side (stem or seal). Service and Correct

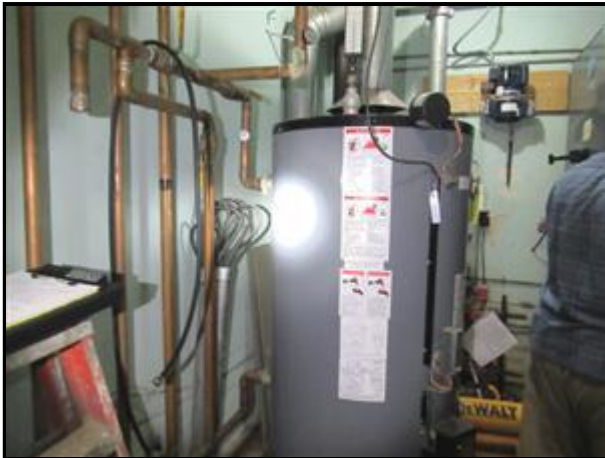
The unit drains to the floor. If it leaks you have water all over the flooring, etc. There is a mop sink next to it that may be a better drain location than the floor.

3.5 Picture 1 Water Heater

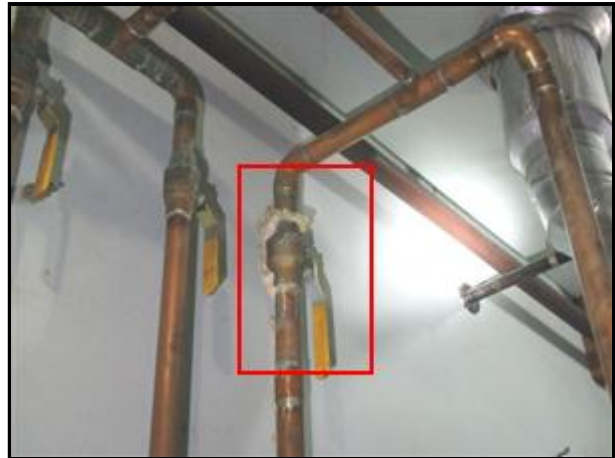
There was corrosion at the tank fittings over the tank (dry today).

3.5 Picture 2 Corrosion

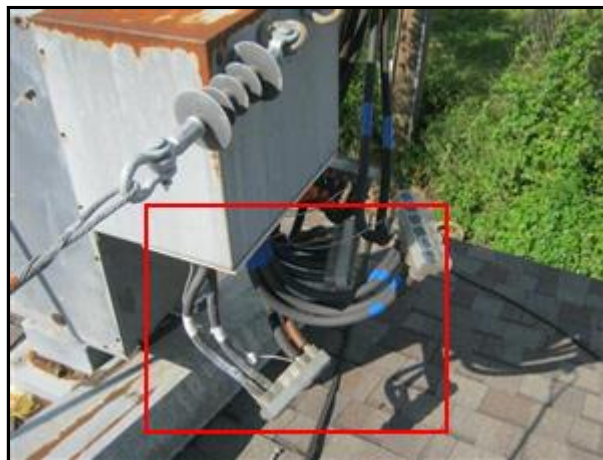
4.0 Picture 4

(2) Exposed Service Conductors observed at Roof. Safety Concern Electrical Contractor to Service / Repair

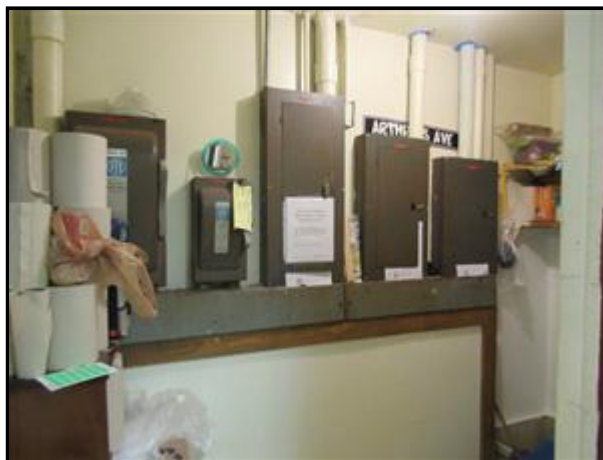
4) Chemical Store Room Panels: 3 Phase. There were 5 panels in this room (1 disconnect and 4 other panels). **Two fuse panels** were blocked by storage and not accessed or examined (nothing is known of the condition of wiring, etc in these panels). **Three breaker sub-panels** were accessed and examined. We observed... improperly terminated wiring inside the panels; Some panel screws are missing AND others were the wrong type (sharp and pointed); Unprotected opening(s) OR missing wire clamps (unused openings are required to be closed equivalent to original condition); Neutral and ground wires were improperly installed on the same buss bar at a sub-panel (in case of a short, this can allow electricity to go in multiple directions); the gutter box was missing screws; the latch at the panels was broken.

4.1 Picture 3 Chemical Store Room

These are samples of unreliable conditions or deficiencies present that should be repaired by a competent electrical contractor.

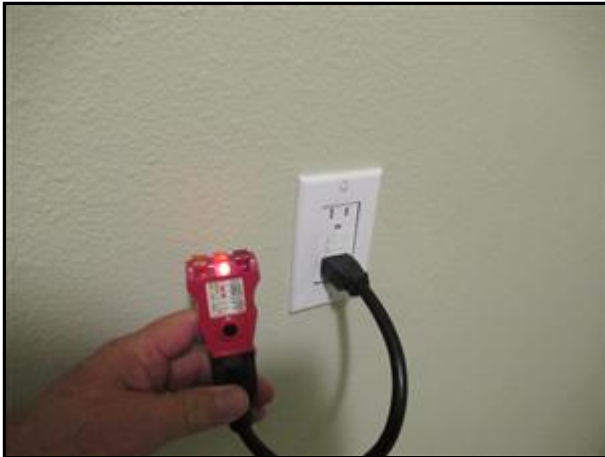
4.2 Picture 1 Ungrounded / Defective GFCI

These are samples of unreliable conditions or deficiencies present that should be repaired by a competent electrician.

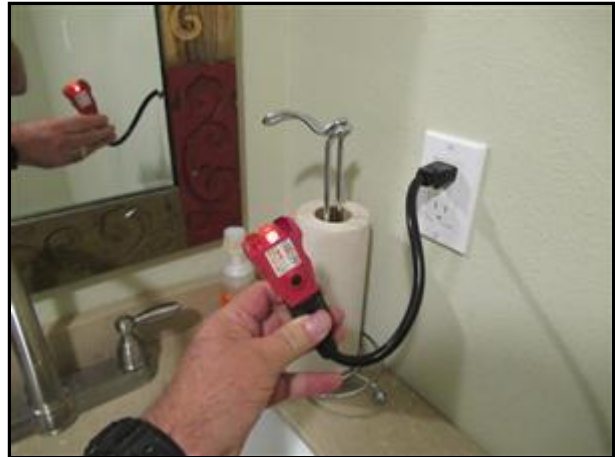
4.2 Picture 2 Ungrounded / Defective GFCI

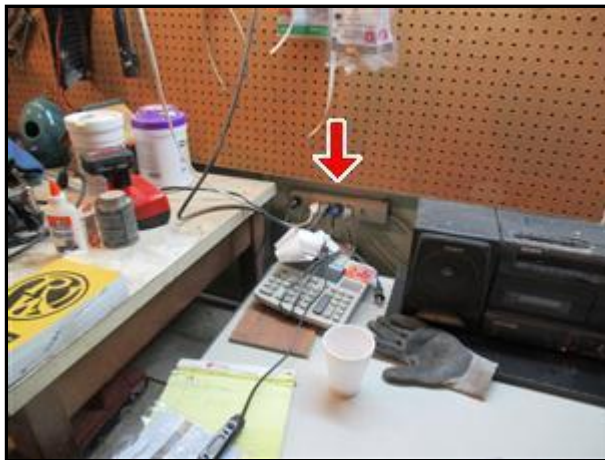
4.2 Picture 3 Extension Cord

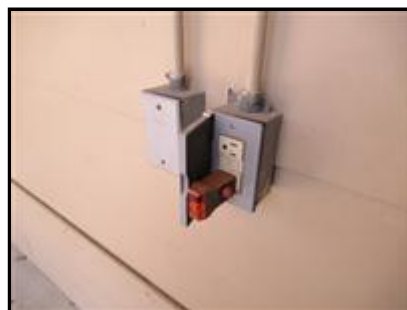
4.2 Picture 6 Defective GFCI Outside

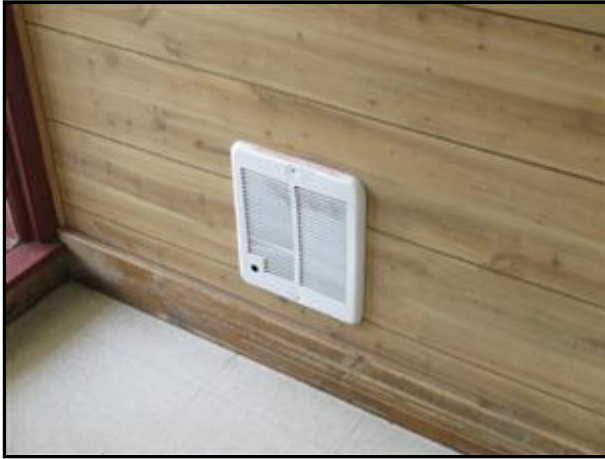
5.0 Picture 1 Electric Heater / No Knobs

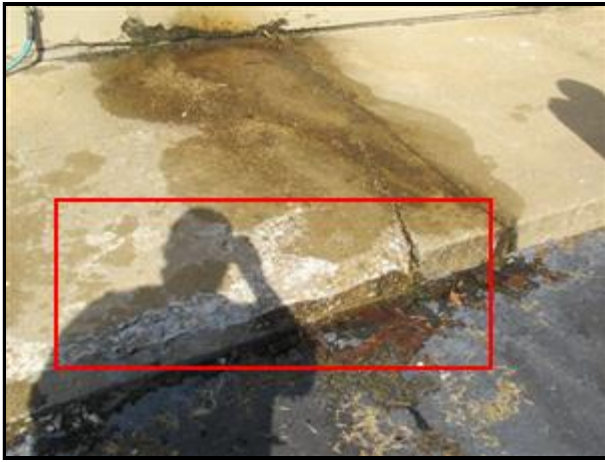
6.1 Picture 1 Damage / Trip Concern

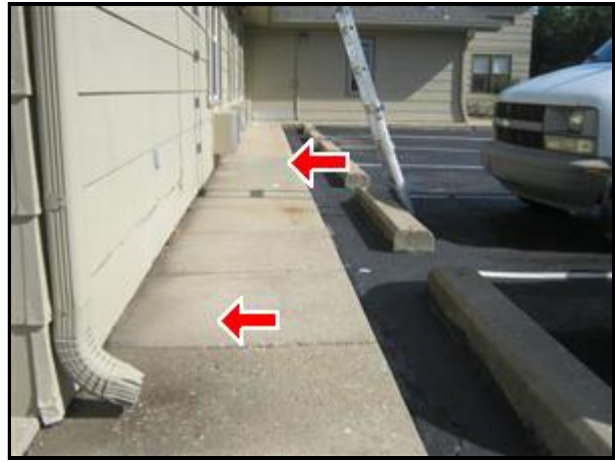
Poor drainage was noted. Sections of the walk(s) slope toward the foundation and will direct water toward the building rather than allowing it to drain away as intended. Service and correct as needed.

6.1 Picture 2 Slopes to Building

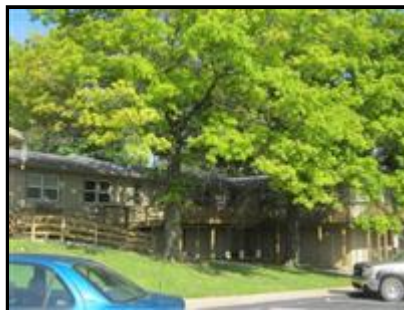
6.3 Picture 4

(2) Shrubs, trees or other foliage rub and obstruct the view of parts of the building, foundation or roof. These should be trimmed back from the structure to allow for proper access and complete visibility of the foundation, siding, etc. After trimming, check these areas prior to closing.

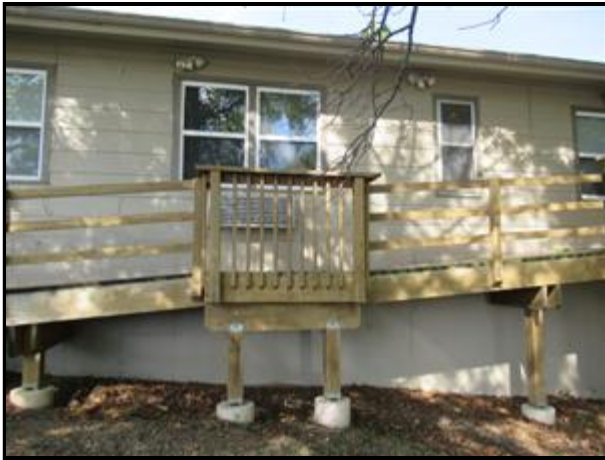
6.5 Picture 1 Large Gaps in Rails

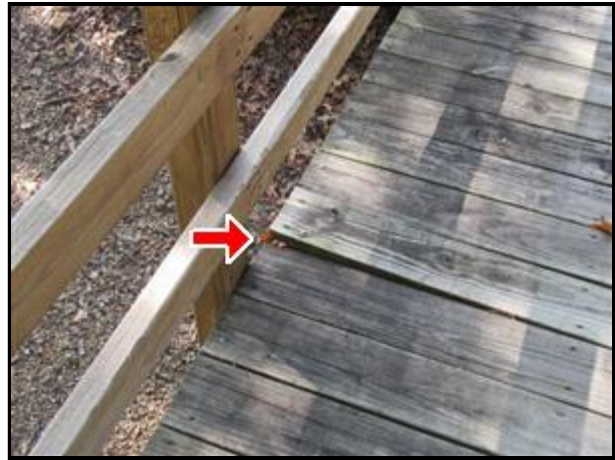
6.5 Picture 2 Raised Boards

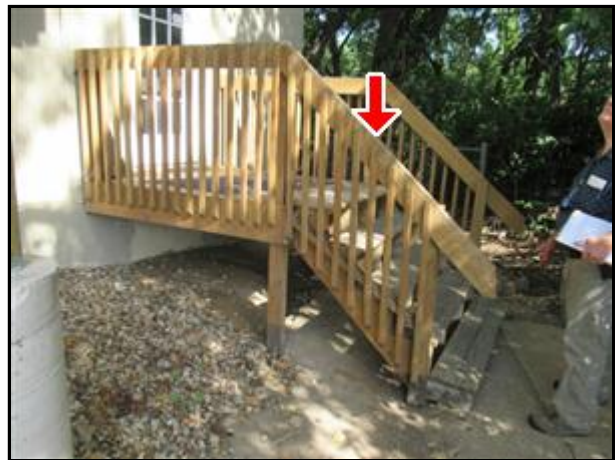
6.5 Picture 4 Not a Grab Rail

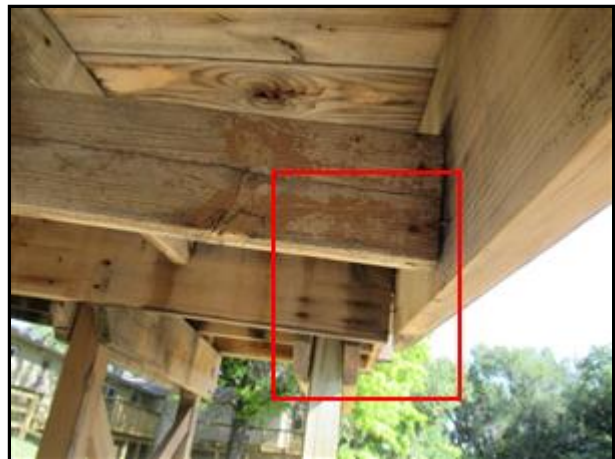
6.5 Picture 6 No Joist Hangers

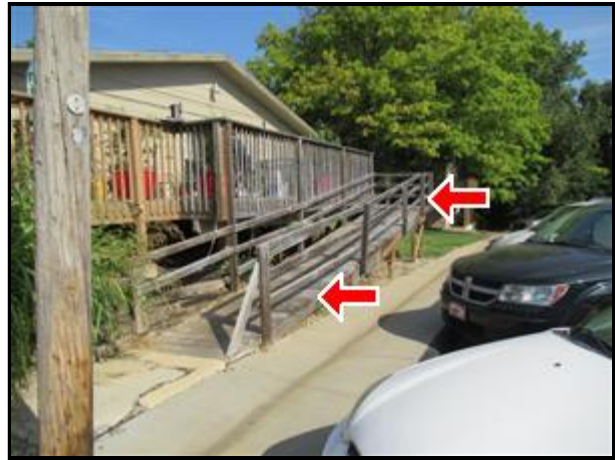
6.5 Picture 8 Loose Rails

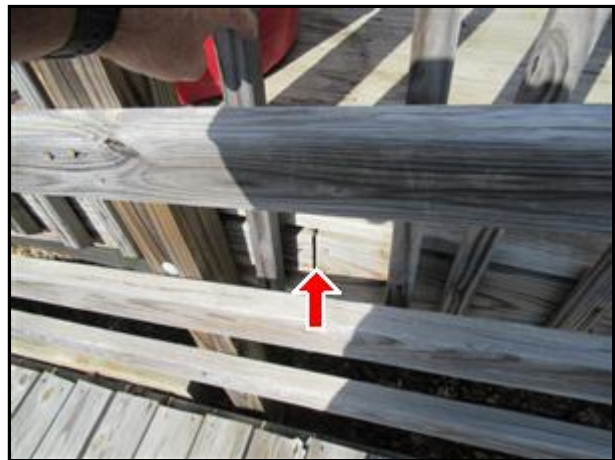
6.5 Picture 10 Big Gaps

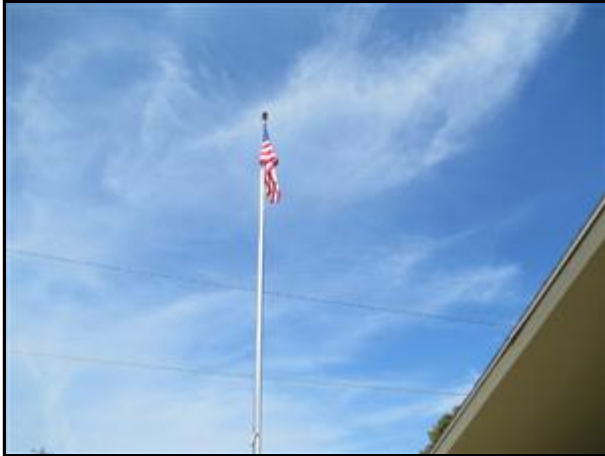
6.7 Picture 1

The exterior items in the pics are not fully secured and if they fell can be a safety issue. Repair as needed.

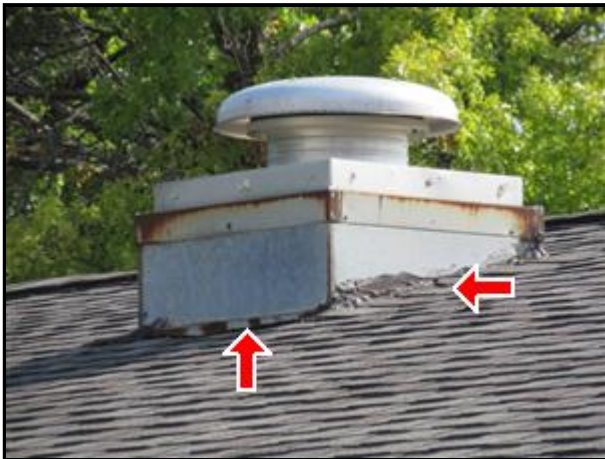
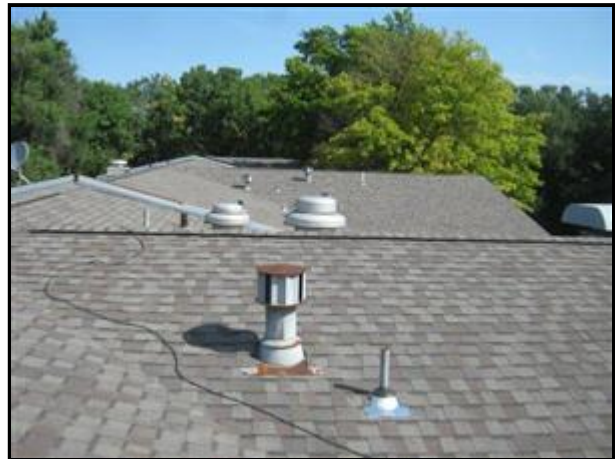
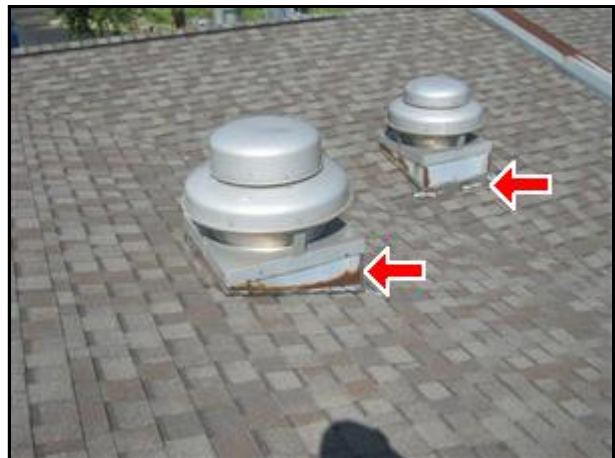
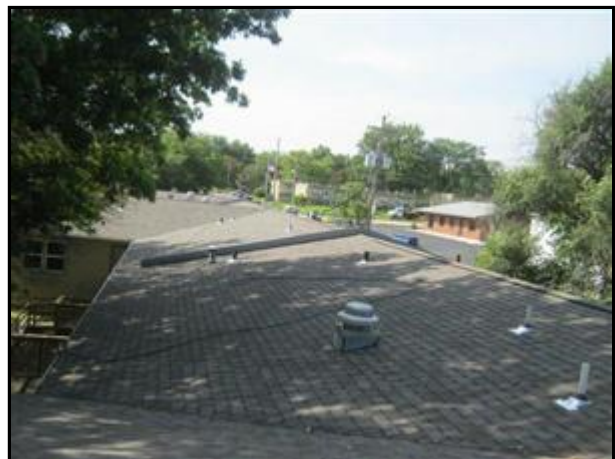
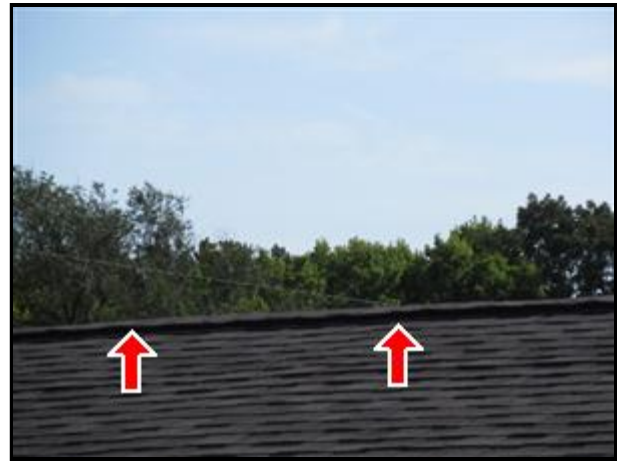
(2) In walking the roof we noted raised shingles at various locations; rusty flashings; heavy built up mastic that was worn or splitting; unsealed separations and gaps at some flashings; the roof ventilation from soffits and ridge vents combined appears minimal in our opinion; the ridge vents were not sealed on the bottoms where they meet the shingled roof; and at the front of the roof we noted the 2nd layer of roofing was not offset which created a flat cup like area that can hold water (seal the edges, etc). These conditions lend themselves to moisture intrusion.

Typical maintenance is recommended for the wood shake or shingle roof. This usually consists of repair or replacement of damaged and/or missing shakes, shingles, flashings or ridge caps. This can help to ensure the water tightness of the structure and should be done on a regular basis.

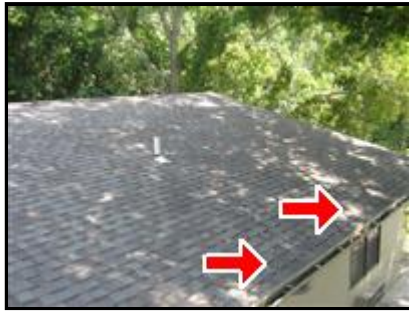
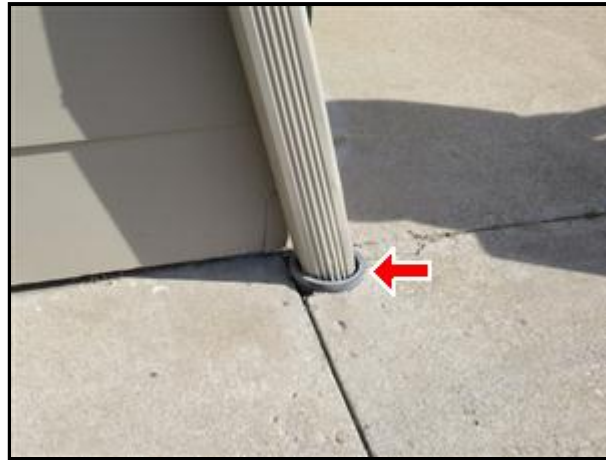
The roof on the left side of the building did not have full gutters, etc. Recommend adding them.

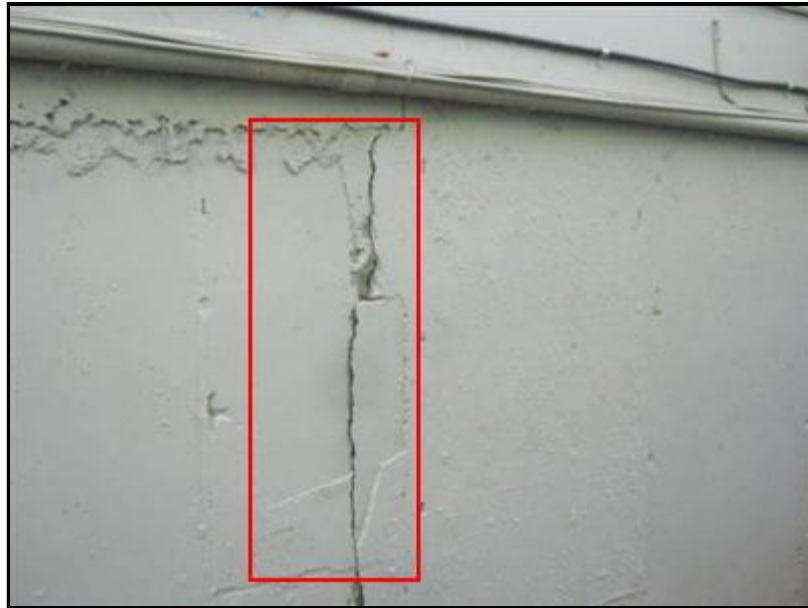
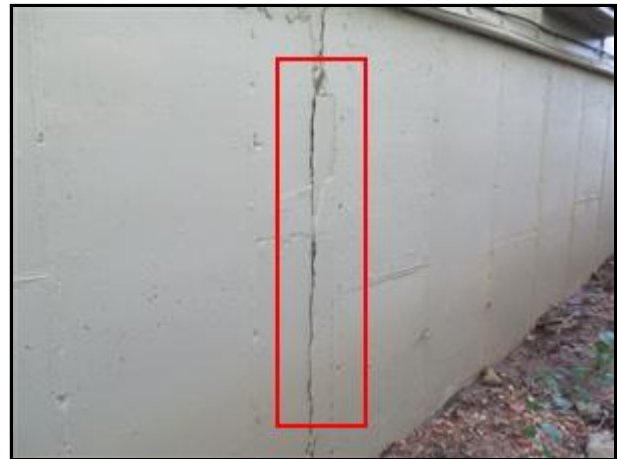
Small cracks, gaps, etc were noted in the foundation walls mainly on the buildings left side. These are often caused by shrinkage or movement in the building or its materials, and in our opinion this is not uncommon for the age and type construction, combined with expansive soils. We recommend keeping any crack, gap or utility penetration well sealed to be able to monitor for future movements or help prevent leakage. If either condition should ever occur, repairs could be needed.

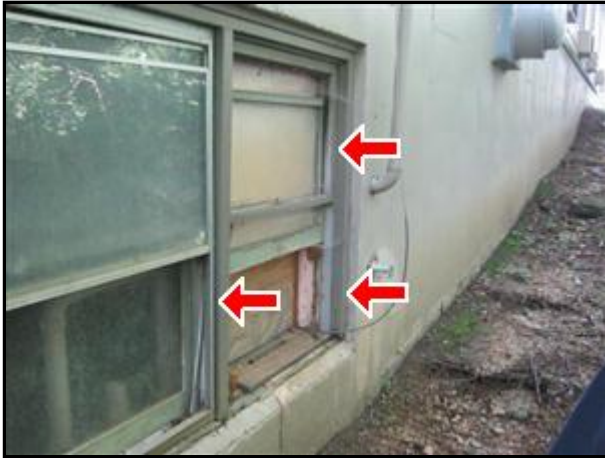
9.1 Picture 1 Window Frames

The cost of doing this Service is unknown to us, so you should consult with a contractor to determine the exact costs prior to the end of your due diligence period. Depending on answers to the question about Masonite and Hardie Board Siding In our opinion you could anticipate costs as low as \$1,500 for simple repairs OR significantly more if recalled siding was involved..

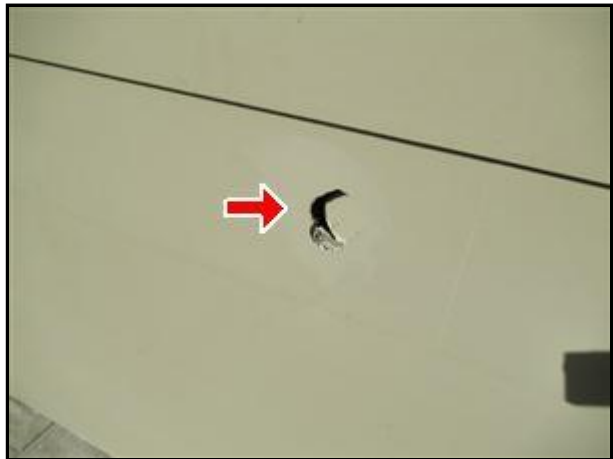
9.1 Picture 4 Siding / Hole

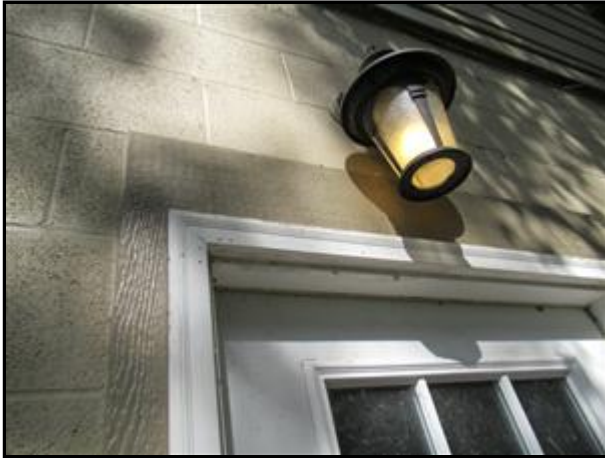
9.2 Picture 1 No Flashing Seen

Flashing is installed to help prevent ponding moisture from entering the structure and/or causing water damage, etc. Modification of areas with missing or improper flashing is recommended.

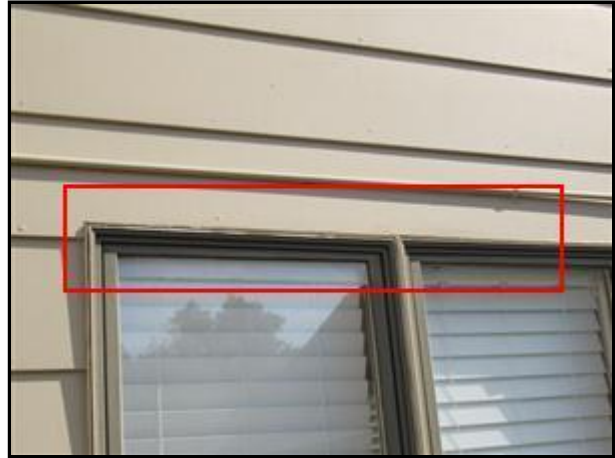
9.2 Picture 2 Head Flashing Not Seen

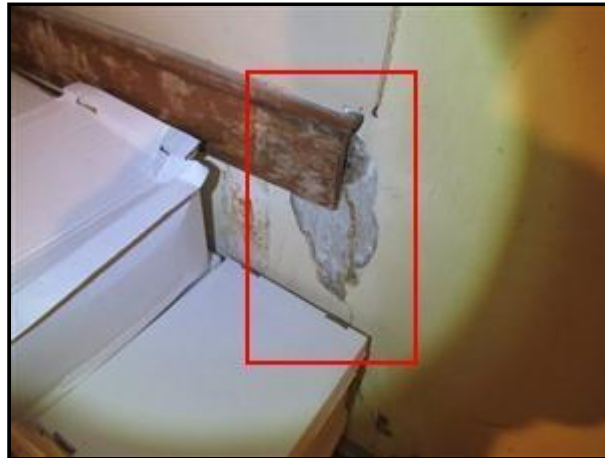
10.0 Picture 1 Example

There were wall cracks that should be sealed to help prevent moisture intrusion and monitored in the future.

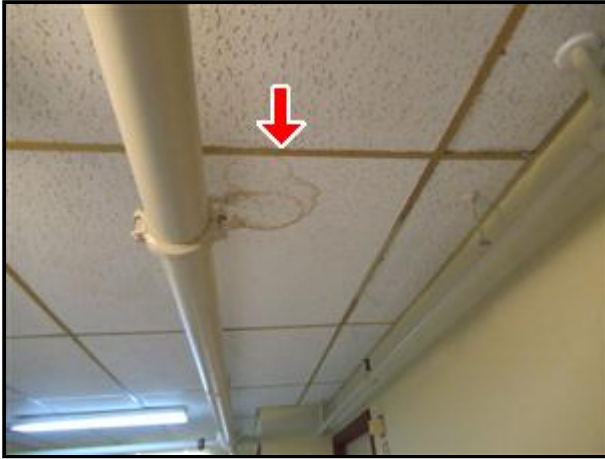
(2) We noted cracks, moisture stains, holes in ceiling tiles or drywall or movements that in our opinion are consistent with the use and function of the component, and not uncommon for a building of this age.

11.1 Picture 7 Moisture Stain Main Level

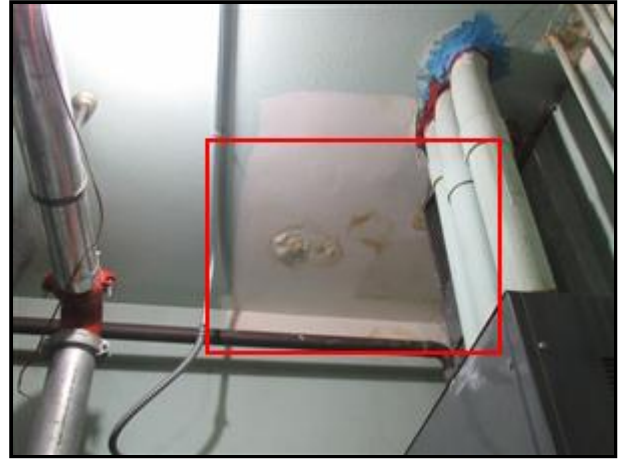
11.1 Picture 8 Moisture Stain Mechanical Room

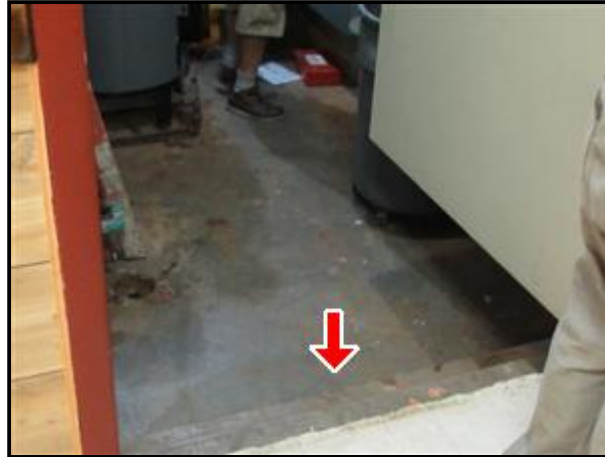
11.1 Picture 12

(6) When the door to the "Boiler Room" was opened, there is an immediate drop of 12" or so. Several times during the inspection someone opened the door and fell into the room. Recommend adding another step or handrail.

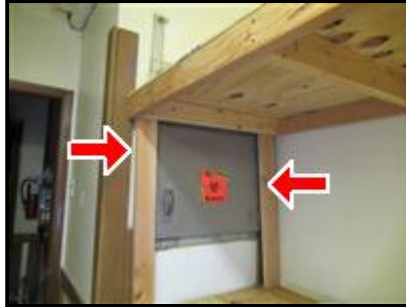
11.5 Picture 1

(2) The Bio-Waste container was blocked by shelving and not operated or checked.
