Inspection Report

Property Address:
1567 E. Anywhere Ln
Kansas City MO 64055

Dan Bowers Company

This is a **Property Condition Report "PCR"** generally using the **ASTM E2018** as a starting guideline to describe the condition of building or buildings for the property inspected. **This process involves visual observation of the property by a person or entity.** It's purpose is to help develop an opinion and preparing a PCR of a commercial real estate's current physical condition. At the option of the user and for an additional fee, the PCA may include a higher level of inquiry and due diligence than the baseline scope described within this guide OR at the user's option, it may include a lower level of inquiry or due diligence than the baseline scope described in this guide. If there are such deviations from this guide's scope it should be disclosed here on this page. **A PCR is a written report, prepared in accordance with the recommendations contained in this guide, that outline the consultant's observations and opinions as to the subject property's condition, and opinions of service or repair, etc for material physical deficiencies that were observed.**

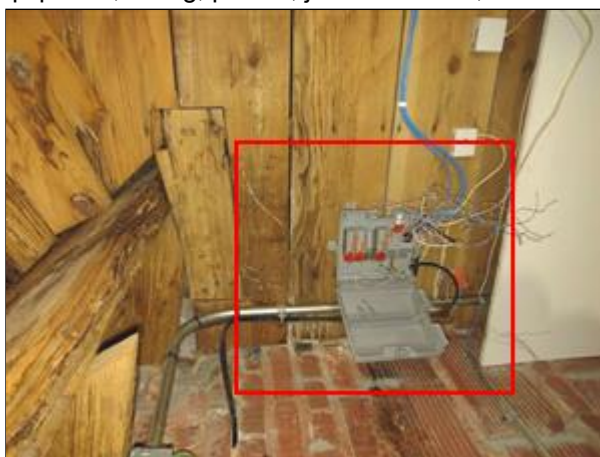
E. Picture 1

(1) Under the **SoP** (Standards-of Practice) for our inspections low voltage wiring, controls or lighting, telephone, cable or wiring for internet, alarms, security monitors, tele-communications, computers, TV's, speakers, intercoms, decorator lighting, computers, etc **IF PRESENT** are excluded and **NOT** inspected or included as part of the General Inspection. We **DID NOT** inspect any of this type equipment, wiring, panels, junction boxes, etc on the property if present.

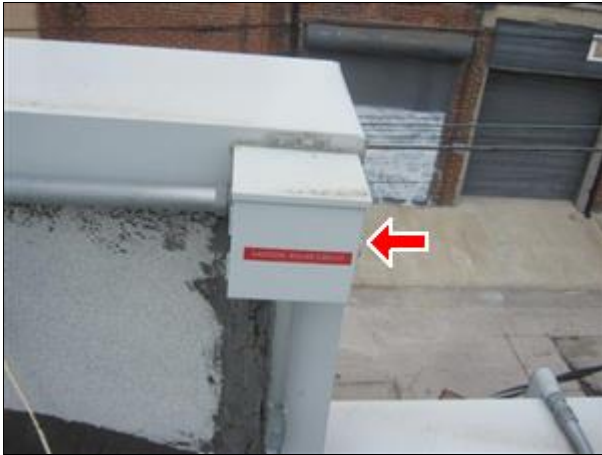
E. Picture 4 Wiring Box on Roof

(2) The building also uses a **solar photovoltaic system** with the knife disconnect by the main meter and **solar panels on the roof**.

We noted several panels with visible damage, and recommend having a professional Solar Panel contractor Service and **Check these prior to leaving your due diligence period to determine if the damage is just cosmetic and they are functioning properly OR if Repair is Needed**. Several Company's that we understand do this are **Ampray Solar (816) 287-4118** or **KC Energy Solar (816) 268-7810**. Other companies may be found online or in the phone directory.

The damage may be hail related If so there might be insurance coverage for this from the sellers insurance policy.

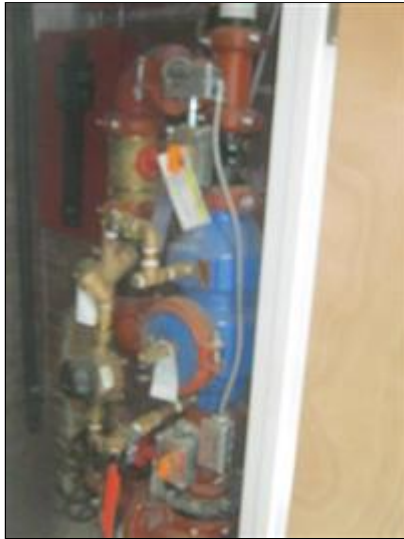
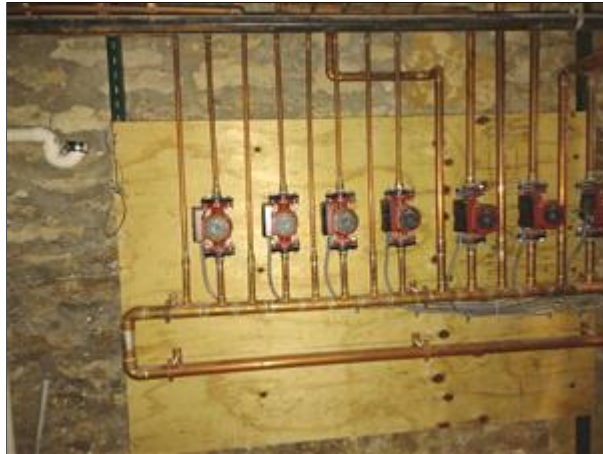
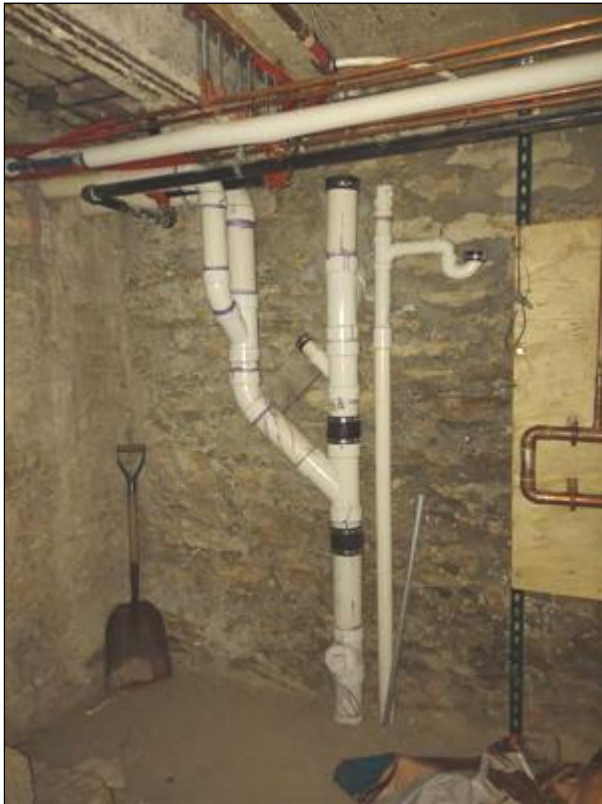
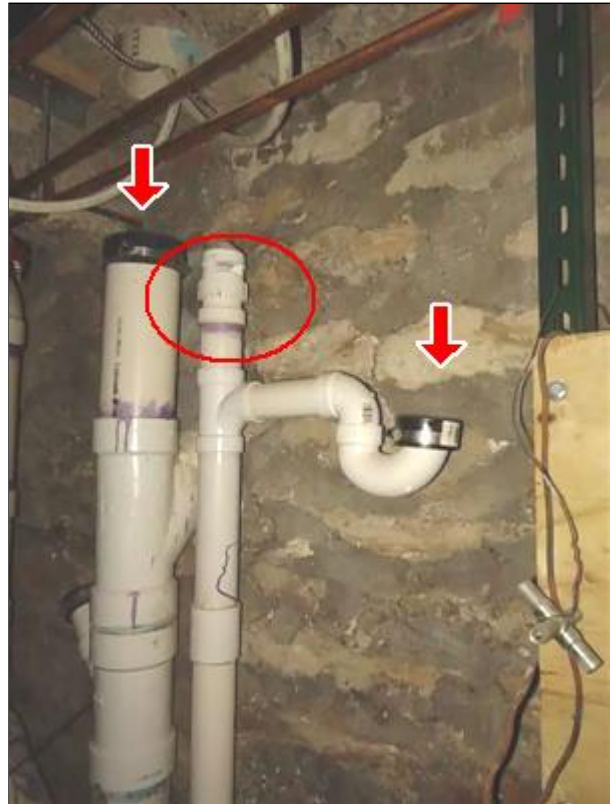
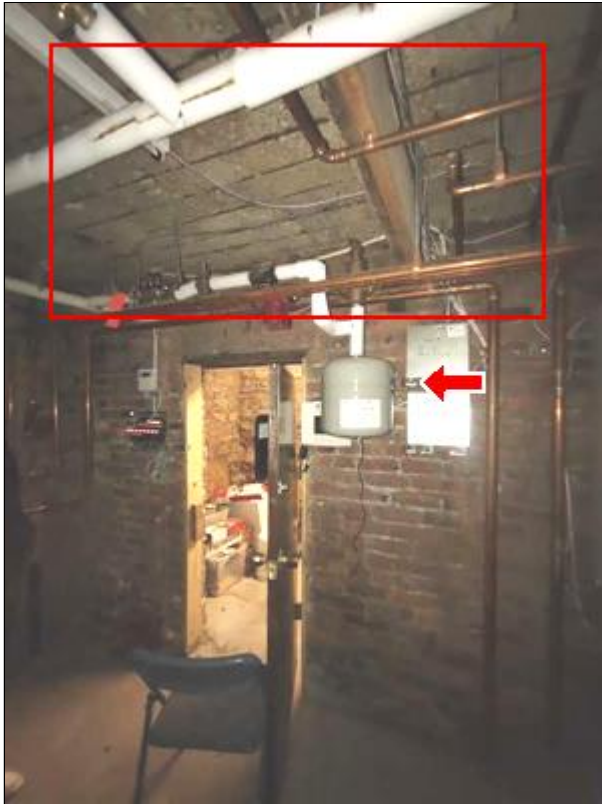
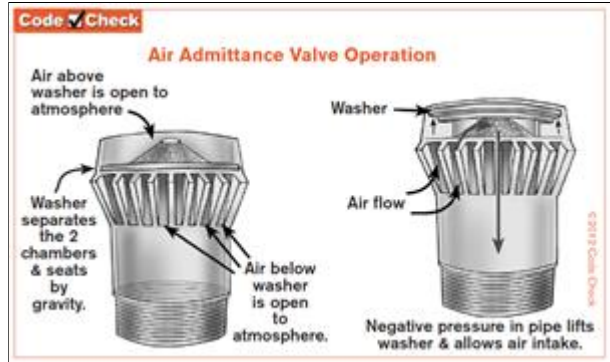
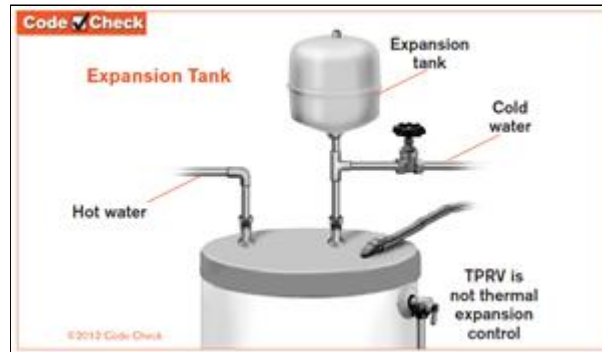
(1) The main water shut-off appears to be at the main level in the mechanical closet. The building has been extensively re-plumbed (probably in the past 10-15 years). New supply and drain lines are present in most places. Upgrades like an expansion tank, pressure reducing valves, a backflow prevention device, AAV's, etc have been added. Some drains or stacks are not in use at this time. They appear functional.

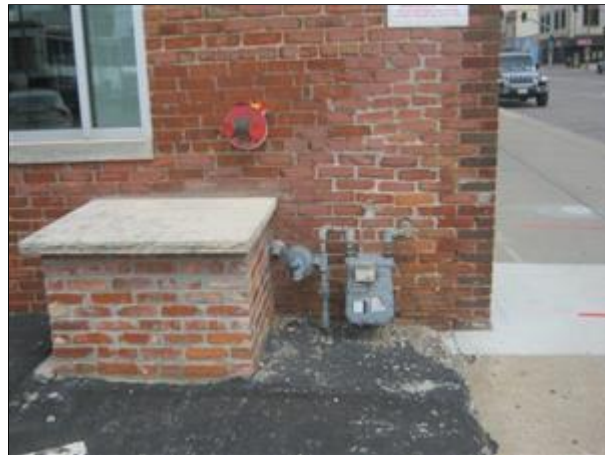
C. Picture 1

View Of The Gas Meter and Main Shut Off at the side of the building. It appeared functional

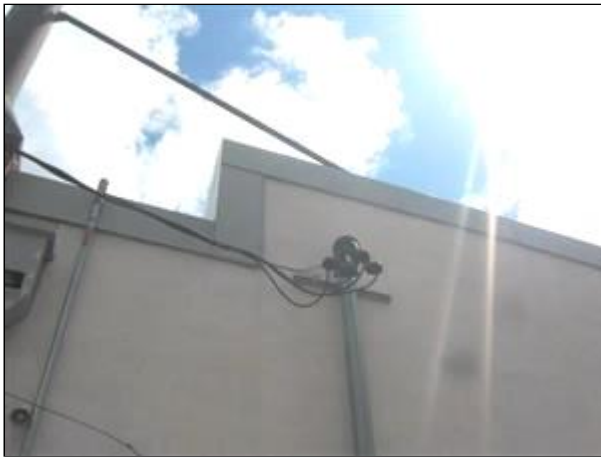
G. Picture 1

(1) Courtesy View of the Service Entry, Meter and Disconnect for the solar photovoltaic system. They look functional.

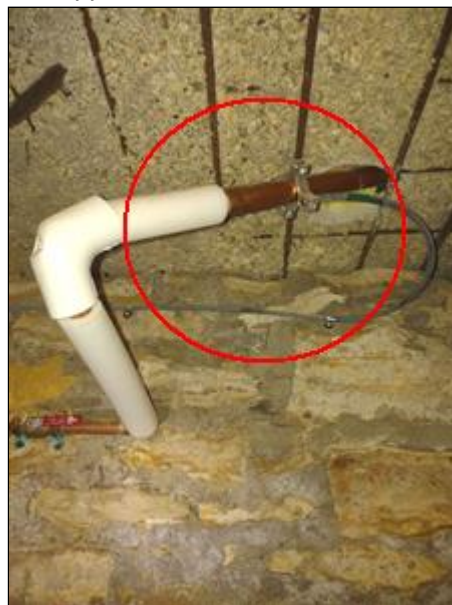
G. Picture 3

(2) The Ground to the water line in basement appears functional.

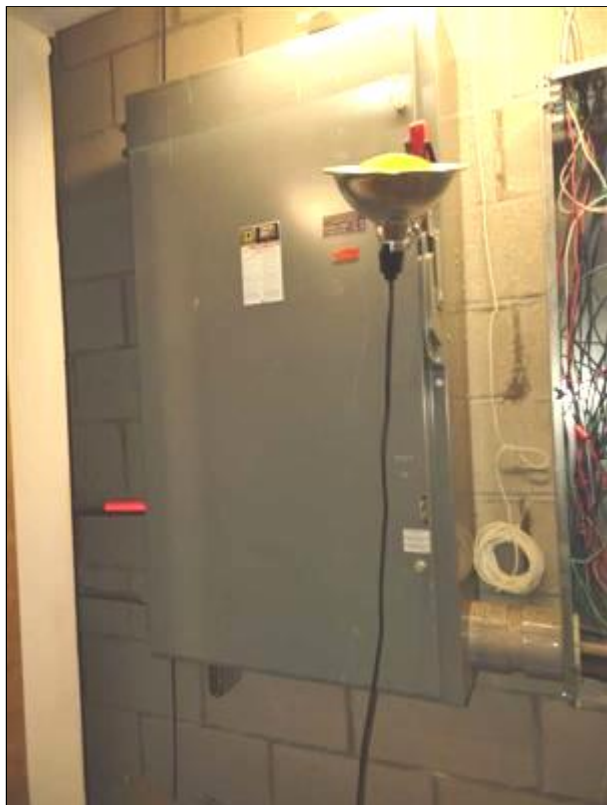
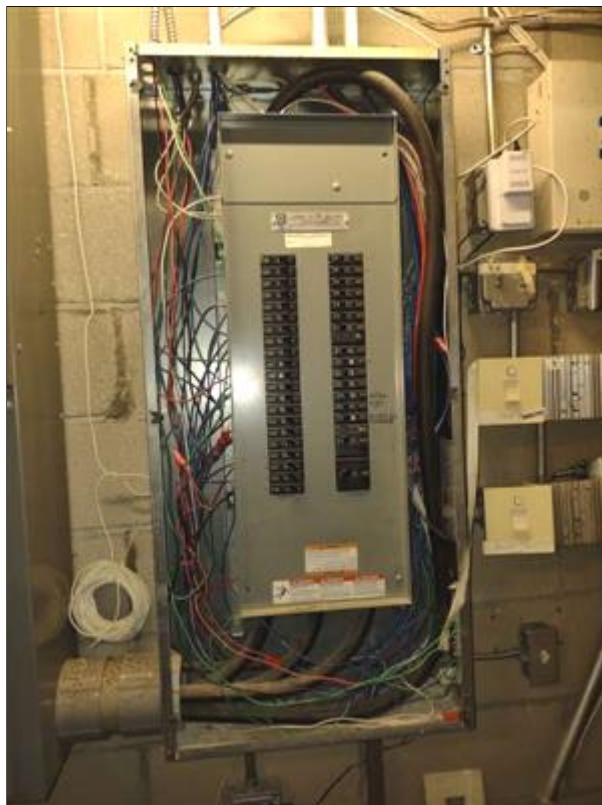
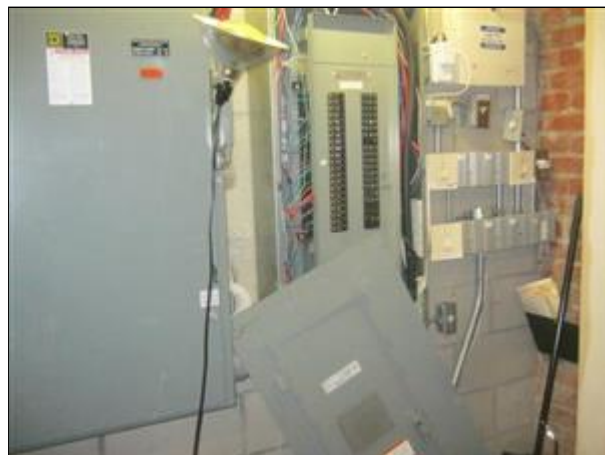
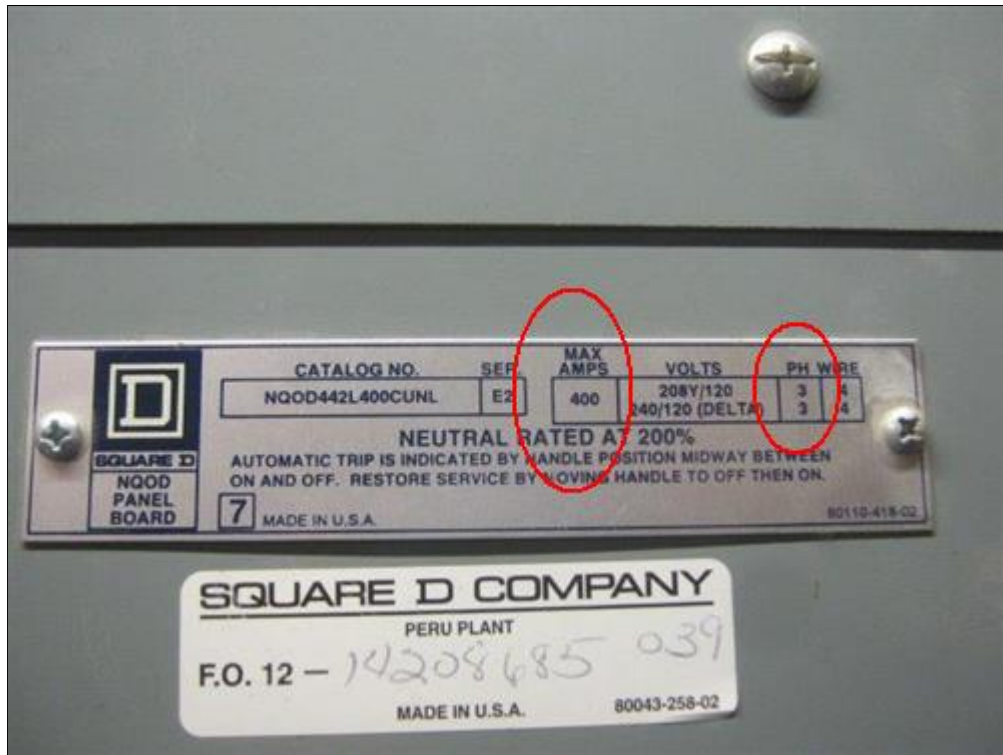
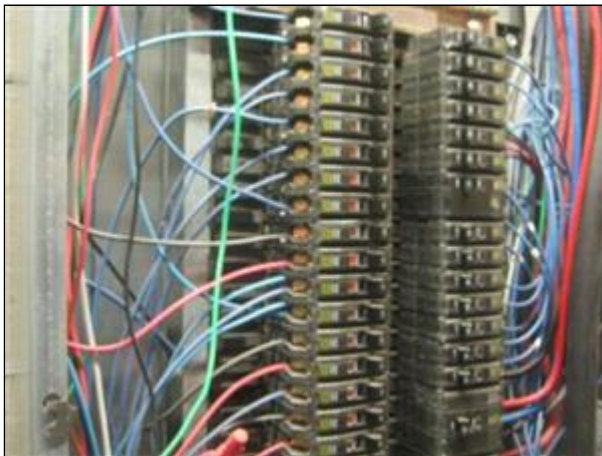
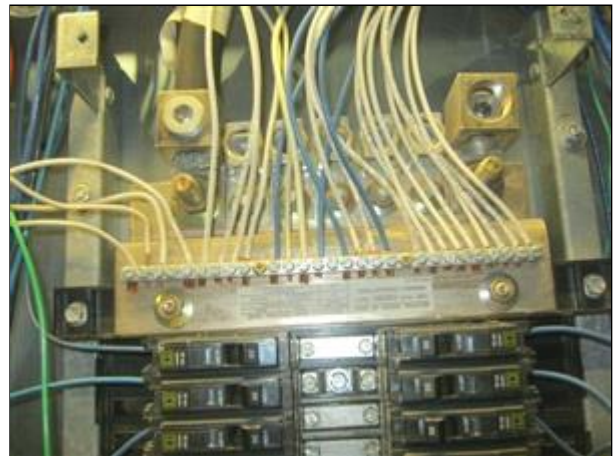
The 400amp / 3 phase main panel was functional.

Note: the panel cover was off when we arrived, so we left it off.

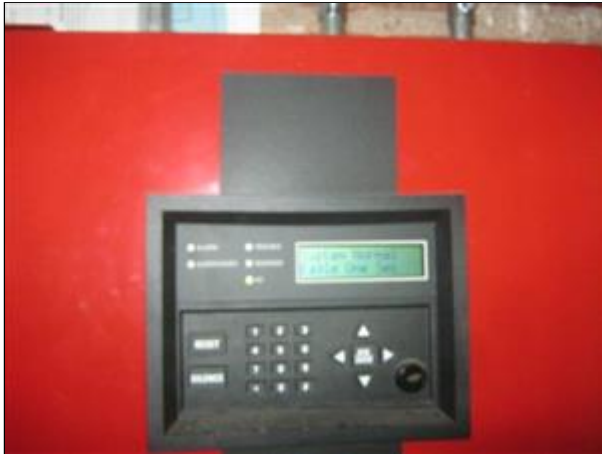
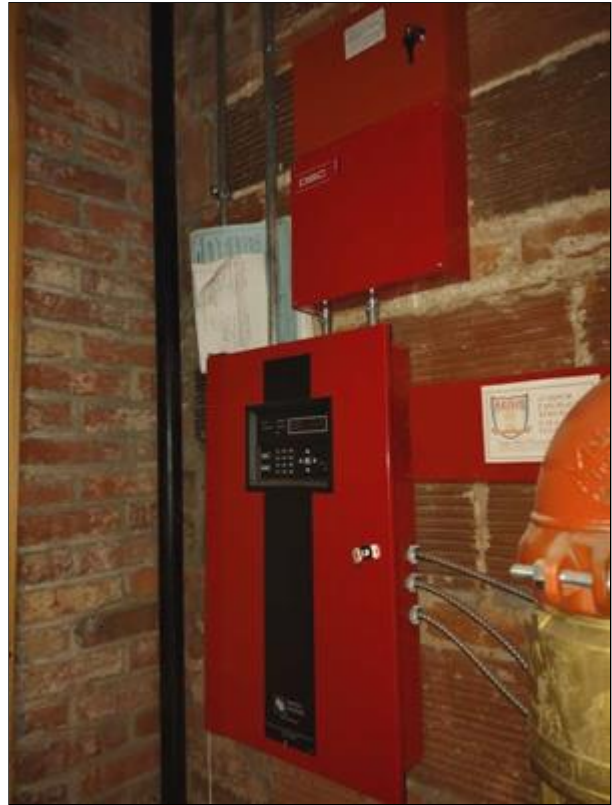
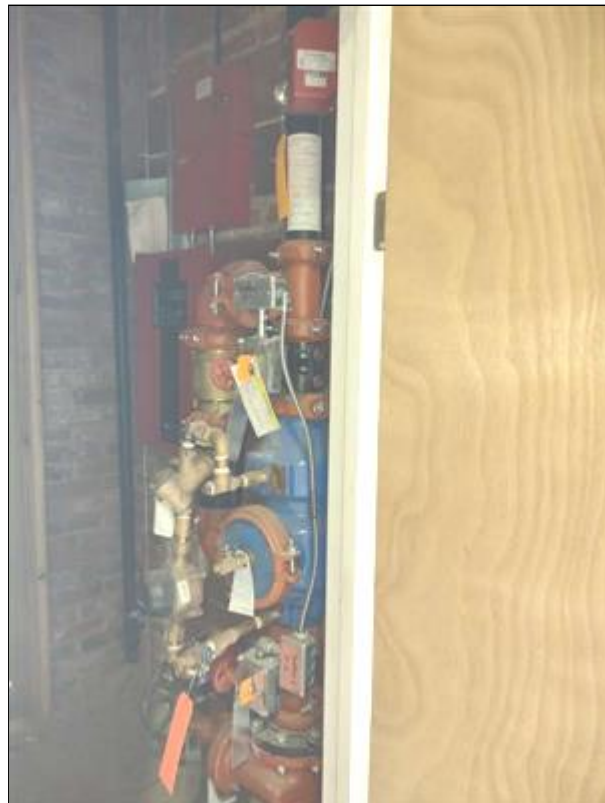
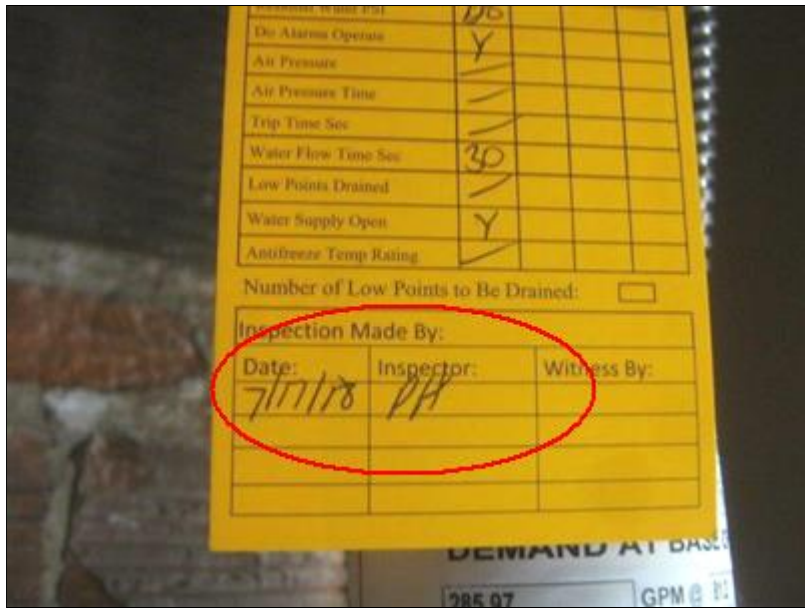
The data tag shows the last service was in July of 2018.

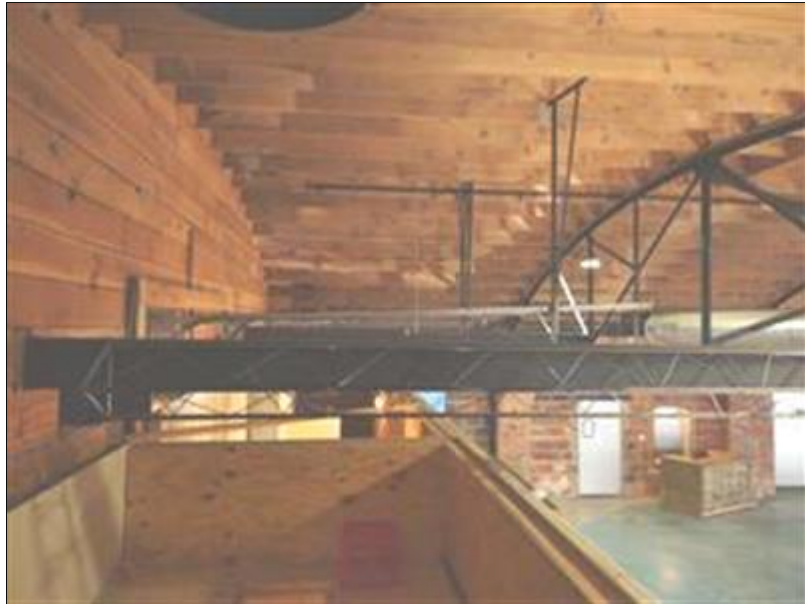
A. Picture 1

FYI - We noted cracks, stains or movements that in our opinion are consistent with the use and function of the component, and not uncommon for a building of this age.
