Inspection Report

Property Address:
4934 S. Happy St
Gladstone MO 64065

Dan Bowers Company

Date: 10/3/2012	Time: 09:30 AM	Report ID: 42676 - 15
Property: 4934 S. Happy St Gladstone MO 64065	Customer: Bobby Mechanic

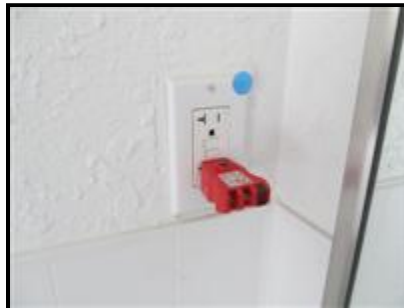
1.3 Picture 1 No Power

1.3 The Office area bath had a GFCI electrical outlet. The outlet and light fixture had no power to them. Service and correct as needed.

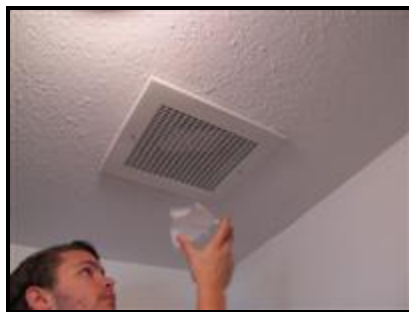
1.4 Picture 1 Shop - Bad

1.4 Both bathroom exhaust fans operate. The Office area vent pulled air, but the Shop area fan did not pull (see pic - would not pull piece of toilet paper). Service and correct.

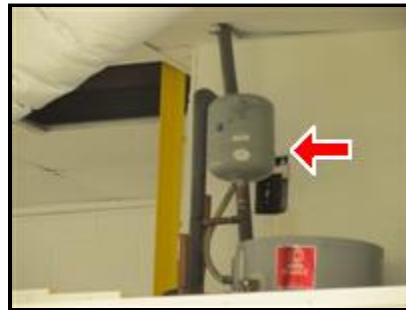
2.0 Picture 3 Expansion Tank

(2) **FYI** - The plumbing supply system has a PRV (pressure reducing valve) in the water lines. This typically means you have high water pressure in the building (usually a good feature). In the past PRV's were not always used, however newer plumbing codes, building standards and even some water heater manufacturers recommend that when a PRV (or closed system) is present - you install an expansion tank (these devices function similar to an overflow tank on a cars radiator system). A recent story in the Kansas City Star reported that although expansion devices have not been commonly required in our area in the past, some insurance companies have now started to deny coverage to damaged water heaters or supply lines when this condition exists **AND** there is no expansion tank, etc present.

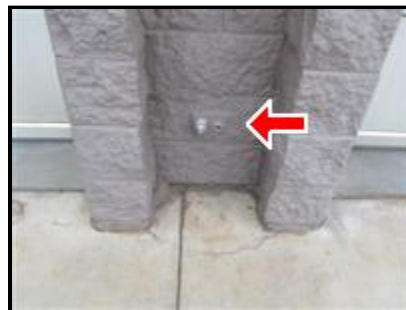
2.3 Picture 2

2.3 Hose bibb handles were missing at all outside locations.

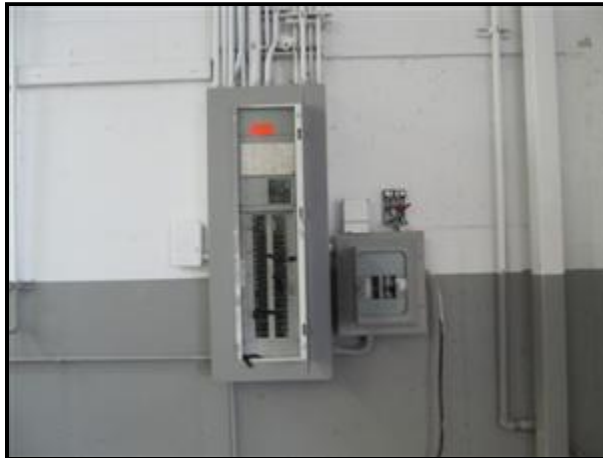
3.1 Picture 1

3.1 (1) Courtesy view of electric panels.

The electrical panels are located at the garage for your information.

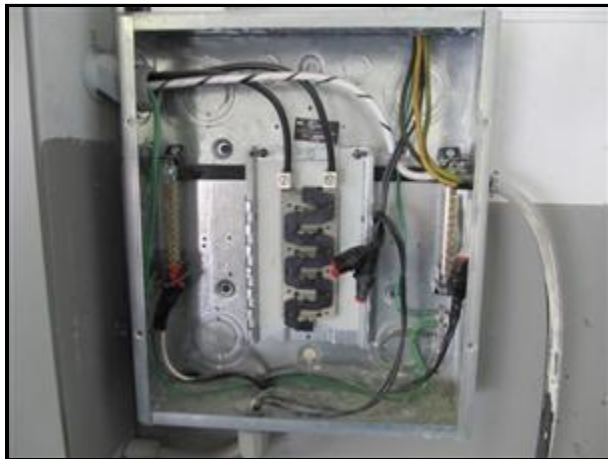
3.1 Picture 4

(2) During the examination of the electrical main and sub-panels we noted deficiencies needing repair, such as the following conditions:

"Double-tapped" circuits in the main panel; loose OR improperly terminated wiring inside the sub-panels; wires capped or taped together and not protected by a breaker OR fuse present in sub-panels; unprotected openings OR missing wire clamps in the panels; panel screws missing at the electrical panels); the main panel used nuts versus screws to hold the inner panel on and 2 were partly stripped (we could not fully get cover off (viewed from the side); paint overspray on breakers at main panel; various breakers were shut off, wires were capped but not terminated properly, etc (prevents us from activating breakers, etc that are off); breakers were missing at sub-panel; etc. These are samples of unreliable conditions or deficiencies noted.

We recommend having a licensed and competent electrician read **ALL** electrical comments anywhere in the report; review the electrical system conditions present; then service, modify or repair any defects or unreliable conditions as necessary, to properly and safely correct them.

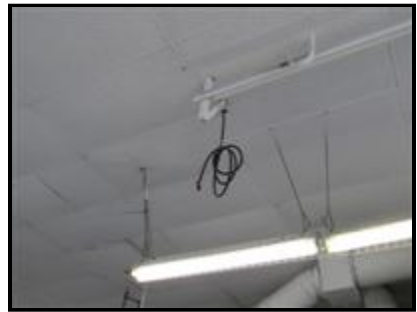
A missing light or other fixture high on the wall in the customer waiting area; live wires exposed on wall or ceiling surfaces at multiple locations in the shop area (wires are to be inside walls, ceilings or conduit); open electrical junction boxes with exposed wiring in the shop area (cover plates missing); many 220v-240v size wires coiled up, not being used with wire nuts on the ends in the shop area (use or properly terminate them); outlets with no power to them in bath and shop (marked with colored dots); many 110v-120v size wires coiled up, not being used with wire nuts on the ends at the exterior walls of the building (possibly lights or signs) use or properly terminate them); exposed electrical splices noted (electrical splices are to be in a covered junction box or fixture, etc); lights we could not get to operate (check the bulbs to start with); outlets with no power. This is a sample of the branch wiring defects noted at the property. See Samples in Pic's

3.2 Picture 3 Shop/Capped Off Wires

We recommend having a licensed and competent electrician read **ALL** electrical comments anywhere in the report; review the electrical system conditions present; then service, modify or repair any defects or unreliable conditions as necessary to properly and safely correct them.

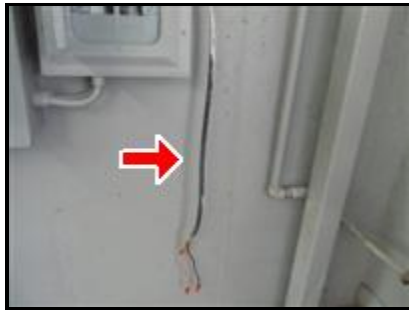
3.2 Picture 4 Wires On Wall / Capped

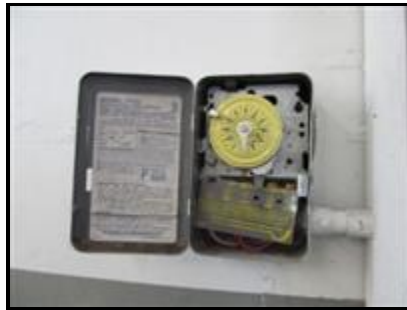
3.2 Picture 5 Timer for ????

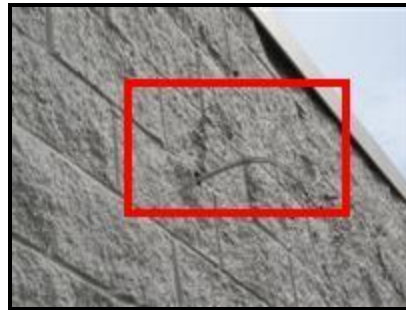
3.2 Picture 10 Exposed Wires
Outside

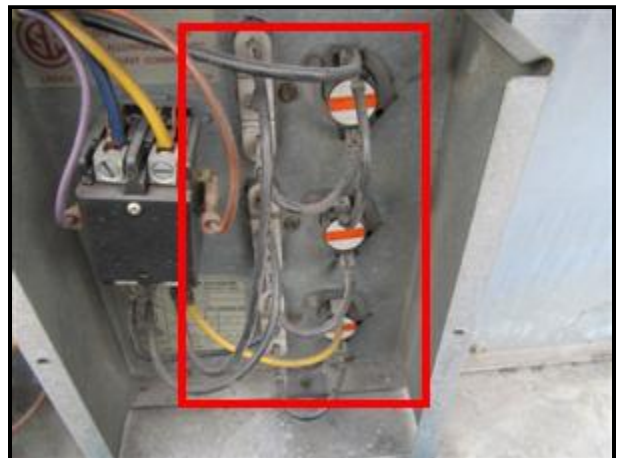
4.1 (1) The rooftop system was operated in both heating and cooling modes and was functional in each. The cooling produced a good 48.9 degree supply air temperature after 10 minutes of operation. The units 3 electric strip heaters produced adequate heating for the conditioned areas.

4.1 Picture 6 Strip Heaters

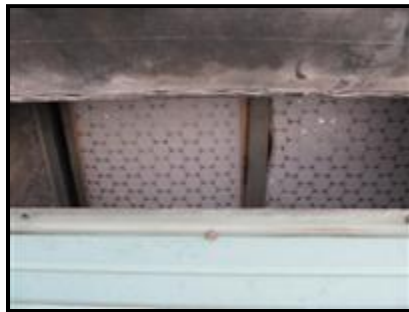
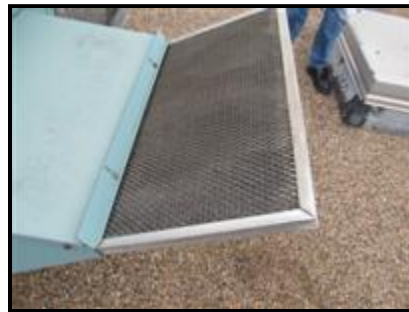
4.3 There are two (2) throw-away filters that are 16x25x2 and one (1) washable metal filter in the hood. We recommend replacing or cleaning the air filters, every 6 to 8 weeks during the heating and cooling seasons to promote clean and efficient operation.

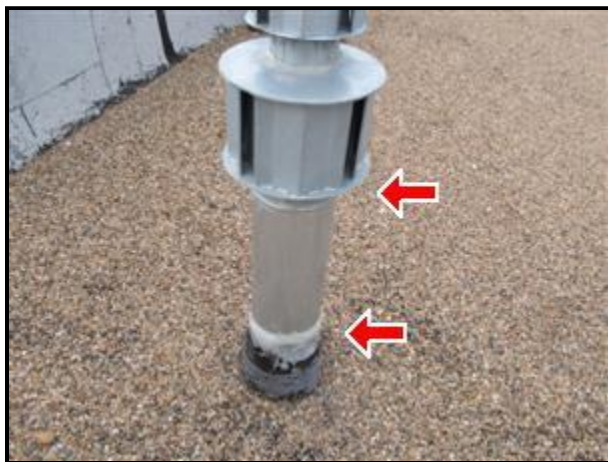
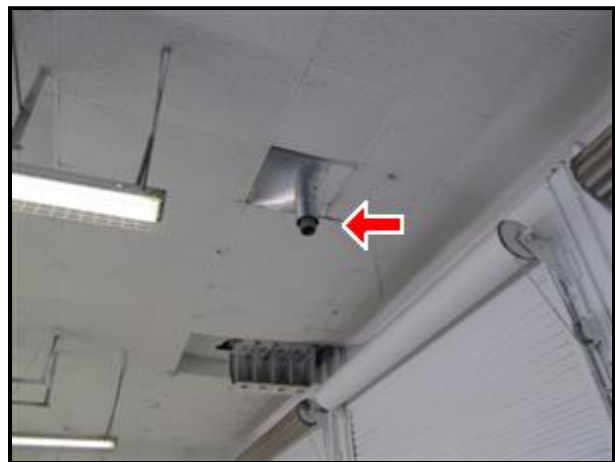
4.4 (1) There were several newer looking flues / exhausts on the roof with heavy caulk around them. They were attached to nothing and their purpose is unknown (maybe air exhausts for shop, etc). Verify purpose with seller.

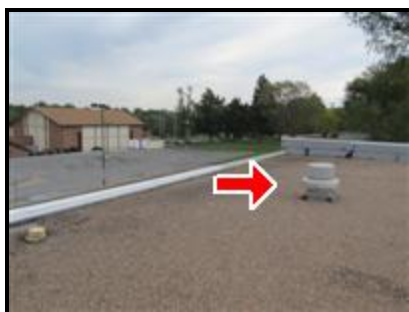
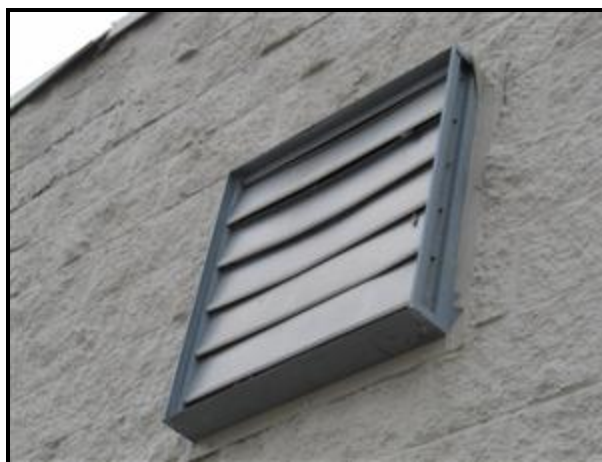
(2) See air intake or exchange fans on roof (several) and at north wall. How well they work is unknown.

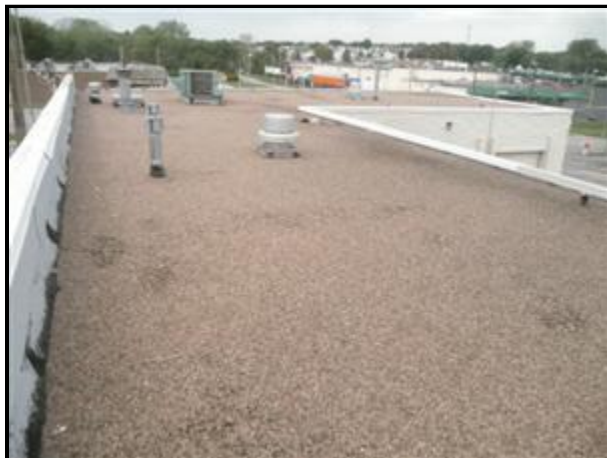
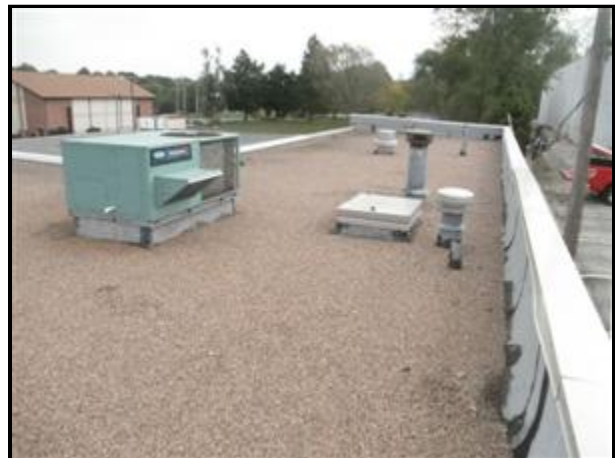
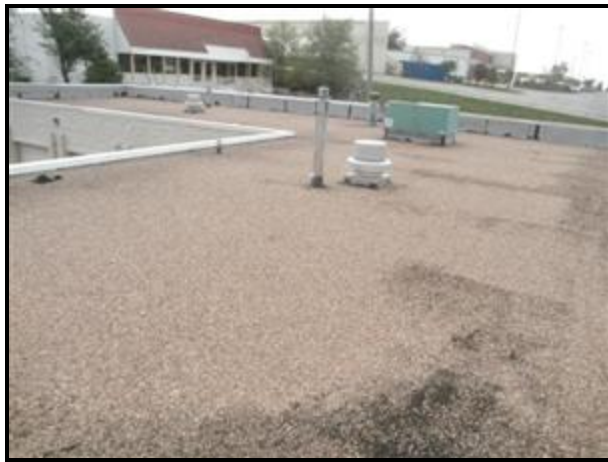
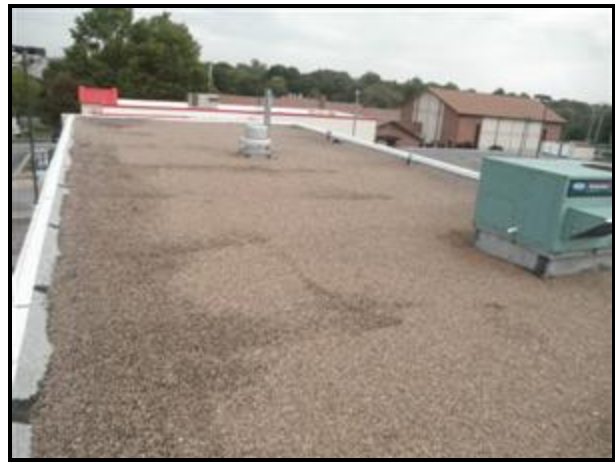
6.0 (1) See Courtesy Views of Roof. The overall general condition appears functional with signs of weathering, aging and service needed. Regular service and inspection is advised to achieve continued service.

(2) Service is recommended. This usually consists of the repair of open cracks in flashings or roof coverings; open seams; deteriorated roof coverings; etc. On B.U.R. it may also include covering any exposed or bare areas with an additional coating of tar or aggregate material.

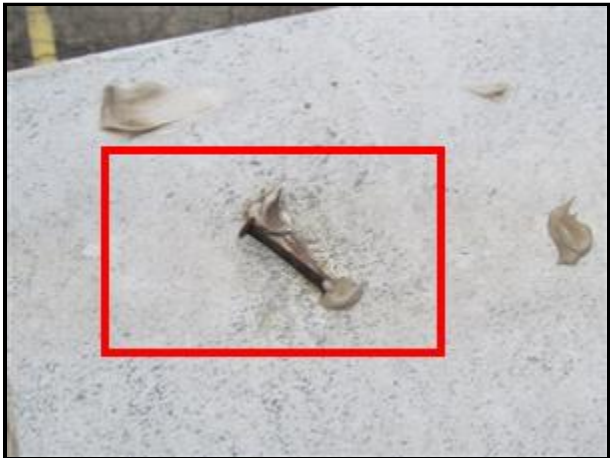
6.0 Picture 11 Nail Example

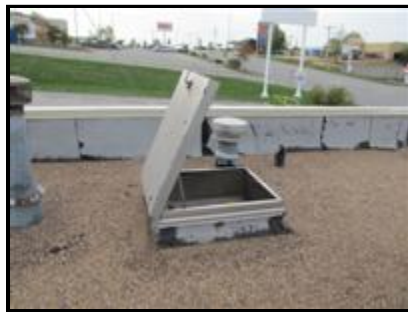
6.1 Picture 1

6.1 The access ladder and hatch were operational. The access was not locked and could be entered from the roof easily. Lock it for security.

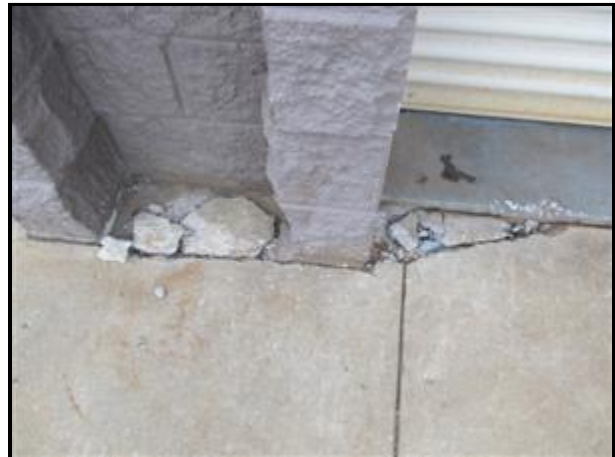
7.0 Picture 2

7.0 Foundation or wall movements noted, mainly along north wall. Review by competent contractor or engineer recommended. This type of movement is usually caused by settlement movements and expansive soils. The amount of movement did not appear structurally significant, however the movement may have affected roof drainage, etc. It would be prudent to have review by competent contractor or engineer.

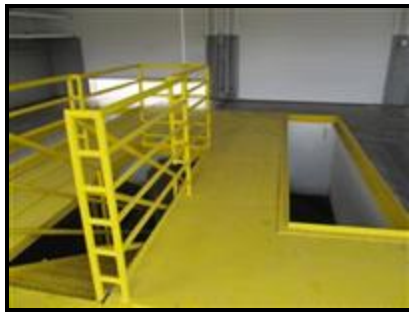
8.2 Picture 1

8.2 (1) The pit, floor, walls and overhead support for concrete garage floor look functional.

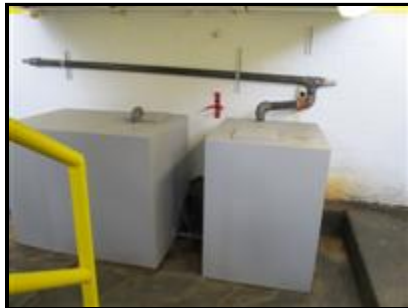
8.2 Picture 4

(2) There were 2 oil storage containers. The right one has oil sludge still in it. The left ones cover was painted or solder shut and its interior was not viewed. The piping going to it was disconnected, indicating its not in use. Get disclosure of where the oil goes (storage tank, pumped or ???). This was not operated in the general inspection.

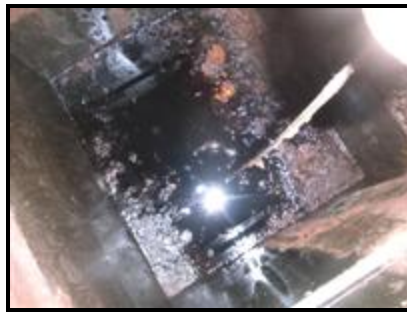
8.3 Picture 2

8.3 The sump pump was functional but the float did not go off until raised VERY high. Adjust the float valve to operate at a lower fluid level. We noted water and oil in the pit and the sump pump exterior drain pipe goes underground. We did not see where it comes out. We suggest verifying with the owner where this is, so you can determine there is a proper drainage through the pipe, etc and that its proper.

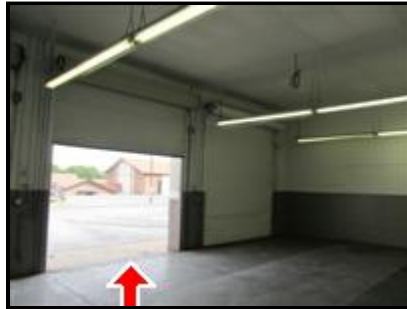
10.2 Picture 2

- 1) The overhead door by the mail slot has a cut in it.
- 2) Several doors on the North side have rust on the door or lintel, OR have minor damage (warping, etc).

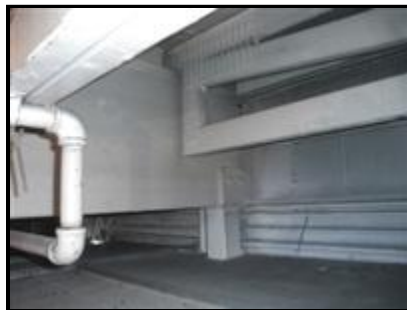
10.3 Picture 2

There were minor moisture stains in attic that were dry at this time. Monitor this in the future.

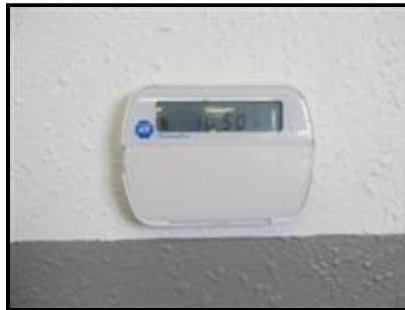
11.5 Picture 1

11.5 (1) An ADT alarm or security system of some type was present. We are not specialists in these type of systems and **DID NOT** perform any analysis, operation or other type testing on the system. Consultation and evaluation by a competent and licensed specialist in security systems can provide information or testing of the system to verify the operation and proper function of the system and its components.

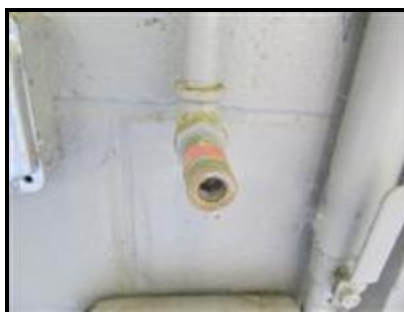
11.5 Picture 2

(2) Piping for air compressor(s) was present at various areas in the garages but no compressor(s) so we **DID NOT** perform any analysis, operation or other type testing on the system. Consultation and evaluation by a competent specialist in these systems can provide information or testing of the system to verify the operation and proper function of the system and its components.
