Inspection Report

Saint Jefferson Parrish

Property Address:
6235 Missouri Blvd
Jefferson City MO 65109

Date: 1/17/2019	Time: 09:30 AM	Report ID: 011719 - Church
Property: 6235 Missouri Blvd Jefferson City MO 65109	Customer: Saint Jefferson Parrish

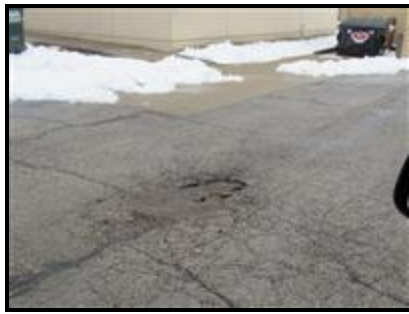
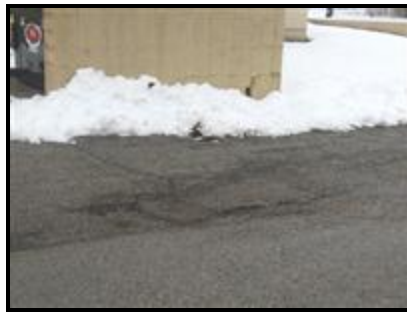
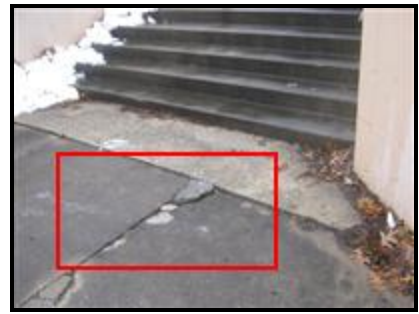
Signs of cracks, chips, spalling, offsets, surface movement, deterioration, etc in the flatwork are not considered uncommon, and are found at the majority of properties in this area due mostly to shrinkage, curing or expansive soils.

E. Picture 1

E. Picture 2

E. Picture 3

Ongoing maintenance will include sealing gaps, cracks, pot holes or other deterioration to help prevent future damage, moisture intrusions or a trip potential.

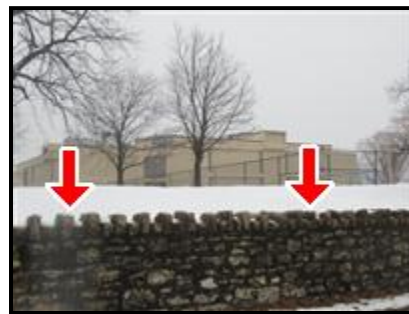
F. Picture 2

The stone retaining walls at the south side of the building has deteriorated or loose mortar and stone that does not look uncommon for the type and age in our opinion. It looks like a contractor may have been repairing it (see sign on top of the wall). Verify with seller if the repairs have been done; if soare they complete and paid for.

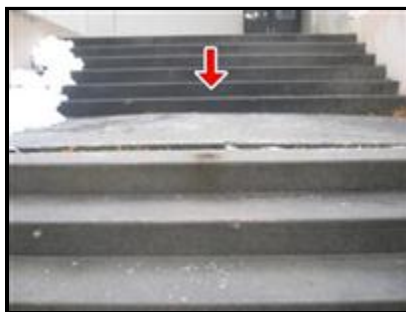
G. The front landing stoop and/or steps have had excessive movement (over1"-2" +/- that in our opinion looks like heaving movements) resulting in uneven step heights or other damage that can be a trip hazard. Repair or replace any applicable areas as needed. This may include sealcoating the surface, correcting any surfaces offset by more than 1", and/or restoring the component to its original position.

G. Picture 2 Heave or Movement

Have a competent concrete contractor or similar read the report; evaluate the conditions present; then service, modify or repair any deficiencies or unreliable conditions as needed to safely and properly correct them.

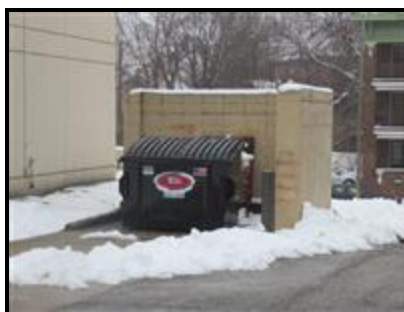
F. Picture 1

The block walls of the dumpster enclosure are cracking, chipping and have signs of moisture deterioration.

Repair as Needed.

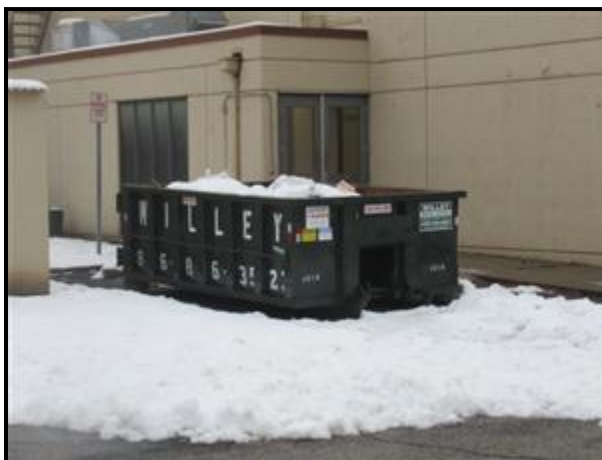
F. Picture 2

(2) There was a demo dumpster at the rear of the building. Ask seller to verify why its there; who provides it; for how long; who is paying for it; and how long its to be here.

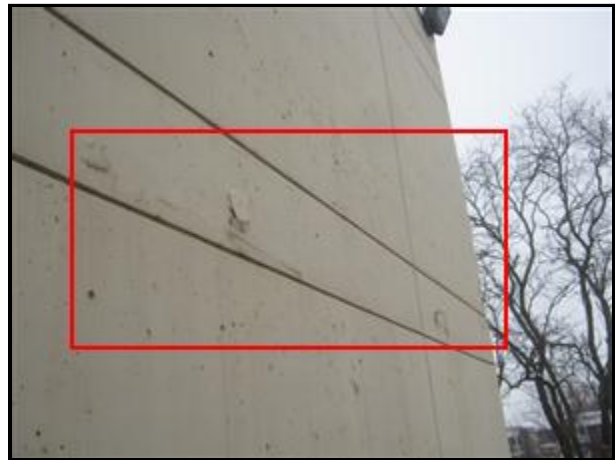
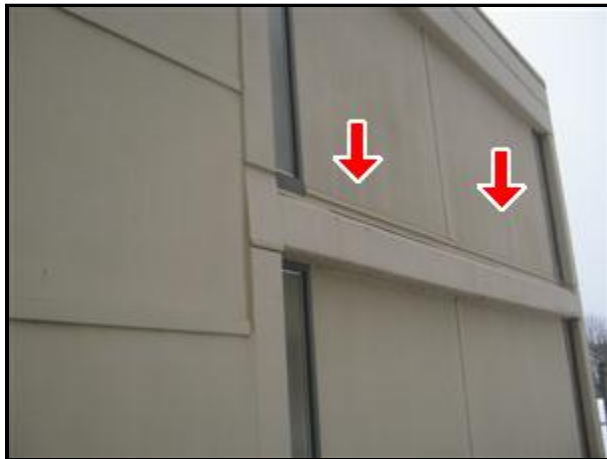
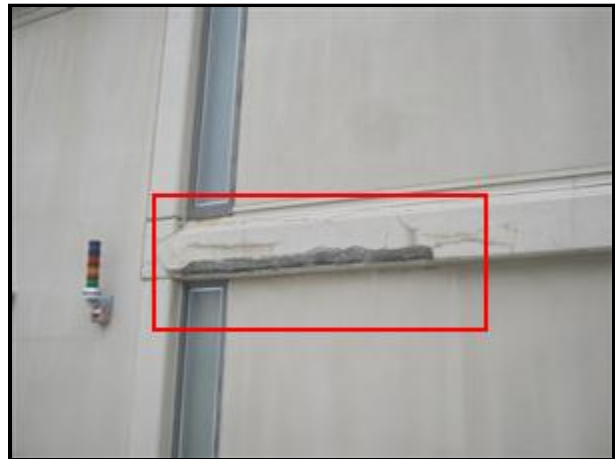
See Examples of Damage or Moisture Intrusion Sites

D. Picture 2

D. Picture 3

D. Picture 4

Exterior repair, sealing, and water-proofing of concrete and walls, etc recommended.

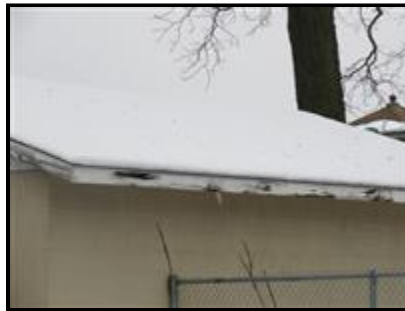
F. Picture 8 Snow Covered

(4) When the snow coverage is gone and the roofing is visible, we recommend that the roof be inspected by a competent roof contractor OR your insurance carrier. This should be done prior to close. We also recommend that you verify the insurability and acceptability of the roofing with your insurance company at that time.

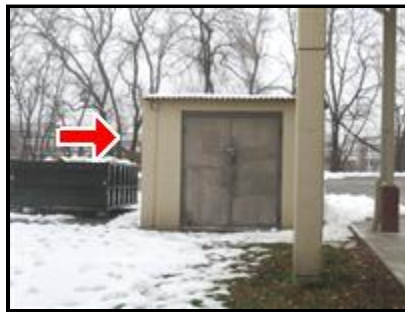
G. Picture 1

G. There was some sort of storage shed at the rear of the building (NE corner). It was padlocked and **NOT** inspected as part of the general inspection. What its used for; whats inside; or its condition is unknown to us. If this is of interest to you we recommend unlocking it and checking it prior to close.

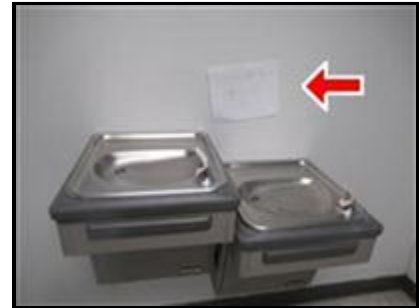
Some were operational at both floors, others were not operational at both floors and are in need of repair.

A. Picture 4 Not Working - 1st Floor

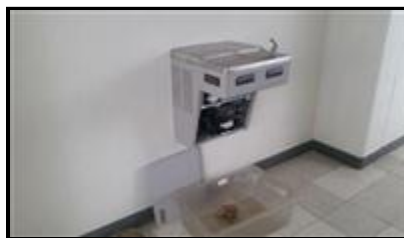
A. Picture 5 Not Working 2nd Floor

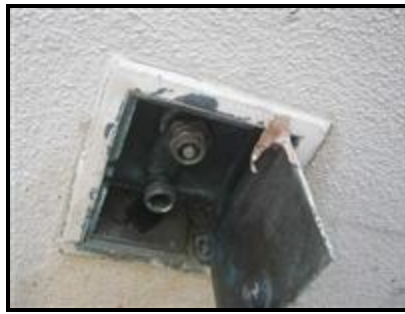
A. Picture 6

(4) Outside hose bibbs missing their handles, **NOT** operated. Have seller provide them to check operation.

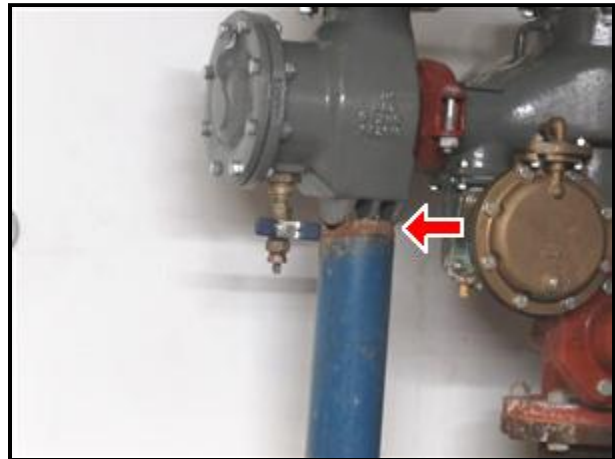
B. Picture 2

(3) There was a large steel post (looks like basement support post) under the water valves, pipes, etc in Pic 1. It has been cut-off to fit and provide support to the water valves, pipes, etc. Although it seems to be working, it is not secured at top or floor. In Pic 4 there is a funnel of some type that looks like its there to catch dripping at the joints of the piping. Both these conditions even if working are a handyman type repair. Recommend Service and full Repair by a competent plumber to prevent future problems.

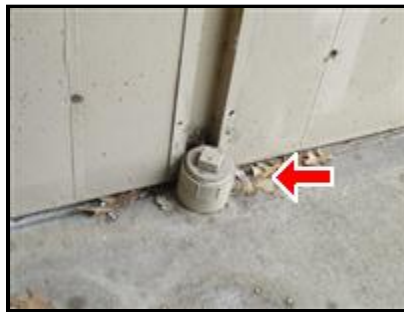
B. Picture 5

(4) We observed plumbing cleanouts outside around the building for easy access.

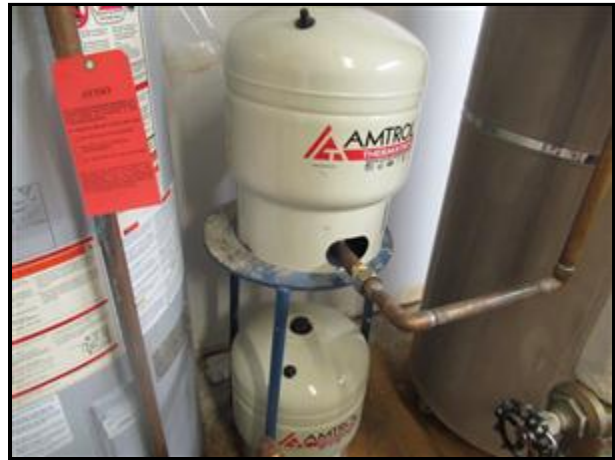
The units have expansion tanks for them. These devices function similar to an overflow tank on a cars radiator system, and can help prevent ruptured water lines, etc. A recent story in the newspaper reported that some warranty companies have denied coverage to damaged water heaters or supply lines when there is no expansion tank, etc present.

D. Picture 2 Expansion Tanks

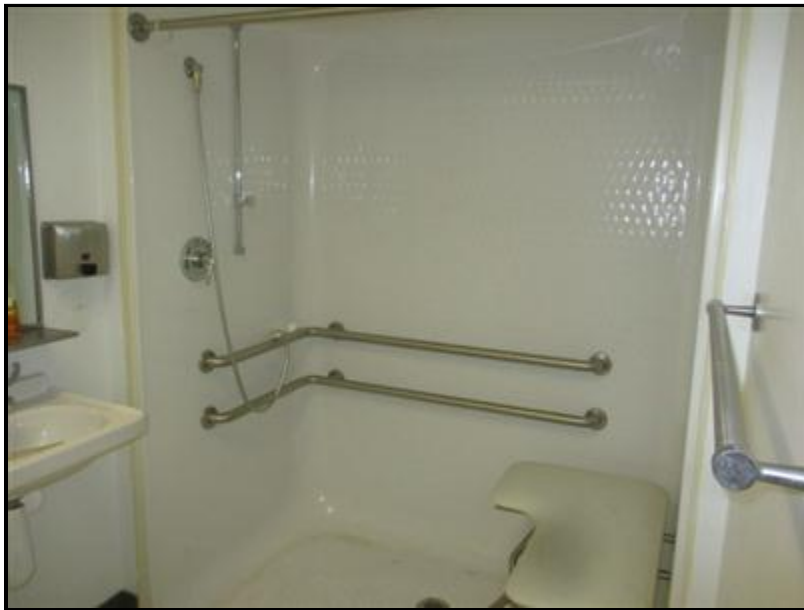
E. Picture 13 Shower

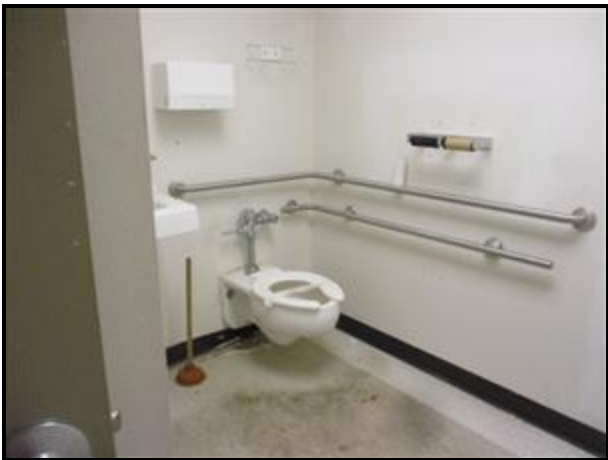
E. Picture 14 Clogged

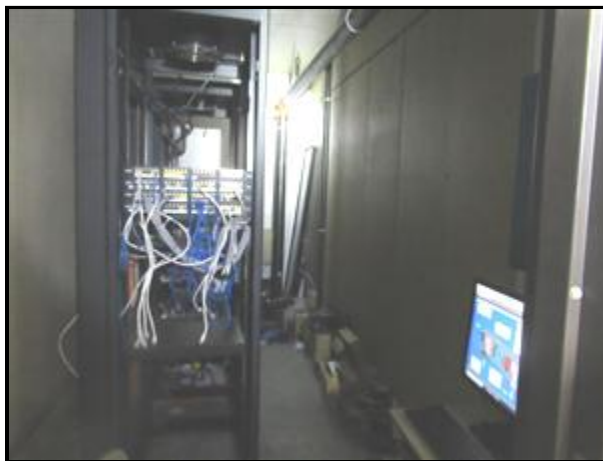
2. The room with the automated computer system had no working lights and 4 RTU's were not calling for heat although all zones were in the temperature range that they should be running (see Pic #7).

F. Picture 7 Automated Control Room

3. **Have a competent and licensed HVAC specialist read the report; evaluate and review the heating and cooling system conditions and controls; then service, modify or repair any deficiencies OR unreliable conditions as needed to safely and properly correct them.**

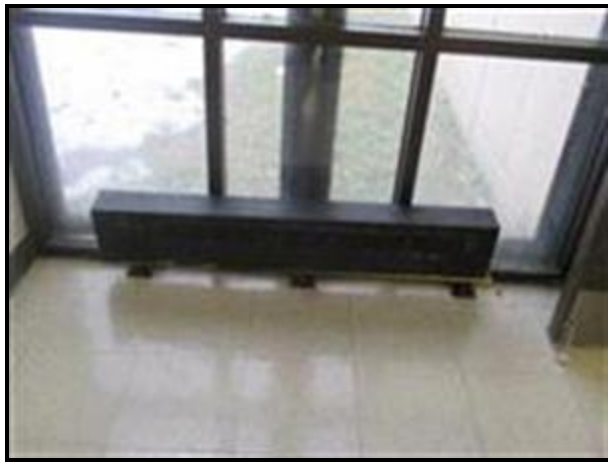
F. Picture 8 Hall

We recommend having a competent contractor Service all and Repair as Needed.

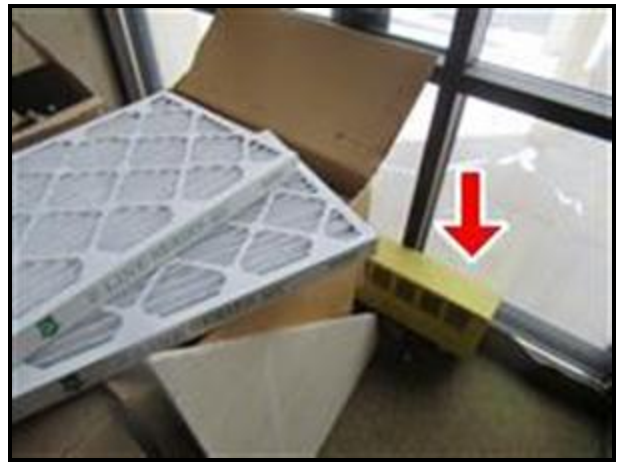
F. Picture 9 Filter Room

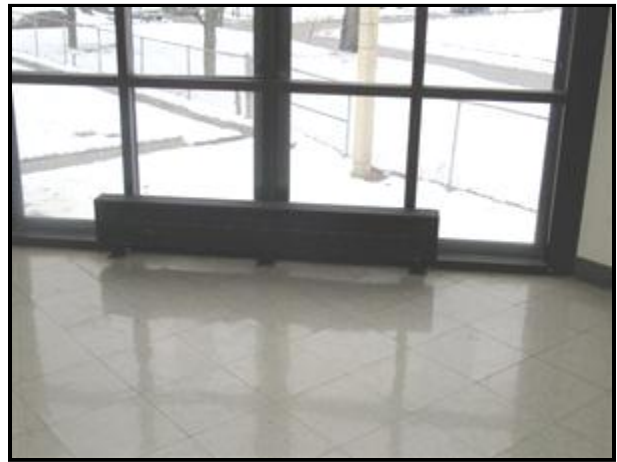
F. Picture 11 1st Level

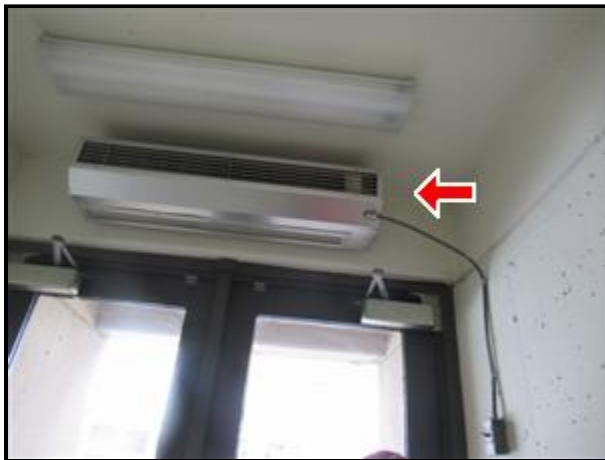
F. Picture 13

Spot-checking these most worked, but some did not. We recommend having a competent contractor Service all and Repair as Needed. See Examples in the Pics

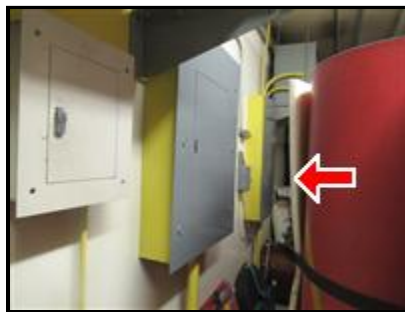
The main disconnect are fuses. There were multiple sub-panels at the property (breakers or fuses) including at the main electrical room itself, the kitchen, the exterior garage, and at 2nd floor storage area, etc. Some were obstructed and not easily accessible Not fully viewed.

H. Picture 6 Obstructed in Gym

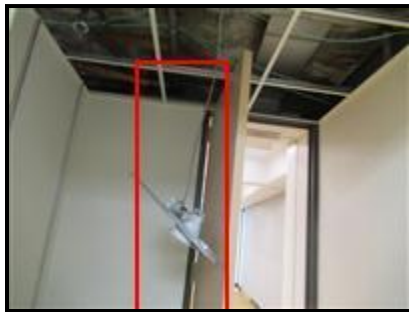
I. Picture 1 2nd Floor Light Fixture

These are samples of unreliable conditions or deficiencies present that should be repaired by a competent electrician. **Have a competent and licensed electrician read ALL electrical comments anywhere in the report; evaluate and review the buildings full electrical system conditions; then service, modify or repair any deficiencies OR unreliable conditions as needed to safely and properly correct them.**

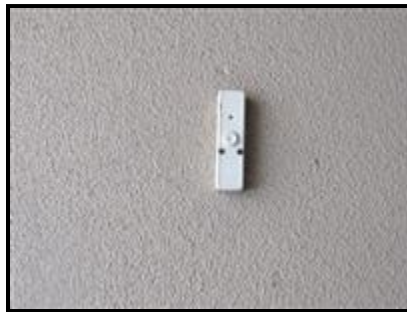
I. Picture 2 Doorbell Not Working

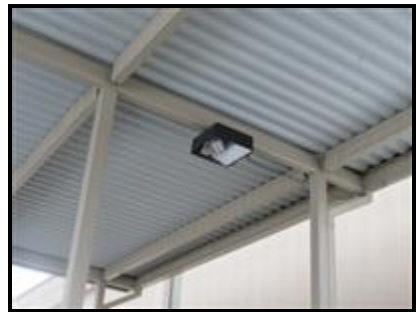
I. Picture 3 Not Lit / No Cover

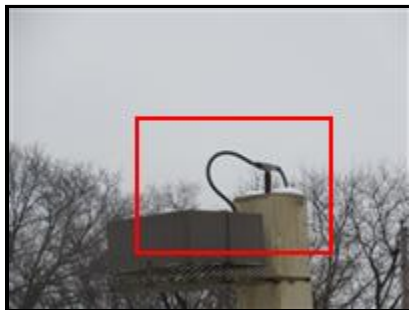
I. Picture 4 Light Not There

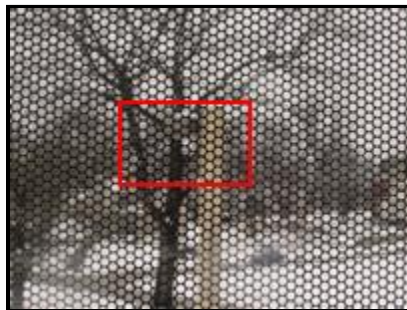
I. Picture 5 Light Not On

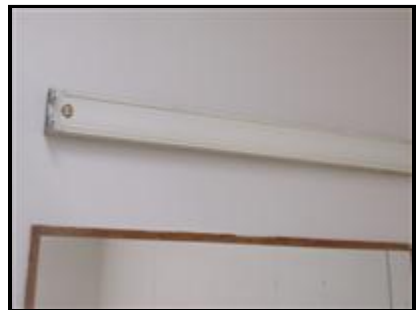
I. Picture 6 No Bulbs

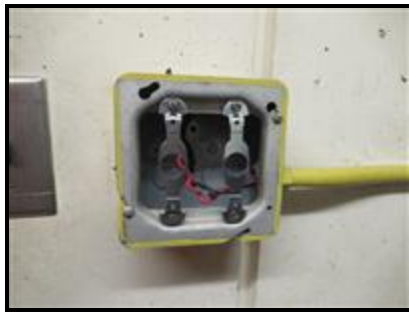
I. Picture 7 Open Bulbs

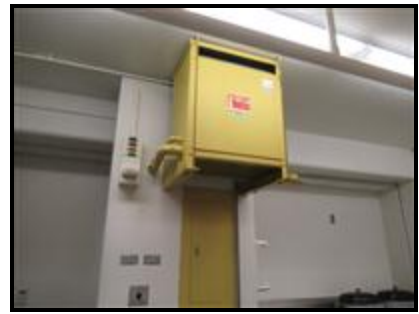
I. Picture 9 Kitchen Transformer Hums Loudly

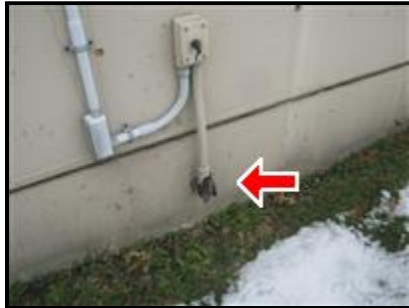
Damaged wiring or conduit such as outside and in the kitchen; open electrical boxes OR switches & boxes with no covers and exposed wire splices or wiring (electrical splices are to be in a covered junction box or fixture, etc); interior or exterior lights that we did not get to operate (check the bulbs to start with); GFCI(s) that were not tripping / resetting properly such as in the kitchen area ; "Wet Areas" without GFCI protection (wet areas are outlets at the exterior, garages, restrooms, rooftops; kitchens; etc); gas stove in kitchen not on a shunt breaker; improperly terminated or exposed wiring at the kitchen, by classroom sinks, etc; sub-panels with missing "knock-outs" in the storage room; loose or unsupported conduit at various rooms; damaged or dangling fixtures; ground and neutral wires not isolated in sub-panels like the kitchen sub-panel; green wires used for hot wires like in the kitchen sub-panel; the kitchen transformer humming loudly; exterior alarm light dangling loose by its wires; a tripped breaker that would not reset at a panel on the 2nd floor AND one in the main electric room on the 1st floor; extension cord used for permanent wiring such as at the east gym; etc.

I. Picture 10 Exposed Wires/ Dumpster Area

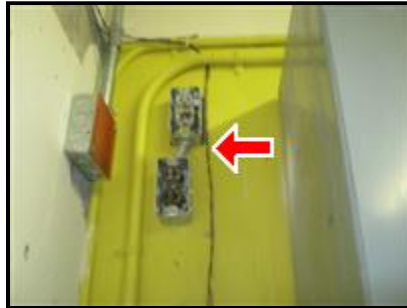
I. Picture 11 Open Electric Boxes

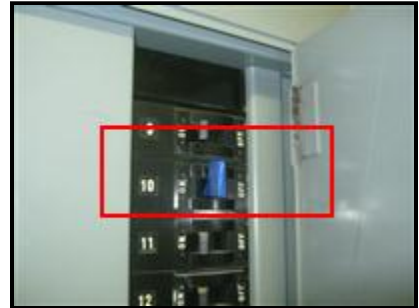
I. Picture 12 Tripped Breaker Did Not Reset

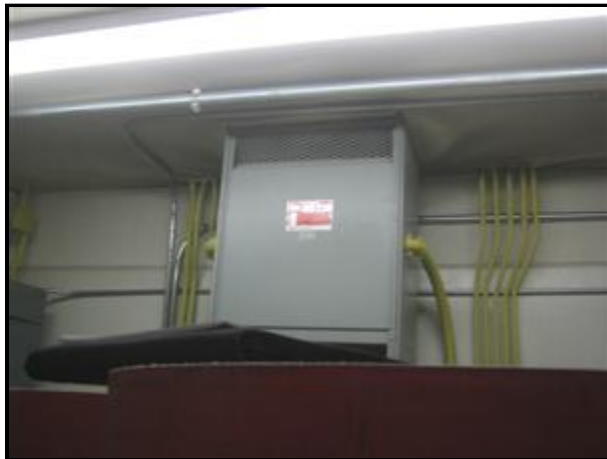
I. Picture 13 Gym Room

(2) There were multiple Transformers present of varied sizes that appear operable.

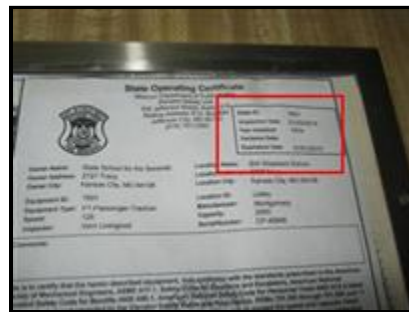
Most cities in the metroplex require annual safety inspections of this equipment by a specialized company and posting of a Permit for this in the elevator. **The permit we saw was outdated and expired (done in 2014). We also observed the doors would sporadically stick open OR stick shut which is a safety hazard.**

J. Picture 2 Inspection 2014

Service, Inspection and Repair by a competent elevator specialist recommended.

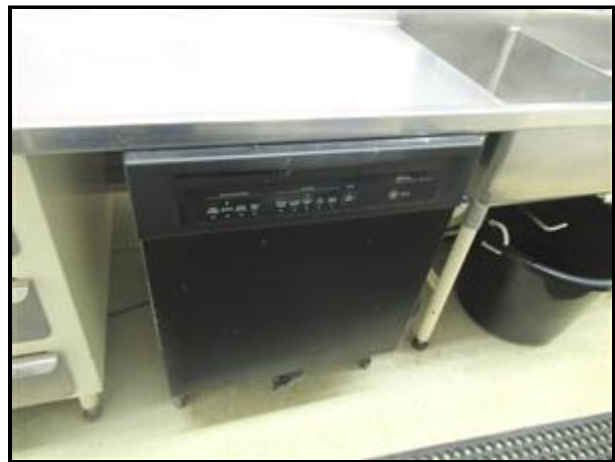
- A dishwasher that had its latch frozen did not close .. so not turned on
- 2 refrigerators that were cooling.
- A small portable microwave on a counter came on. A large microwave under counter had parts missing.

K. Picture 4 Dishwasher

- A fire extinguisher marked last checked in 2013.
- No power to some outlets. No GFCI protection at outlets.
- A janitors closet with a defective GFCI.
- If these are present and staying, we recommend having the seller or a company servicing or dealing in this type equipment verify and demonstrate proper operation for you.

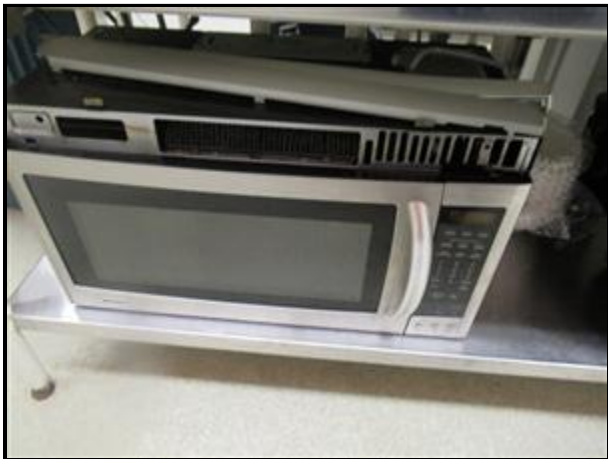
K. Picture 7 Not Working Microwave

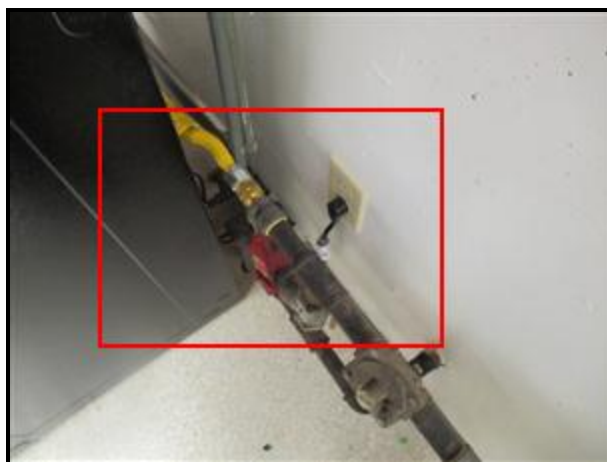
- Several coffee makers Not turned on..
- One of the gas lines for the end gas range had a gas odor (check for leak ???).
- A double sink with a large opening looks like a disposal goes there (disposal missing now).

K. Picture 12 Area of Gas Odor

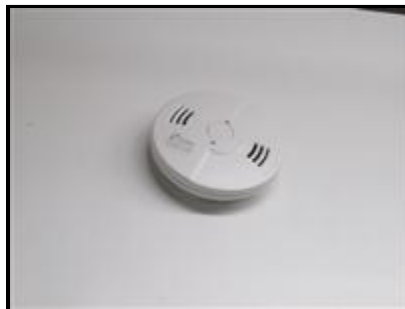
Current safety standards recommend a CO-monitor at any equipment room(s) or similar areas without one. We suggest installing these at any above areas without one and verifying operation of any present.

A. Picture 1 CO Monitor / Mechanical Room

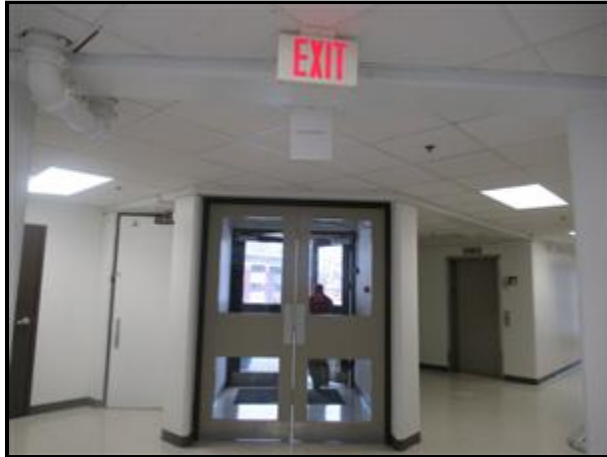
B. Although Emergency Exit signs were present at many locations, *they were not seen at **All Exits in the building.*** They should be. We also noted that **NOT** all Exit signs present were operational or the type that have battery back-up lights that are illuminated / lite up if power goes out They should be. **At least one or more was broken.**

B. Picture 1 Working

Service and Repair or Correction recommended. We are told these can cost \$50 to \$125 or more apiece, with installation extra. Servicing them as needed could cost several hundred dollars each.

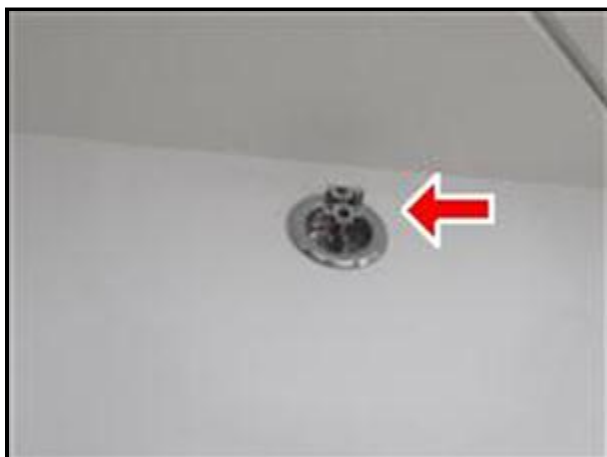
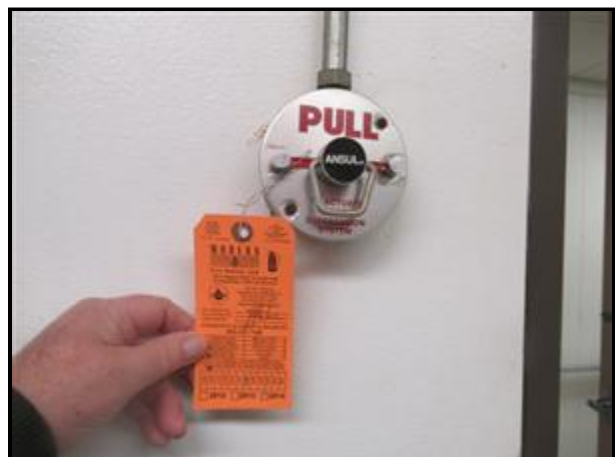
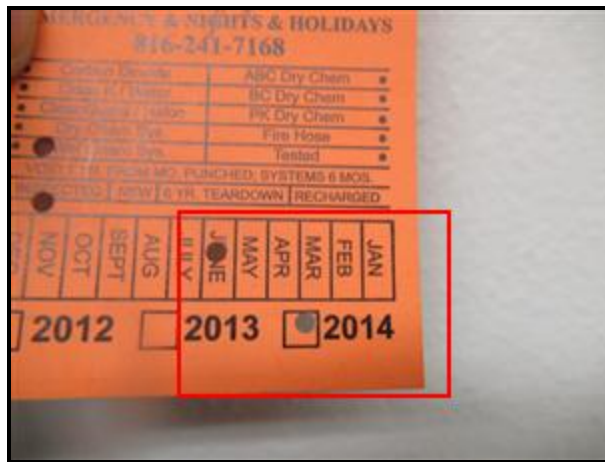
The current inspection tags we observed were out of date and were marked over 4 years ago in either 2013 or 2014. A **licensed fire protection contractor** should inspect the fire suppression systems for proper operation, etc (we are not licensed fire protection contractors). We also recommend you obtain all past fire inspection and maintenance records from the current owner before your due diligence period expires.

C. Picture 1 Heads

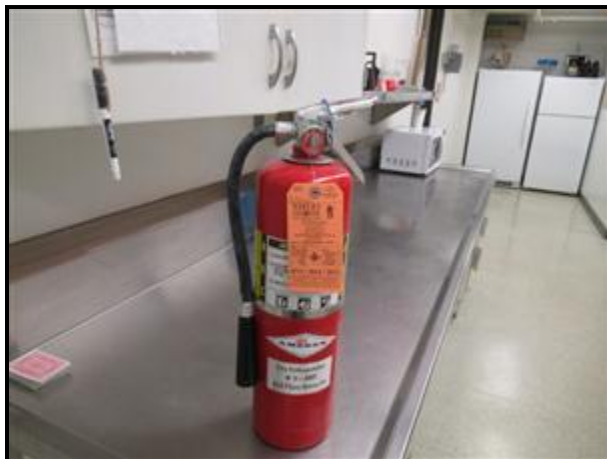
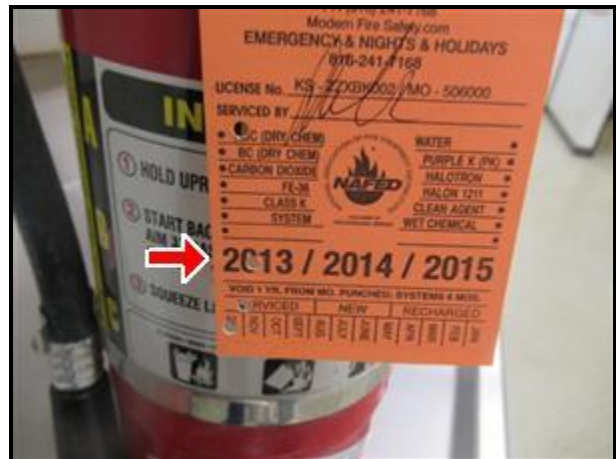
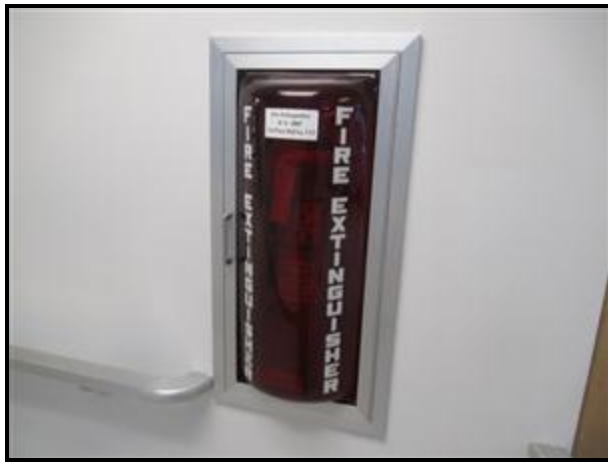
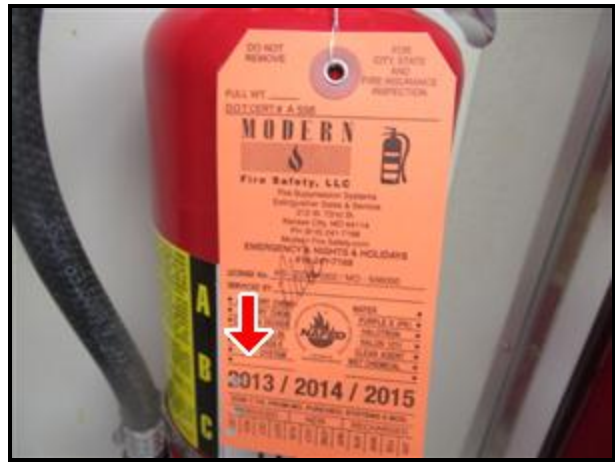
D. Most cities in the metroplex have rules on how many Fire Extinguishers should be present, where they should be, how often they should be checked, by whom, etc. There were many fire extinguishers present in the building. **Those we observed were consistently over 4 years out of date and had mostly been serviced last in 2013 by Modern Fire Safety, LLC.**

We anticipate a new owner will need to have these checked, filled and serviced upon occupancy and verify with the city or fire marshall there are the correct amount and at the needed locations.

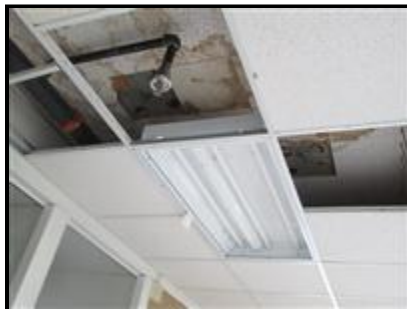
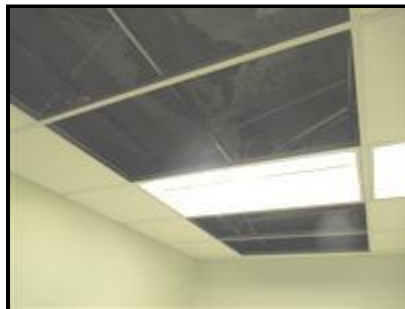
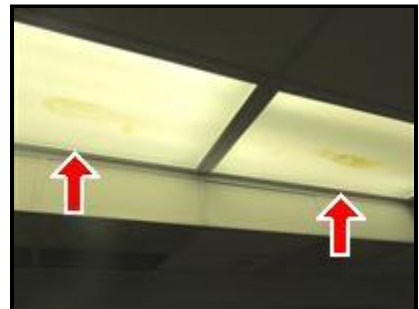
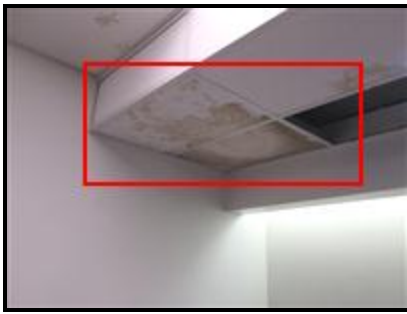
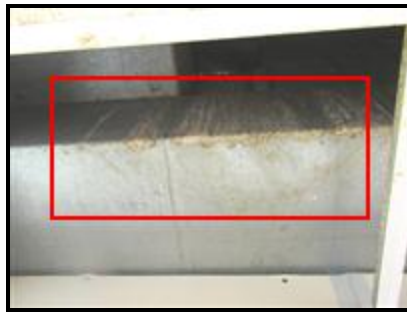
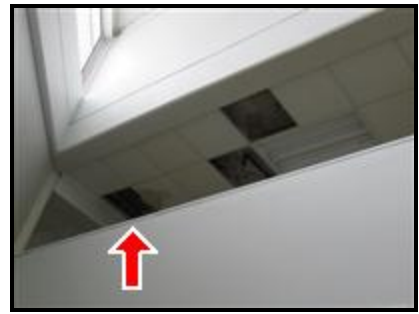
Moisture stains were observed at many ceiling tile areas. The stains were dry today and possibly came from prior roof leaks above OR from exterior walls, hvac ducts or boots above ceiling registers, etc. Verify information with the seller. Repairs may be needed.

Ceiling tiles are damaged, missing and heavily stained at multiple locations on both floors. Repair or Replacement Needed at this time.

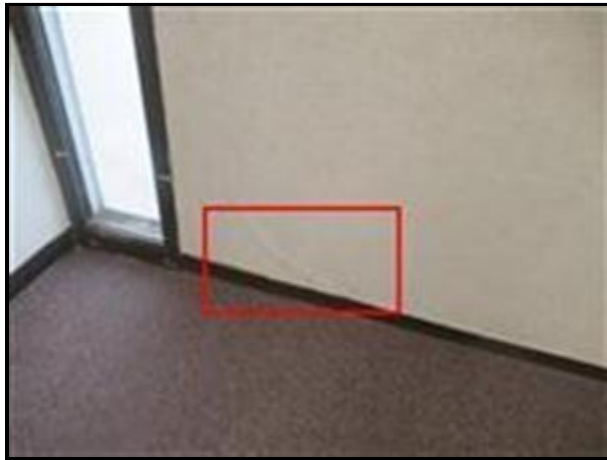
A. Picture 7 1st Floor

However there were signs of indeterminately aged moisture staining at the walls at both floors in many rooms. The water stains are indeterminate at this time (unknown to us due to freezing temperatures and snow coverage outside if they're still active or not), but have seller verify when they occurred and if they have been permanently repaired. Then monitor them to see if further evaluation or additional service is needed for active leaks.

Service and Repairs are Needed to the Current Leak Stains Areas at This Time.

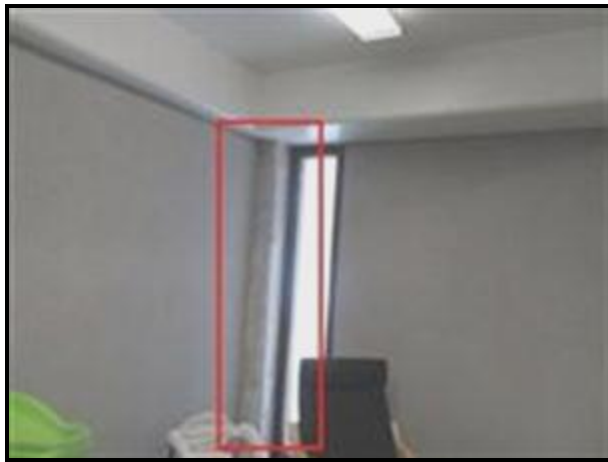
A. Picture 9 1st Floor Classroom

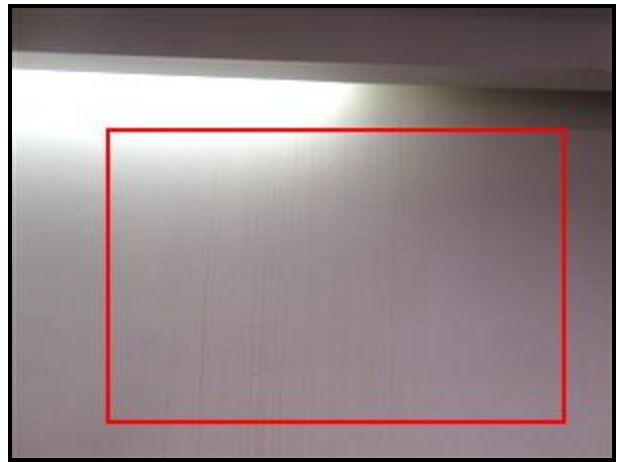
A. Picture 10 1st Floor Room

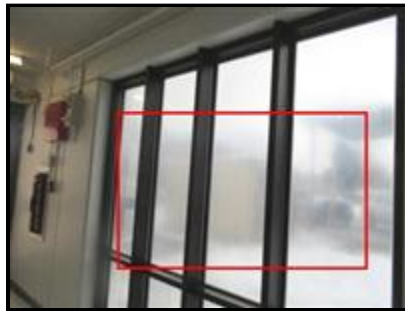
Most windows were thermal pane windows with another "storm window like pane" outside of those. Many windows at both levels of the building were fogged up. They have either lost their thermal seals or are dirty between panes. Without cleaning them all OR having access inside the outer pane we could not verify this condition.

If thermal seals are failed, they will allow moisture condensation to develop between the glass panes. Over time this will increasingly compromise visibility and appearance thru the window, and will effect the windows insulation ability. If present have a competent window contractor replace any and all windows with failed seals.

B. Picture 2 Seals ??

Also many windows have worn out or deteriorating caulking, or glazing, etc. We recommend having a competent window specialist service all windows to verify which condition exists and Correct or Repair as Needed..

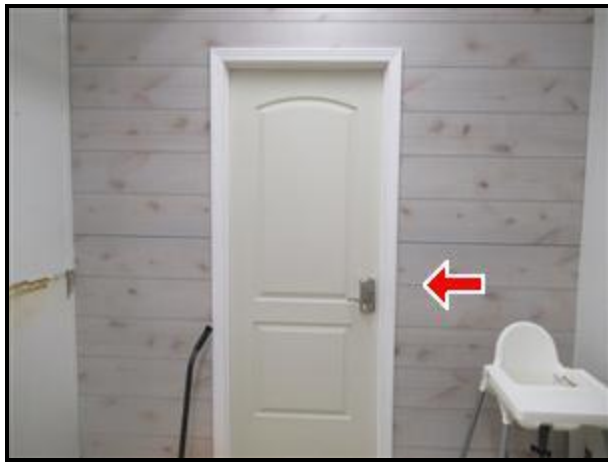
- In this building there were a few locked doors at both floors that were **NOT** accessed or operated. The owner can open them and verify operation, what is in the rooms, their condition, etc when accessible.

B. Picture 4 Locked / Not Inspected

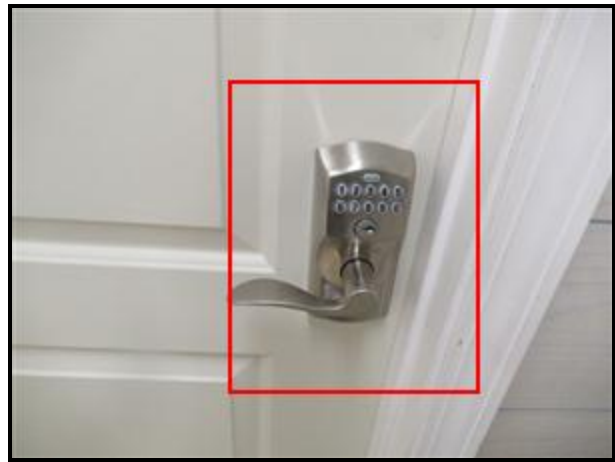
- There were doors with missing or malfunctioning hardware.
- A door in the kitchen area had a **keypad type lock** on it. We did **NOT** have a combination so the room and whatever is in it was **NOT** inspected. The condition of the room and its contents is unknown to us. One person thought it could back up to the mechanical room and have some controls, meters, etc inside. Have seller verify why locked, whats inside and provide access so you can check this area prior to close, etc.

B. Picture 5 Locked Keypad / Not Inspected

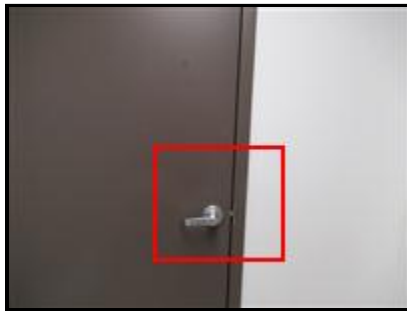
- We observed several stairwell doors with padlocks on them. For fire safety, etc these should be removed.
 - See Examples in Pics
 - **Service and Repair as Needed.**

B. Picture 6 Locked @ 1st Floor Hall

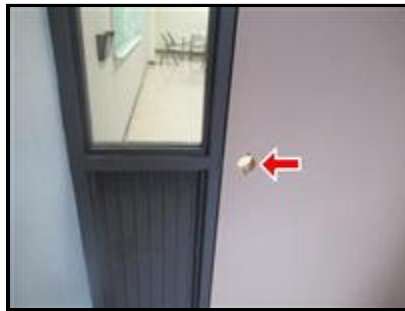
B. Picture 7 Missing Hardware

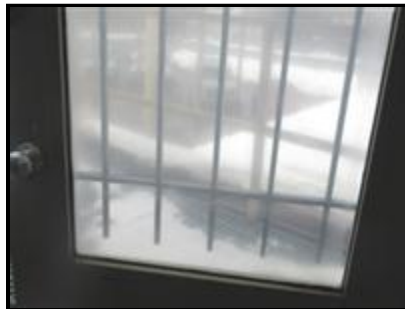
- We saw at least 1 or more door glass that either lost the thermal seals or are dirty between panes. Without cleaning them all OR having access inside the outer pane we could not verify this condition.

B. Picture 10 Failed Thermal or Dirty

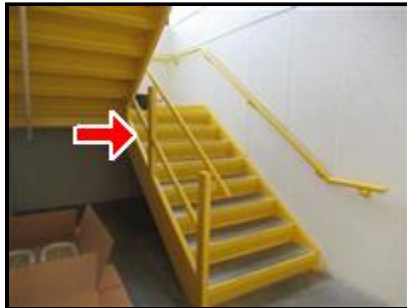
D. The gaps between the railings at the interior stairs are larger than 4". Although commonly seen in buildings of this age, current safety standards use less than 4" gaps to minimize safety risks for small children, the elderly, etc. Service and Correction Recommended.

D. Picture 1 Large Gaps

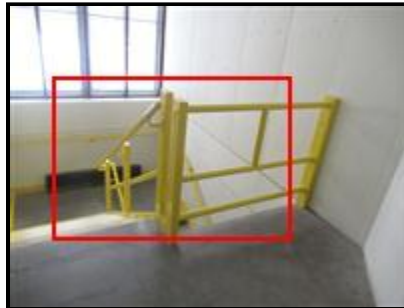
D. Picture 2 Large Gaps
