# Inspection Report

**Property Address:**  
8027 E. Shamrock Lane  
Topeka KS 66612

<b>Date:</b> 1/8/2016	<b>Time:</b> 09:30 AM	<b>Report ID:</b> 59013 - Sample
<b>Property:</b> 8027 E. Shamrock Lane Topeka KS 66612	<b>Customer:</b> Jack Thomson

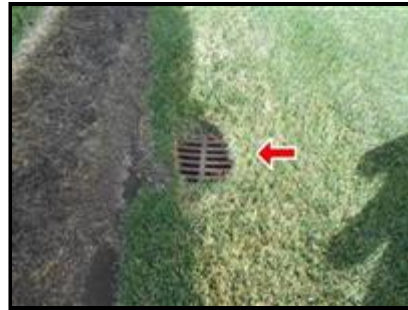
C. Picture 3

(2) Several "Area Surface Drains" were noted at the perimeter of the building. We believe some are necessary for the collection of roof "run-off water" coming off the standing seam roof. Underground drains are **NOT** tested as part of a visual survey. We recommend observing them in a strong rain to see if the drainage is acceptable or not **AND** verifying functionality with the maintenance department or facility manager.

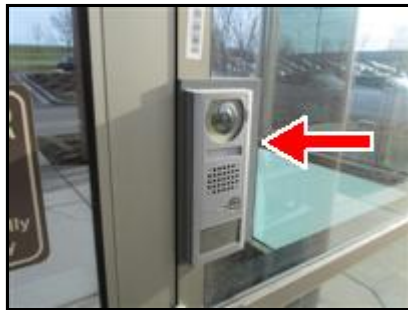
D. Picture 1

(1) There were multiple access and egress doors at the front, side and rear of building. They appear functional.

The front entry door has an intercom for security, and the ability to operate automatically when unlocked internally. This can allow for access by wheelchair, walkers, or assist in handicap access.

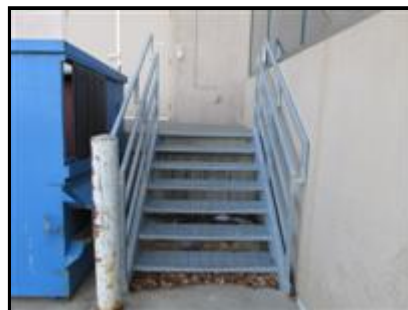
D. Picture 4

(2) The exterior rear stairs were functional

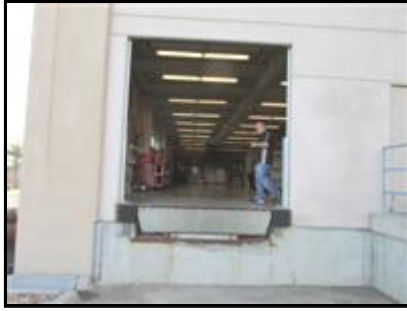
D. Picture 5

(3) The loading dock and overhead door were operated by a warehouseman and were functional. The overhead door reversed when it bumped him (proper action).

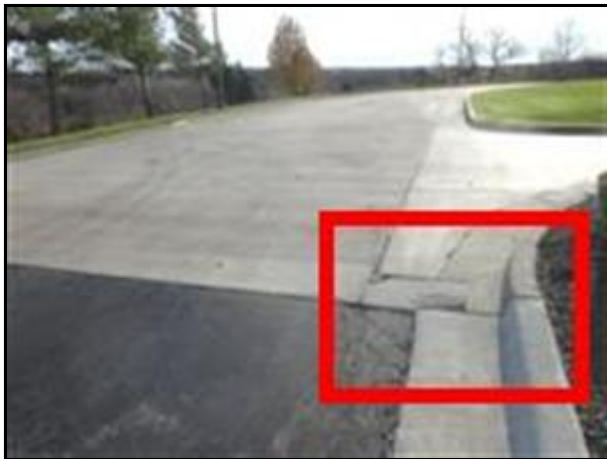
E. Picture 3

(1) Overall the hard surface parking, drives and curbs were functional at the time of the inspection showing common wear and deterioration consistent with the age and useage. Signs of cracks, chips, spalling, alligatoring, movements, etc are considered common, and found in hard surfaces of drives or parking lots at the majority of properties in this area due mostly to shrinkage, expansive soils, weathering and vehicle traffic. Ongoing service and maintenance will include sealing the surface periodically to help prevent future deterioration or trip potentials.

See Examples of what we consider common deterioration.

Many contractors charge by the foot or square feet to seal cracks, overlay deteriorated surfaces, and seal coat drives and parking lots therefore the cost is unknown, nonetheless with lots / drives of this size it can be a significant cost. **The cost of doing this service is unknown to us, so you should consult with a contractor to determine the costs prior to the end of your due diligence period. You should however expect the total costs to exceed \$10,000 when done.**

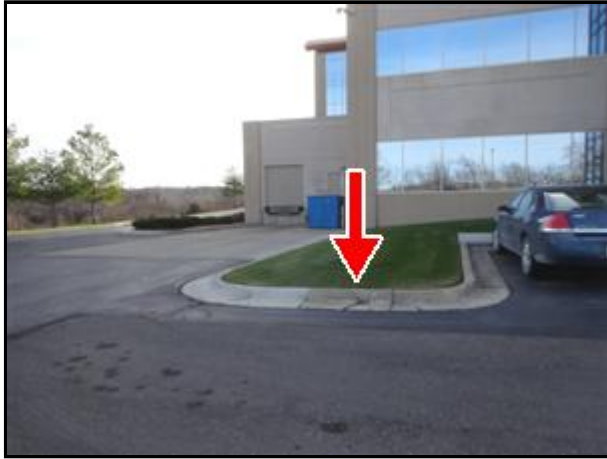
E. Picture 5

(2) Significant damage to curb by rear parking dock noted. **See Pics 1 and 2.** Repair or Replace the damaged area(s) recommended.

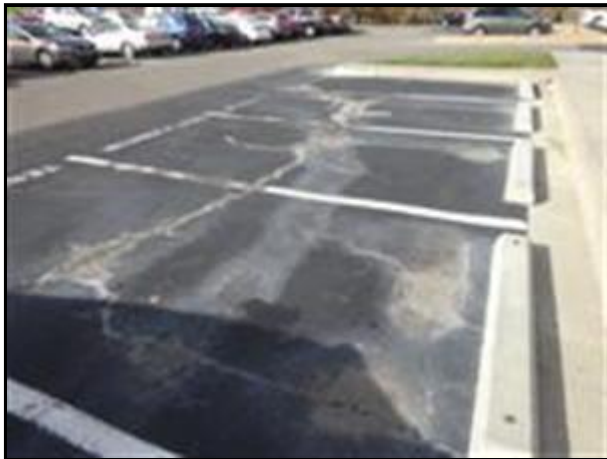
E. Picture 7

Significant damage or offsets in surfaces enough to be trip hazards noted at several areas, such as in concrete pad by rear dock and at asphalt parking area for Test / Visitors noted. **See Examples in Pics 3 and 4.** Repair or Replace any damaged area(s) recommended.

**These type concerns are a tripping hazard and any applicable areas should be replaced or repaired. The cost of doing this service is unknown to us, so you should consult with a contractor to determine the costs prior to ending your due diligence period. If out-sourced, you should expect costs to exceed \$1,500 (verify with contractor).**

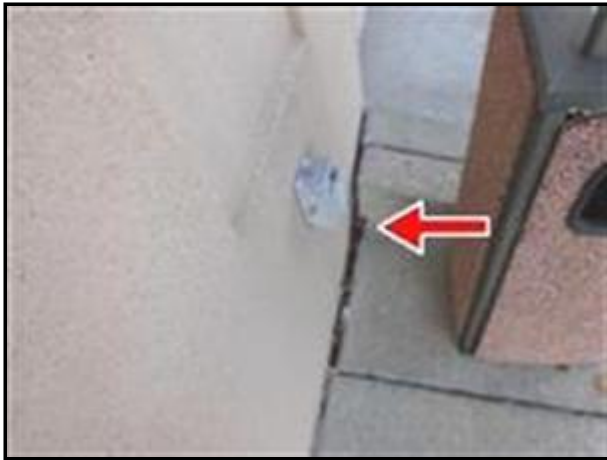
(1) Overall the concrete flatwork was functional at the time of the survey. Signs of minor cracks, chips, spalling, movements, etc in the concrete flatwork are considered common, and found at the majority of properties in this area due mostly to shrinkage, curing or expansive soils. Ongoing maintenance includes sealing gaps or cracks to help prevent future deterioration or a trip potential.

Common service and maintenance will also include sealing any gaps at the concrete flatwork to building wall around the perimeter of the building to help prevent moisture intrusion at these areas and future deterioration or movements of flatwork. See Examples

F. Picture 1 Rear of Bldg by Service Door

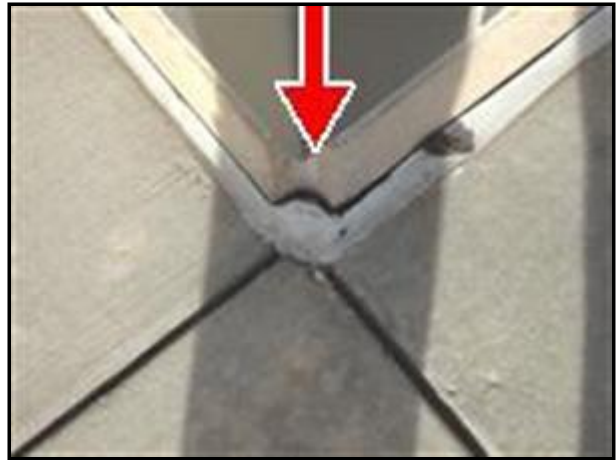
F. Picture 2 At Patio

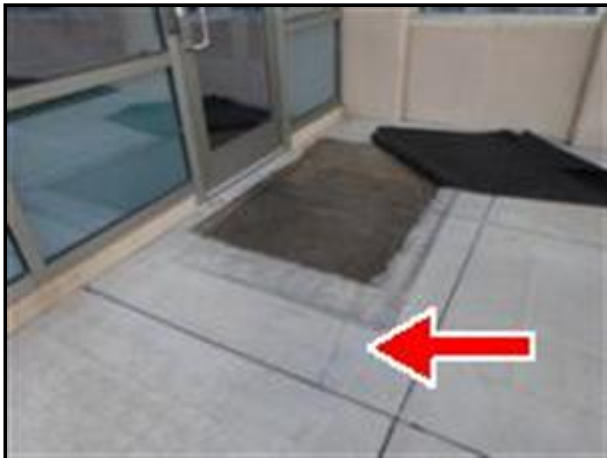
F. Picture 3 Sample Minor Cracks

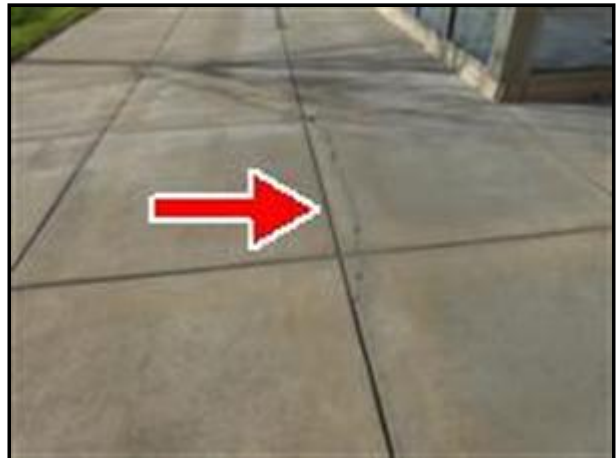
F. Picture 4 Common Cracks

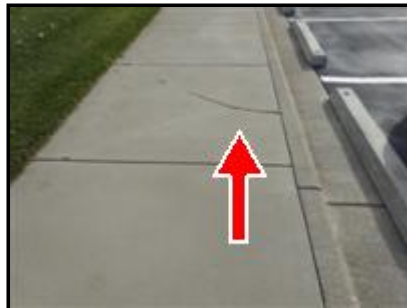
F. Picture 6 Front of Bldg

(2) Significant cracks, damage or offsets in the surface in the walking surfaces noted at some areas around the building (front, rear and sides). See the Example in Pics of what we consider significant.

**These are a tripping hazard and any applicable areas should be replaced or repaired. You should expect costs to range from \$1,000 to \$2,000 (verify with contractor).**

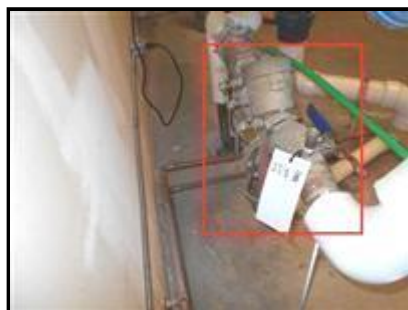
G. Picture 1

(1) Sprinklers were present for the irrigation and landscaping. Being outside, sprinklers are typically winterized and shut off in cold weather to prevent freeze-ups. Sprinkler / irrigation systems are required to have backflow prevention protection. All backflow preventer assemblies or devices are required to be tested by a certified backflow tester upon initial installation and annually thereafter; after repairs have been made; and when a device or assembly has been relocated.

Operation of the sprinklers and backflow device are **NOT** part of a visual property survey (especially in cold weather). We recommend you obtain all past inspection and maintenance records from the current owner before your due diligence period expires to verify this has been done.

As a reminder, irrigation systems should be winterized and backflow preventers should be shut off, drained and/or removed for the winter season. If your backflow device should ever freeze and break, a new one is required, as well as a Cross Connection permit.

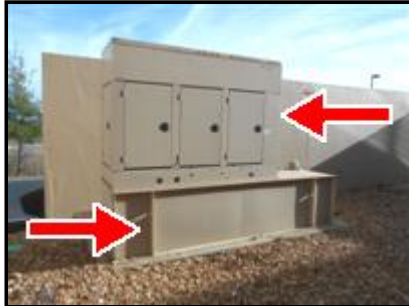
There is a back-up generator in place at the rear of the building. The control panels are located in the electrical / mechanical room. These are **NOT** operated as part of the visual survey. We recommend having the maintenance department or facility manager familiarize you or your maintenance personnel with the process of using the generator and be aware of what outlets or power is on the back-up system.

The fuel source for the generator is diesel fuel, stored in what looks like an above ground dual wall tank underneath and integrated with the generator. Verifying the tank integrity, if its full in case its needed, etc is **NOT** part of the visual survey. We recommend having the maintenance department or facility manager familiarize you or your maintenance personnel with the process of using this.

The manufacturers nameplate on the unit indicates it is from: Wedlake Fabricating in Tulsa Oklahoma (Model 749019). The data tag is faded but looks like it says the tank capacity is 700 gallons.

F. Picture 1 Generator Above / Tank Below

Get all maintenance, service or inspection records on this from the sellers facility department and determine if annual or semi-annual inspections or certifications are required by the city (if so have they been done and by whom), etc. If the electricity should go off does the generator automatically start AND what critical systems does it power.

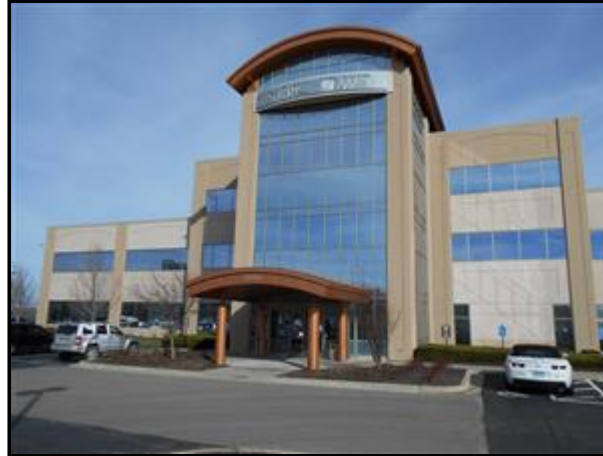
C. Picture 1

The front of the building is a precast concrete curtain wall system with glass. There were no significant deficiencies observed.

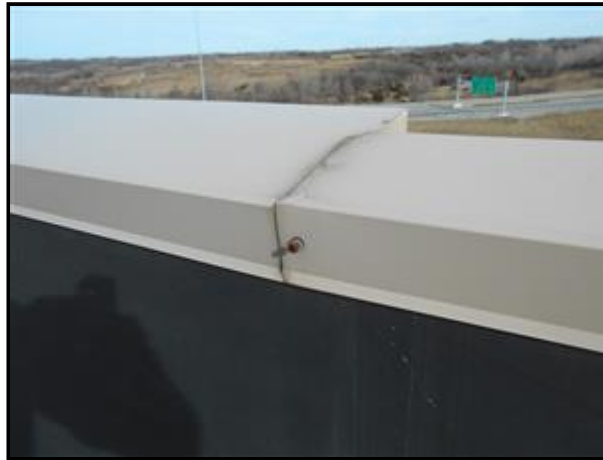
F. Picture 1

Typical Parapet Detail looks functional. Some screws were loose at the parapet cap flashing. Caulking was showing age but is still performing. Service as needed as part of routine building maintenance.

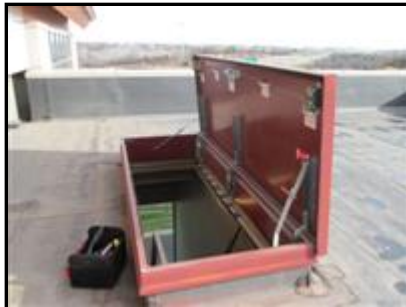
G. Picture 1

(1) The roof was accessed by an interior metal stairway and metal roof hatch. They were functional at this time.

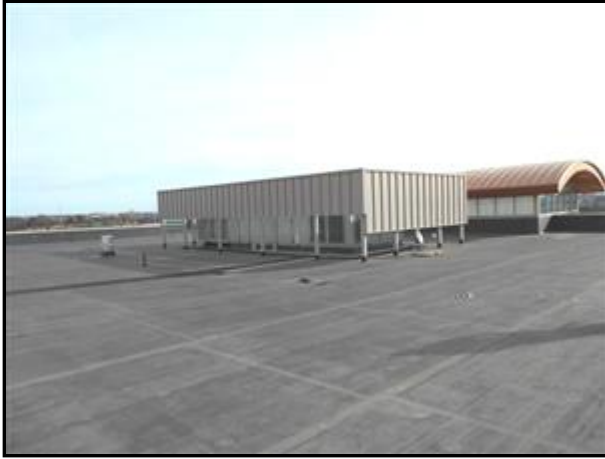
G. Picture 3

(2) **FYI** - Typical view of EDPM Roofing on the building. We did not observe significant deficiencies.

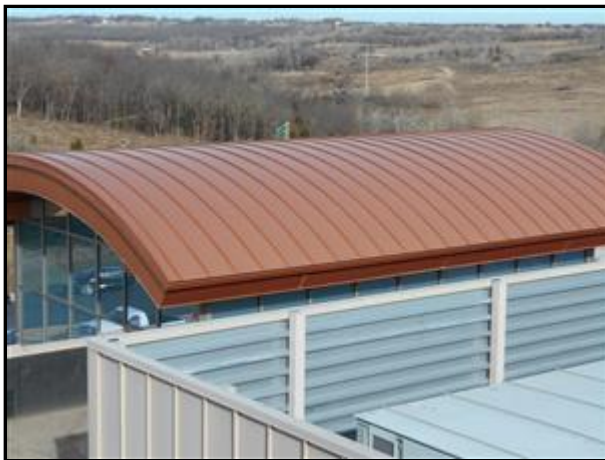
G. Picture 8

(6) **FYI** - Typical view of curved standing seam roofing on the building. We did not observe significant deficiencies.

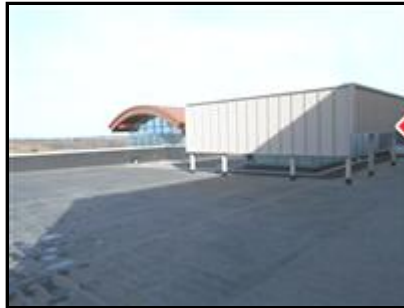
G. Picture 12

(8) **FYI** - Typical view of hvac and mechanical equipment facade (wind protection, etc). We did not observe significant deficiencies.

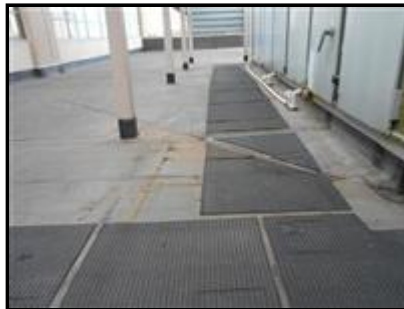
G. Picture 13

(9) **FYI** - Roof walk-way mats were used to help protect flat roofing from foot traffic damage and give service personnel safer footing in wet weather.

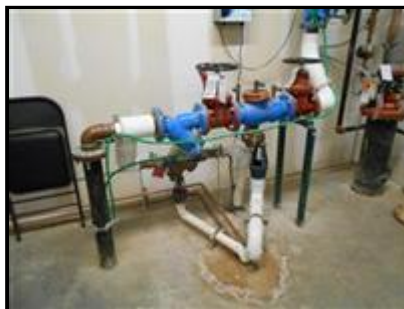
A. Picture 1

(1) Main Water Service Entrance has a backflow preventer

All backflow preventer assemblies / devices are required to be tested by a certified backflow tester upon initial installation and annually thereafter; after repairs have been made; and when a device or assembly has been relocated. Operation or testing of the backflow device is **NOT** part of a visual property survey (especially in cold weather). We recommend you obtain all past inspection and maintenance records from the current owner before your due diligence period expires to verify this has been done.

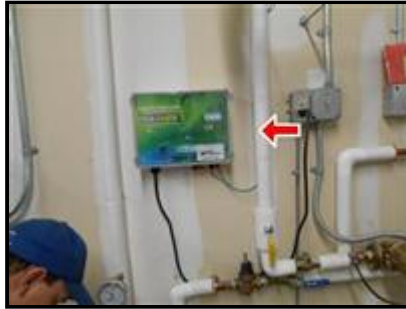
A. Picture 3

(2) Operation of the "Scale Buster System" for main water service entrance and dishwasher booster heater. Operation of this specialty device is **NOT** part of a visual property survey per ASTM standards. Past service or maintenance records from the current owner may indicate its condition.

Pipe insulation was **NOT** re-installed after the "Scale Busters" were installed. Recommend re-installing this as normal maintenance/service.

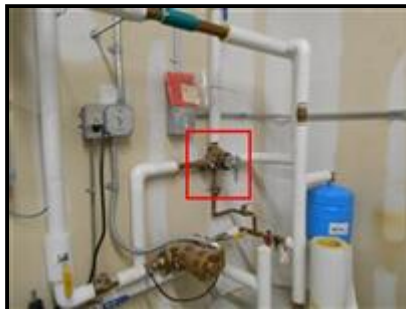
A. Picture 6

(5) **Main Level**

This valve is designed for a hydronic HVAC Style installation. **It is being used for potable water, not an approved application on the label.** Verify with manufacturer if this is acceptable AND change out if necessary.

**If Repair is needed, we don't believe you should expect repair costs to exceed \$1,000 (verify with contractor once its determined if repair is needed).**

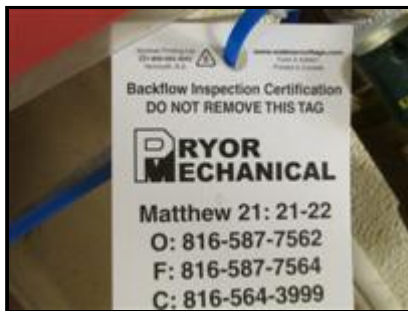
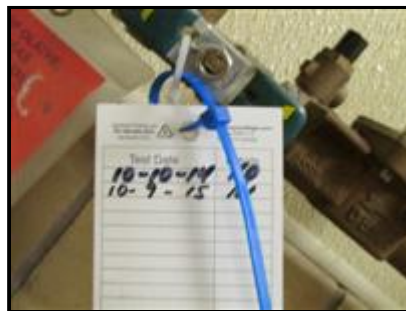
(8) **FYI -** Example of backflow preventer devices in the building. These were in the main level large kitchen. Backflow preventers were present at multiple locations in the building. All backflow preventer assemblies or devices are required to be tested by a certified backflow tester upon initial installation and annually thereafter; after repairs have been made; and when a device or assembly has been relocated. Operation or testing of the backflow device is **NOT** part of a visual property survey. We recommend you obtain all past inspection and maintenance records from the current owner before your due diligence period expires to verify this has been done.

Backflow preventers were present at various locations throughout the building. We spot checked inspection tags on them ..... the ones we observed had been checked within the past year by Pryor Mechanical. See Examples in Pics

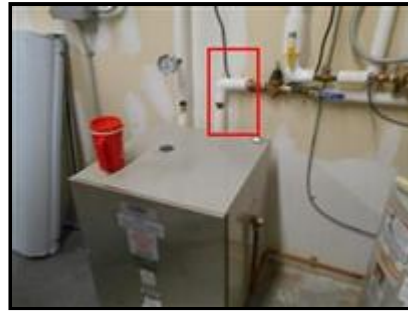
C. Picture 4

(2) **FYI:** Water Heater Booster for commercial dishwasher on main level was a 9,000 Watt unit that looks like it was approximately 9 yrs old.

There was no visible "Record of Flushing". These are high temperature units and most manufacturers recommend regular flushing to help prolong its life. Verify if this has been done with facility maintenance records. If not it needs to be done (typically in-house service).

A temperature gauge was not present on inlet side of the unit for safety. **Recommend contractor installing one.**

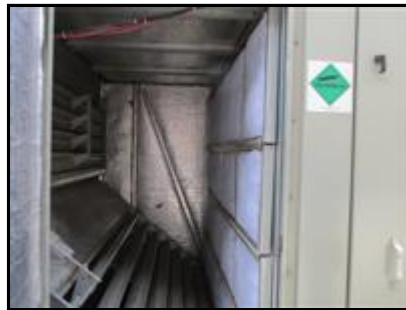
E. Picture 2

(2) While on the roof we noted one unit (Trane 40 ton unit on center 3-story roof) had broken or damaged latches on the filter rack door and the door did not latch fully. In high winds this could allow the door to be pulled open or further damaged and let excess outside air into a sealed compartment. Service and repair recommended.

We also noted several condensate lines on the flat roofs separated or not getting into the roof top drains. This allows condensate water to stand on the flat roofs. Service and correction recommended.

**In our opinion these are most likely in-house maintenance personnel service or repair functions.**

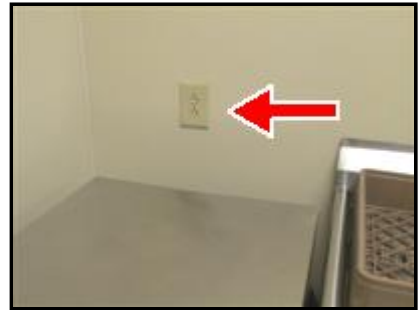
G. Picture 3 Not GFCI

These include **ALL** exterior GFCI outlets we observed were defective. Either tripped and would not reset OR would not trip.

**Service and repair recommended. In our opinion these are typically in-house tasks performed by maintenance personnel.**

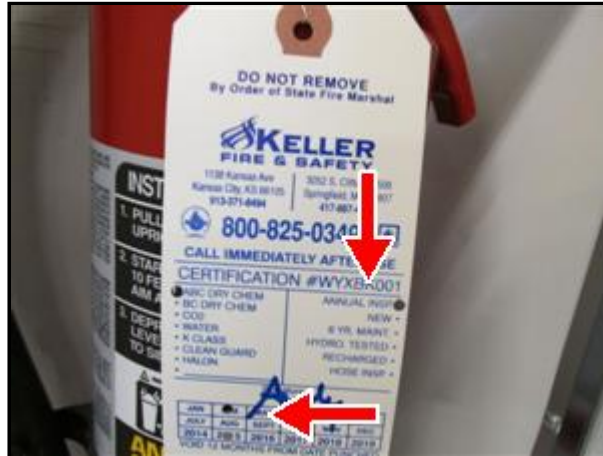
C. Picture 1

(1) **Fire Extinguishers:** Were present throughout the building, and spot checking them ..... the ones we observed had been checked or filled within the past year by a Fire Safety Company. See Example.

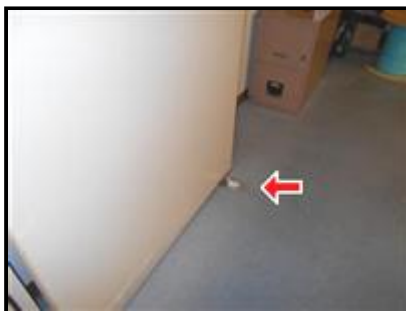
The door interior entrance door has a closer, but the door was blocked open, this compromises the rooms ability to perform as a designed.

A. Picture 1 door stop

**Check with facilities manager to determine if this is a issue. Correct if needed.**

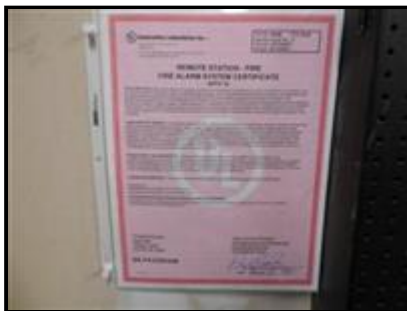
A. Picture 1 Fire Alarm Certificate

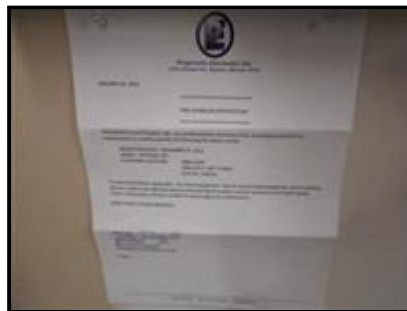
A. Picture 2 Fire Alarm Recertification
