# Inspection Report

**Property Address:**  
8737 Taco Street  
Columbia MO 65203

**Dan Bowers Company**

<b>Date:</b> 7/8/2015	<b>Time:</b>	<b>Report ID:</b> 142876 - Sample
<b>Property:</b> 8737 Taco Street Columbia MO 65203	<b>Customer:</b> Larry Buyer

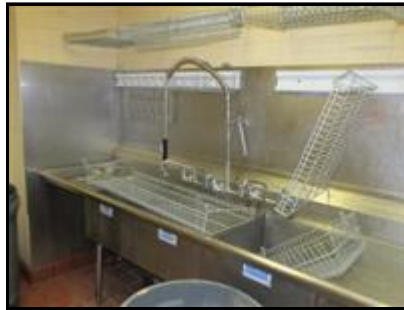
2.1 Picture 2

(2) Not all plumbing fixtures were operational. The bathrooms, kitchen sinks, mop sinks, prep sinks, etc had no water flow on the hot water sides of fixtures. The rearmost kitchen sink had no water flow at all. Service and correct.

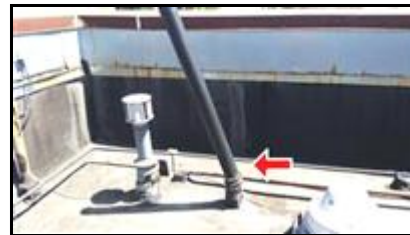
2.2 Picture 3 Roof-Top

(2) We noted some vents were loose and others broken on the roof. Service and repair.

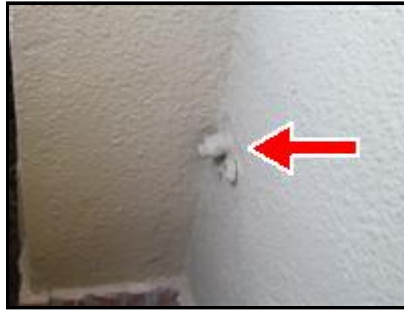
2.3 Picture 1

Hose bibb handles or hardware were not on faucets so these were not operated or tested.

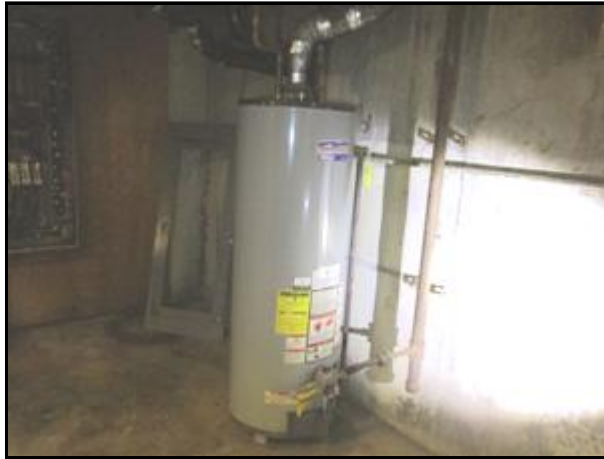
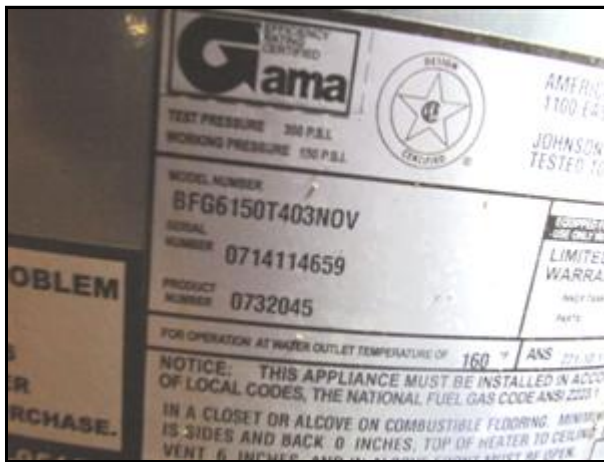
Courtesy view of water heater(s). The unit was made by "American" / 50 gallon, manufactured in 2007.

Have a competent and licensed plumbing contractor review the system conditions; then service, modify, or repair any deficiencies or unreliable conditions as needed to safely and properly correct them.

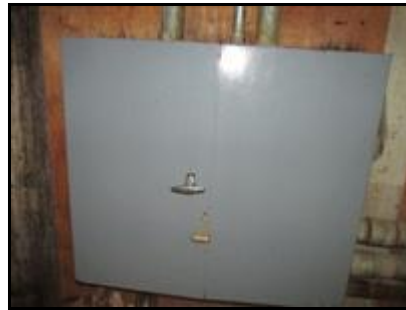
4.6 Picture 1

There was a large locked panel in the basement by the main electrical panel. Its use is unknown to us but thru a gap in the door it looked like it could be some type of meter reading equipment???. Further evaluation needed to verify use.

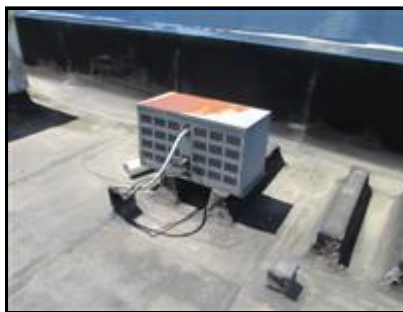
5.1 Picture 1

**FYI** - There is an older abandoned / disconnected / not operational cooling/refrigeration unit on the roof. its original purpose is not known.

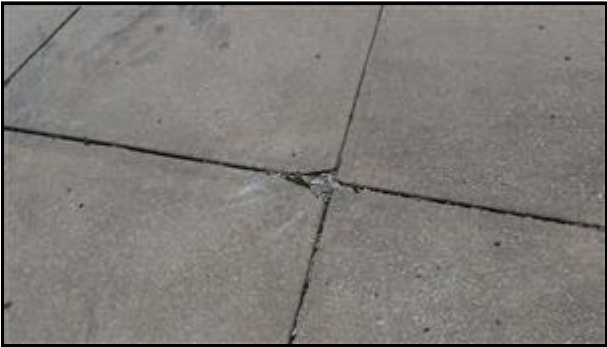
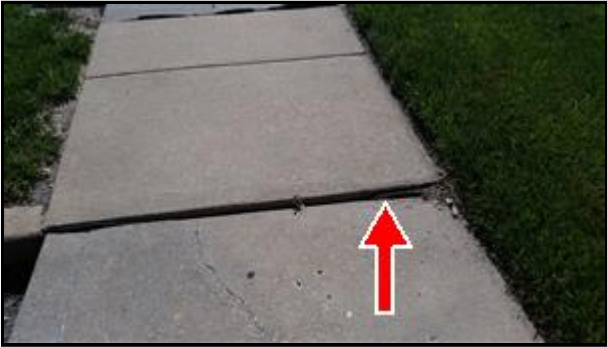
The hard surface flatwork was usable at the time of the inspection, however there are multiple areas at the sidewalks, parking lots, driveway, etc that show signs of cracks, chips, spalling, offset movements of over 1" (**trip or tire hazards**), etc in the flatwork. Although in our opinion these are not considered uncommon, and found at the majority of commercial properties of this age in this area (due mostly to shrinkage, traffic, a lack of ongoing maintenance and curing or expansive soils) **Ongoing** service and maintenance includes sealing gaps or cracks to help prevent future deterioration or a trip potential, etc.

Repair or replace any applicable areas as needed. This may include sealcoating the surfaces, sealing the cracks, repairing and correcting any hard surfaces offset by more than 1", filling in potholes or ponded spots and/or restoring the hard surfaces to the original position.

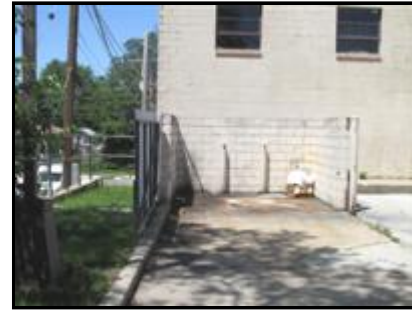
6.1 Picture 2

Courtesy view of Dumpster Corral. No dumpster(s) present. Clean up of area recommended.

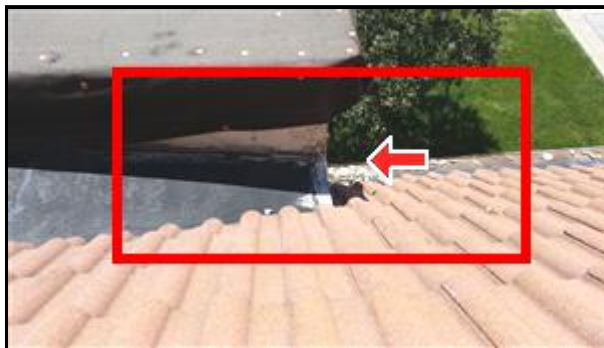
7.0 Picture 2

- There were holes and felt showing thru at the tile sloped roof covering at a few locations.
- There were separations of flashing at the roof / wall junction and drip edge at one or more areas.
- Service and repair by a competent / licensed roof contractor dealing with tile roofs.

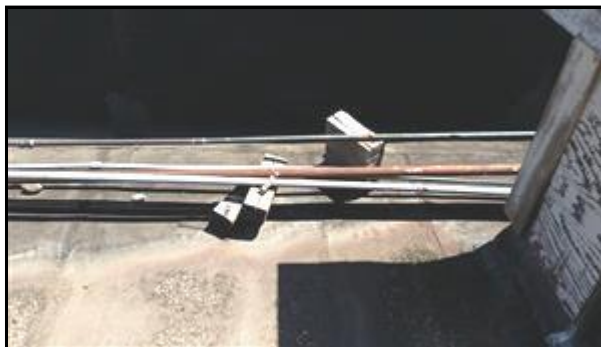
7.2 Picture 2

In our opinion, the general overall condition of the low slope / membrane roof looks functional with common signs of wear, weather or age. Regular maintenance and inspections are advised to achieve continued service. Typical maintenance is recommended for the low slope roll or membrane roof. This usually consists of the repair of open cracks in the flashings or roof coverings; open seams; deteriorated coverings etc. This should help ensure the water tightness of the structure and should be done on a regular basis.

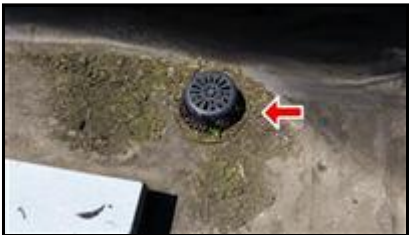
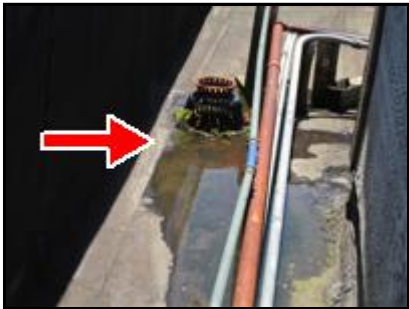
1. Drains / Scuppers were clogged at almost all locations at the low slope / flat roof. Service and clear.
2. No overflow drains were present on the flat / low sloped roof. These should be added.
3. Signs of ponding water / poor drainage was noted at several spots on the roof. It may be due to clogged drains, etc BUT until the drains and/or scuppers, etc are cleared and free-flowing that can NOT be fully determined.
4. Have a competent contractor service, correct and repair as needed.

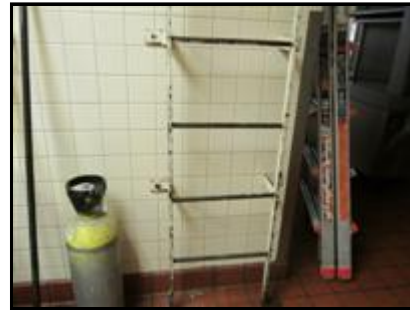
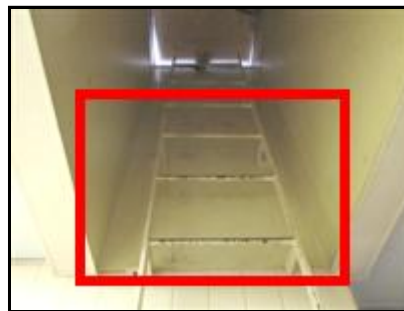
There was an internal steel ladder bolted to the wall leading to the roof access hatch . A few of the internal roof access ladder bolts were getting loose at the wall and/or had missing hardware. Secure them

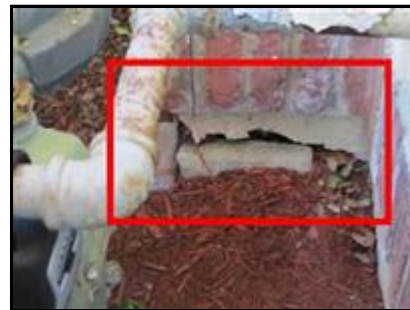
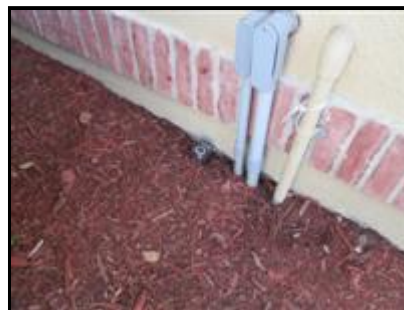
There were damaged masonry, concrete, brick walls at the exterior foundation. They were damaged. We recommend further evaluation and repair by a licensed and competent foundation and stucco contractor.

The soil level was too high at the foundation (this can lead to moisture intrusion, wood rot and pest entry (like termites or others).

Service and repair as needed.

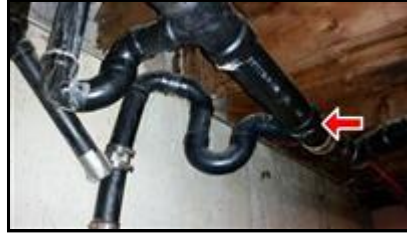
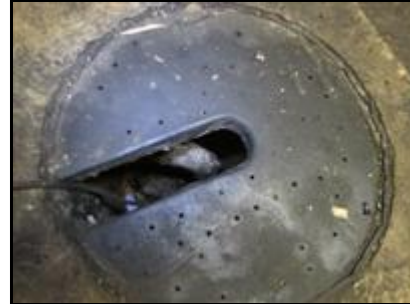
1. The sump pump discharge piping drains to the city sewer. Although commonly done in the past, many localities no longer allow this type of drainage connection. Verify this with the local utility.
2. The unit was operational, but had debris in the pit that can clog a pump motor. Clean out the pit.

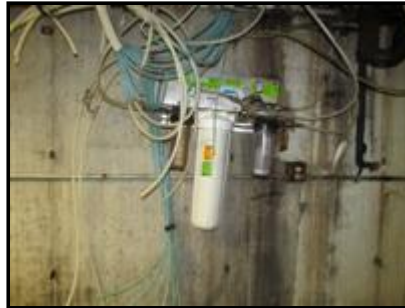
11.4 Picture 1

Private water filtration and/or a carbonated drink system or equipment of some type was present. These were disconnected / not in use. We **DID NOT** perform any testing, analysis or component evaluation on these systems or components. Consultation and evaluation by a competent specialist in these systems can provide information or testing to verify the quality, quantity, and safe performance of the system components.
