Inspection Report

Kris Kringle Enterprises

Property Address:
6732 W. Anywhere Ave
Wichita KS 67234

Date: 7/31/2017	Time: 09:00 AM	Report ID: DB73117 - Retirement
Property: 6732 W. Anywhere Ave Wichita KS 67234	Customer: Kris Kringle Enterprises

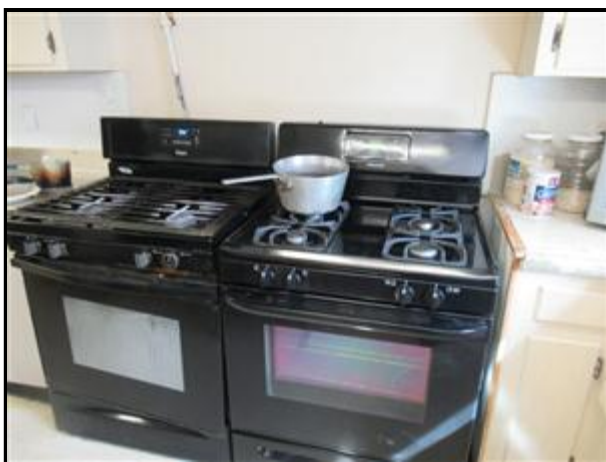
1.0 Picture 7 2 Gas Ranges

- 1) Hood over dishwasher was not operable
- 2) No gas cock shut-off for the 2 gas ranges and left one has a broken door
- 3) Dishwasher sink had leak under it / far left

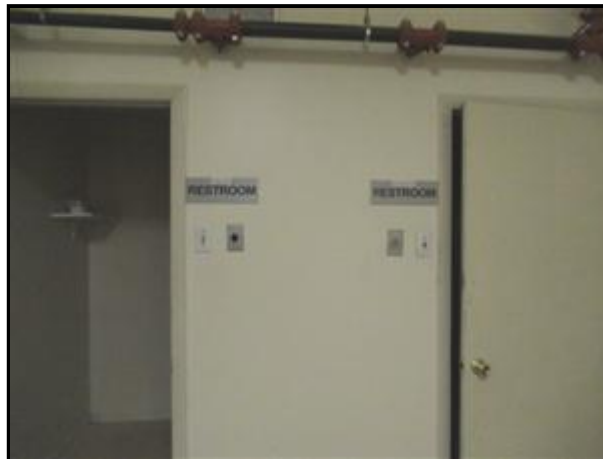
2.0 Picture 1 Basement

This bath has no heat source (not required on half baths), no electrical outlet & no GFCI (typically seen at any restroom), and the exhaust fan needs repair or replacement.

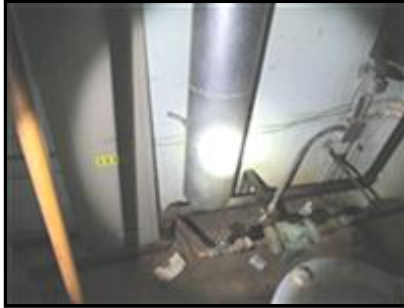
3.0 Picture 2

(2) The main valve was at the main level mechanical room the staff calls the "Boiler Room". It looked functional

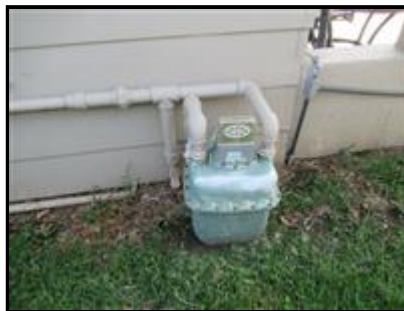
3.4 Picture 1

View Of The Gas Meter and Main Shut Off on the left side of the building.

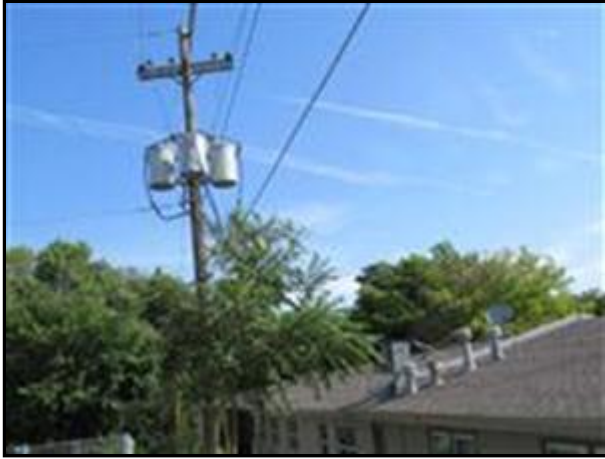
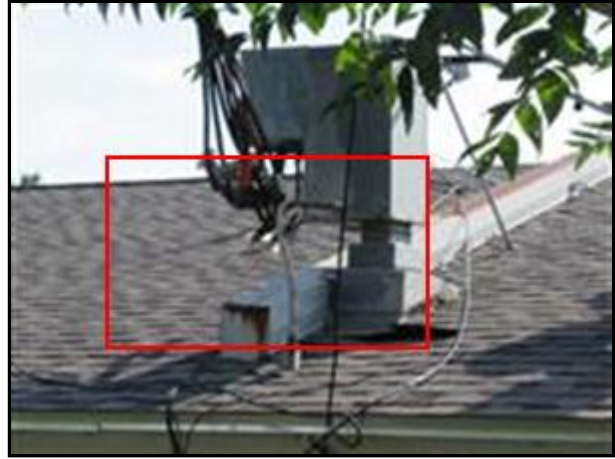
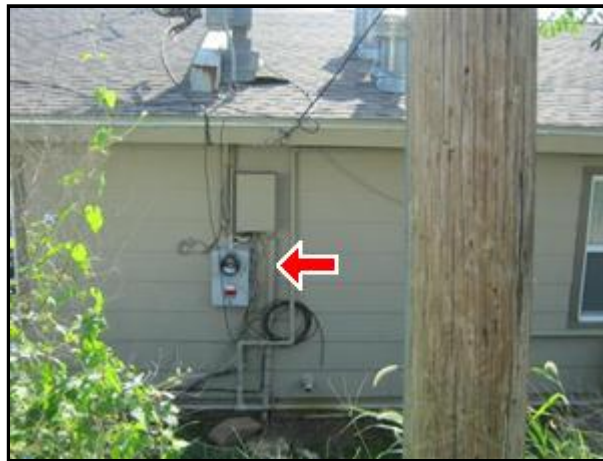
(1) Courtesy View Of Main Electrical Entry on left exterior of building.

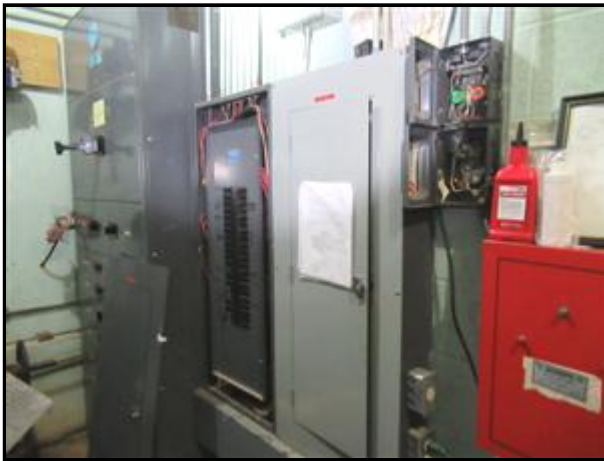
4.1 Picture 1 Main Panel & Sub-Panels

To check wiring inside the main panels (high voltage) and small panels immediately below it would require turning off power to the building. This was **NOT** done. Nothing is known of the condition of wiring, etc in these panels.

We **DID NOT** kill power to the building, so the wiring, circuit protection inside these panels was **NOT** inspected. We Recommend having a licensed electrical contractor access those panels to check the condition of wiring and other components inside the panels **AND** since the original building has been added onto multiple times over the years ... determine that current wiring, amps, etc is adequate for the loads.

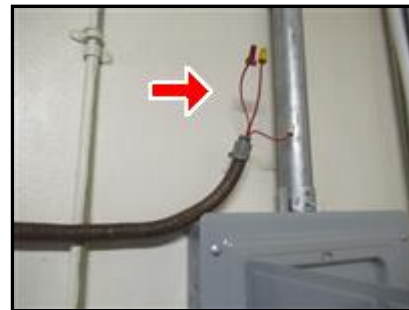
4.2 Picture 4 Exposed Splices

(2) During the examination of the multiple electrical panels throughout the building we noted defects OR unreliable conditions in need of a licensed competent electrical contractor to evaluate and repair, such as the following conditions:

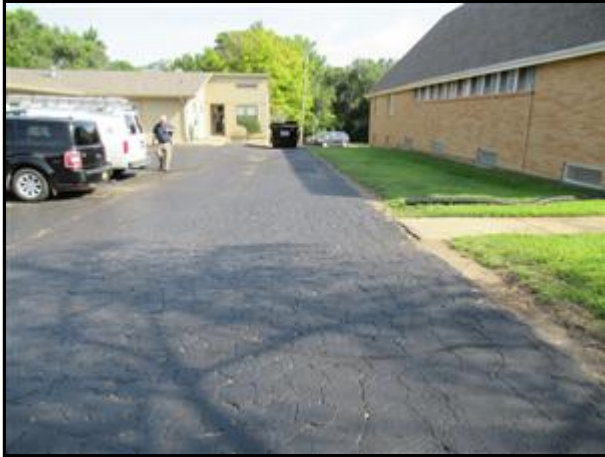
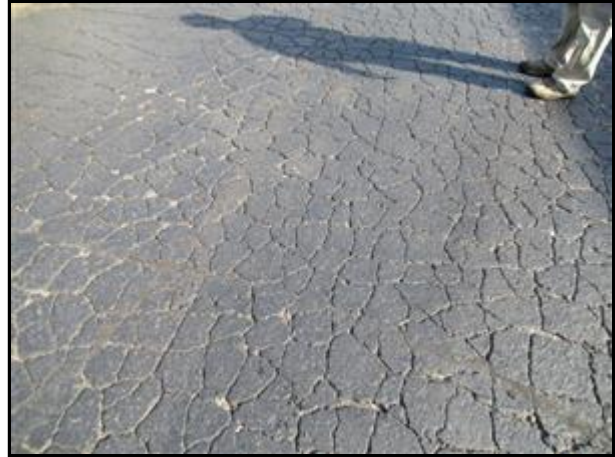
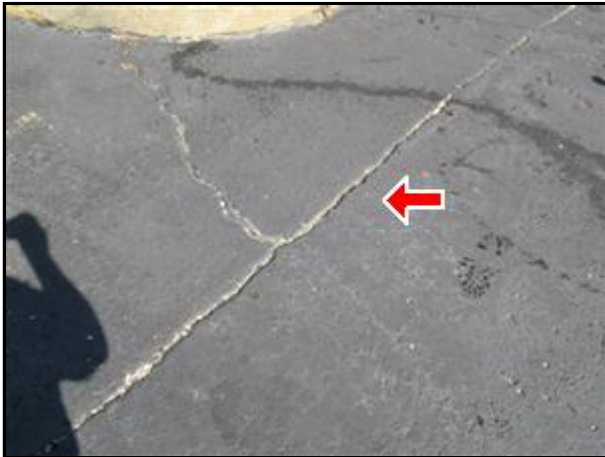
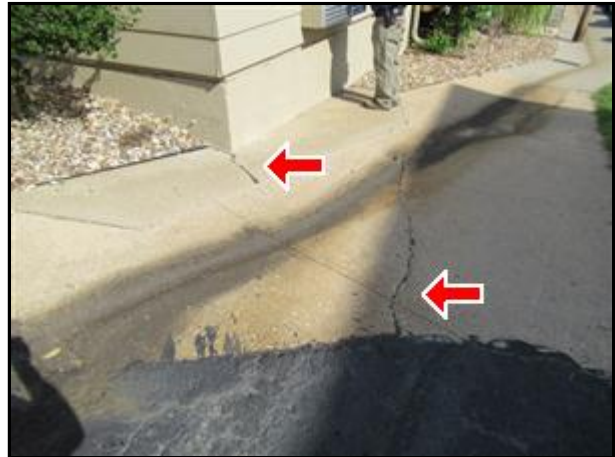
Many contractors charge by the foot or square feet to seal cracks, overlay deteriorated surfaces, and seal coat drives and parking lots therefore the cost is unknown, nonetheless with lots / drives of this size it can be a significant cost. **The cost of doing this service is unknown to us, so you should consult with a contractor to determine the exact costs prior to the end of your due diligence period. In our opinion however you can anticipate costs to exceed \$3,000 if all lots were resealed, etc.**

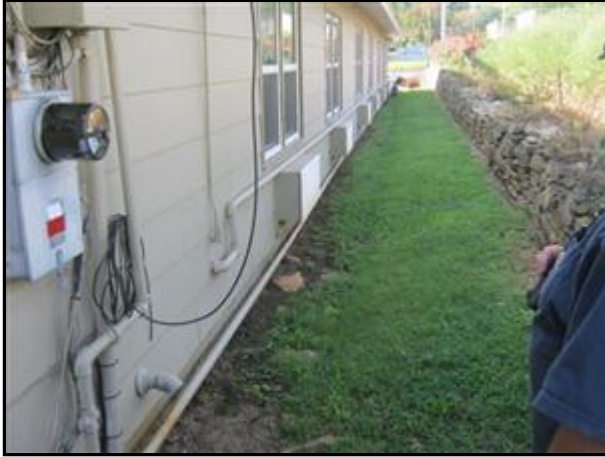
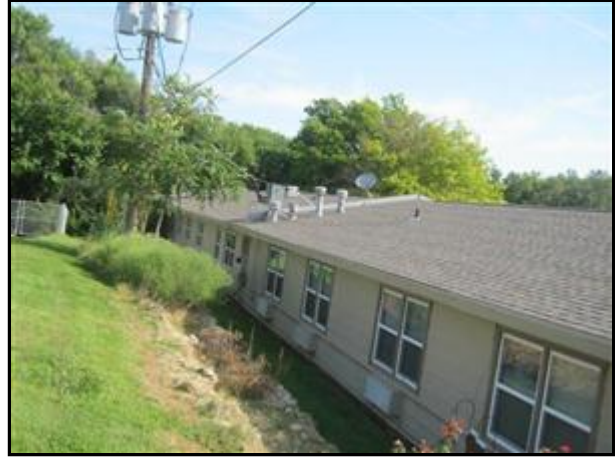
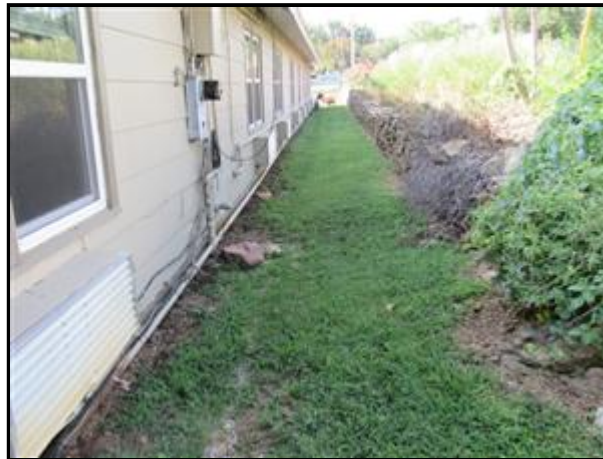
(1) There was at least one or more locations around the perimeter of the building where the grading is either flat or slopes backward toward the structure. The drainage should be improved so that the soil slopes away from the foundation at least 6" in the first 10' on all sides.

When the ground next to the foundation is flat or slopes to the structure, it causes the soil to stay moist. Wet soil can greatly increase the stress on a foundation. This combined with expansive or heaving soils can lead to cracks, movements, and/or potential leakage. The soil, grading and/or other drainage paths should always be maintained to prevent this.

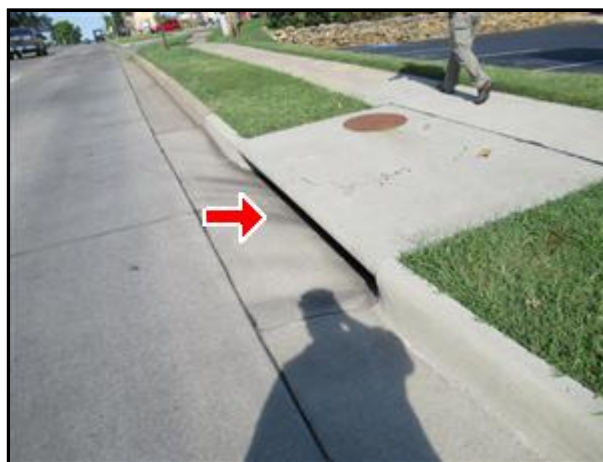
6.6 Picture 1

Storm Drains were noted at the street side of the property, but since underground they were not tested as part of a visual property review. Verify with the seller they are not clogged and they're free-flowing.

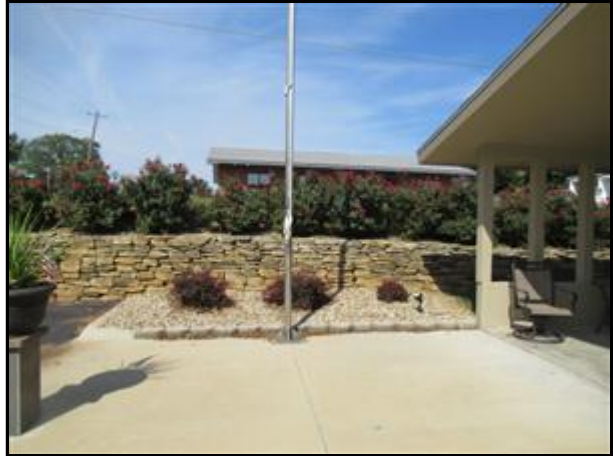
6.7 Picture 2

The exterior items in the pics are not fully secured and if they fell can be a safety issue. Repair as needed.

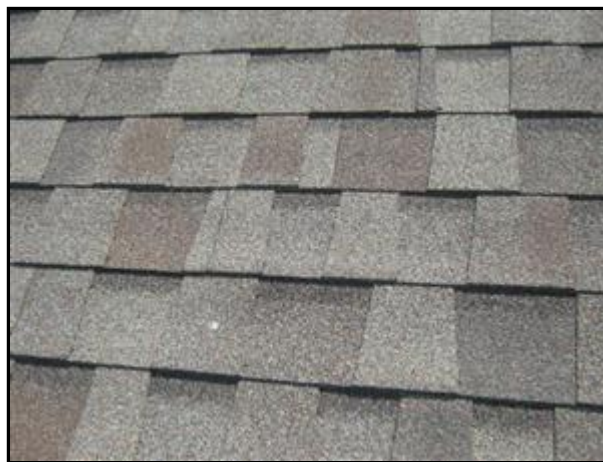
7.0 Picture 1

(1) The general condition appears functional with signs of wear, weather or age that in our opinion do not look inconsistent with their age and useage. Regular service, maintenance and inspections are advised to achieve continued service.

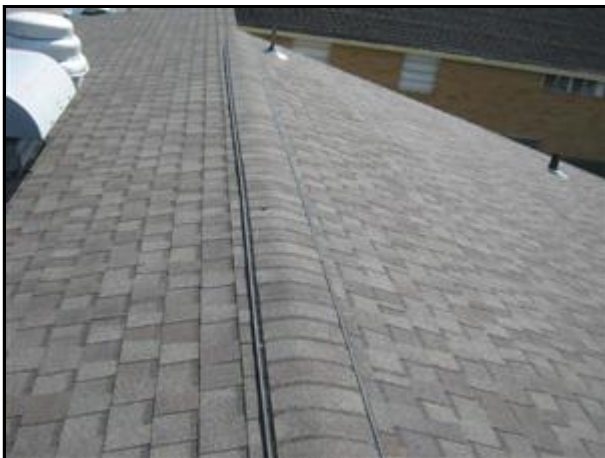
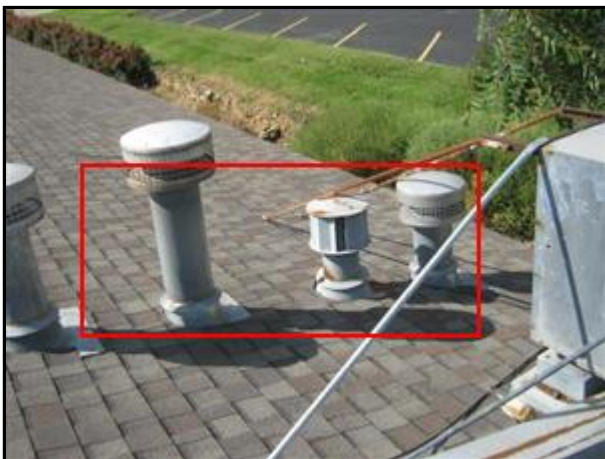
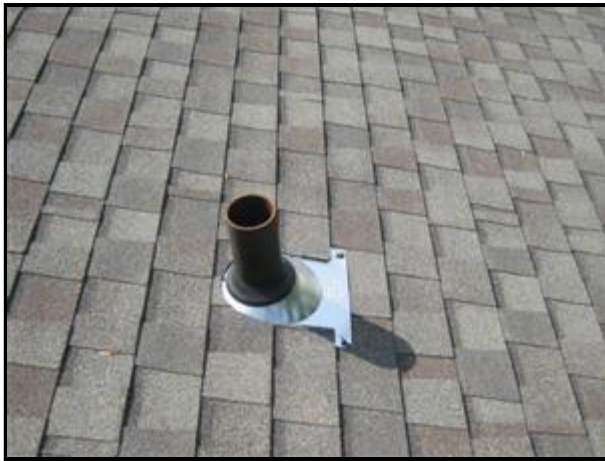
(2) In walking the roof we noted raised shingles at various locations; rusty flashings; heavy built up mastic that was worn or splitting; unsealed separations and gaps at some flashings; the roof ventilation from soffits and ridge vents combined appears minimal in our opinion; the ridge vents were not sealed on the bottoms where they meet the shingled roof; and at the front of the roof we noted the 2nd layer of roofing was not offset which created a flat cup like area that can hold water (seal the edges, etc). These conditions lend themselves to moisture intrusion.

These are samples of unreliable conditions or deficiencies present that should be Serviced, Repaired or Corrected by a competent roofing contractor after evaluating the roof, its accessories and conditions.

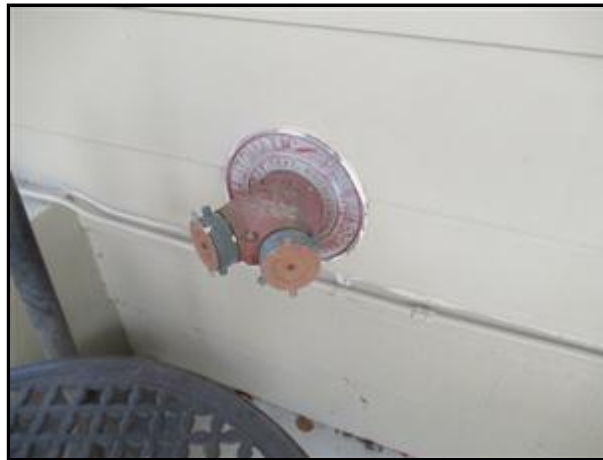
8.0 Picture 1

(1) See Fire Department hookup on front porch / stoop.

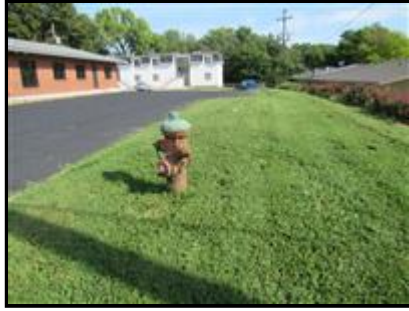
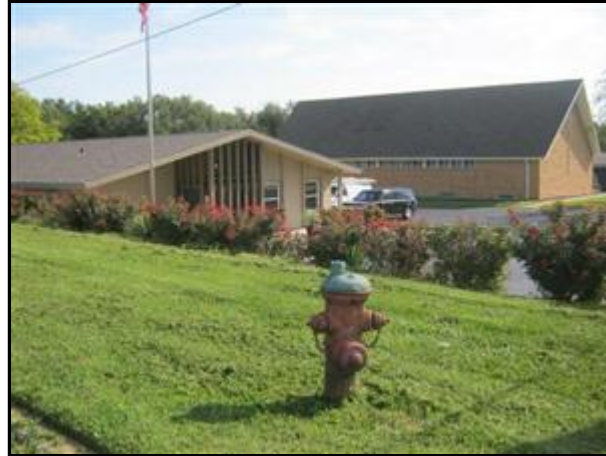
There is a fire hydrant on the same side of the street approximately 200' from this building. Verify with the city this is functional. See Pic 3 Connection at front porch.

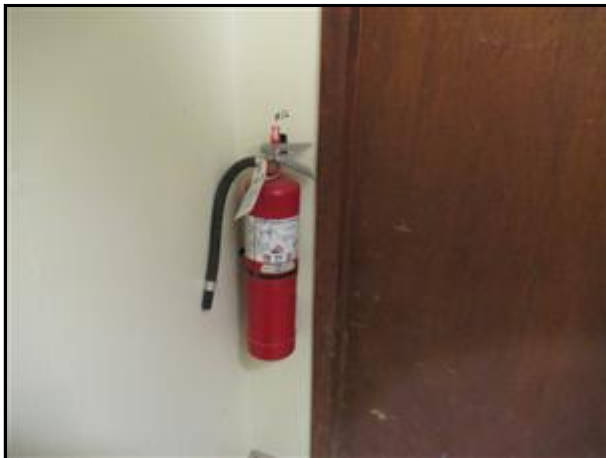
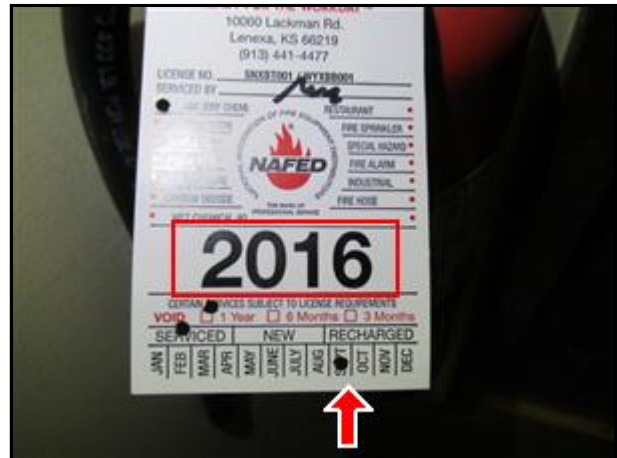
Spot checking tags show most we saw were last checked in September 2016. See EXample

Most cities in the metroplex have rules on how many Fire Extinguishers should be present, where they should be, how often they should be checked and how often re-filled, by whom, etc. We recommend verifying with the city how many are present, when they will be checked next in 2017 and get all of the maintenance records from the current owner if present (we did not see them if present). Then check with the city for their requirements on these. We would anticipate that a new owner may have to add these and do regular service or maintenance.

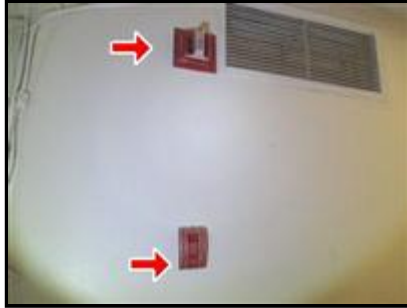
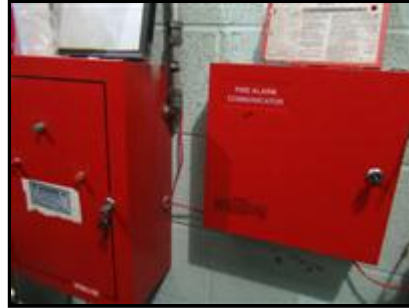
An alarm, security and/or fire suppression system of some type was present. Under the **SoP** (Standards-of Practice) for our inspections, these type devices are excluded and **NOT** inspected as part of the General Review. We are not specialists in these type systems and **DID NOT** perform any analysis, operation or other testing on the system. Consultation and evaluation by a qualified individual

OR competent specialist in these systems can provide testing to verify the proper operation of the system / components.

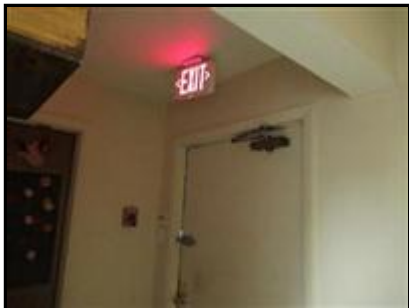
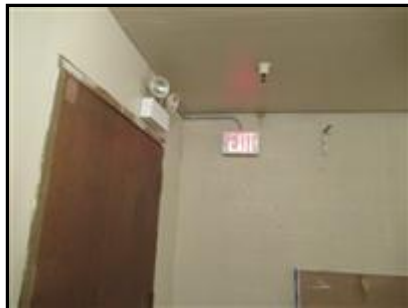
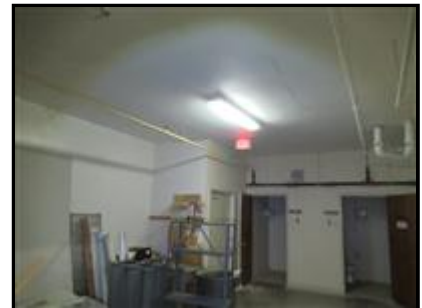
Although signs were present at most egress areas, they were not seen at **All** Exits in the building. They should be. We also noted that not all Exit signs present were the type that are illuminated / lit. They should be.

Service and Correction recommended.

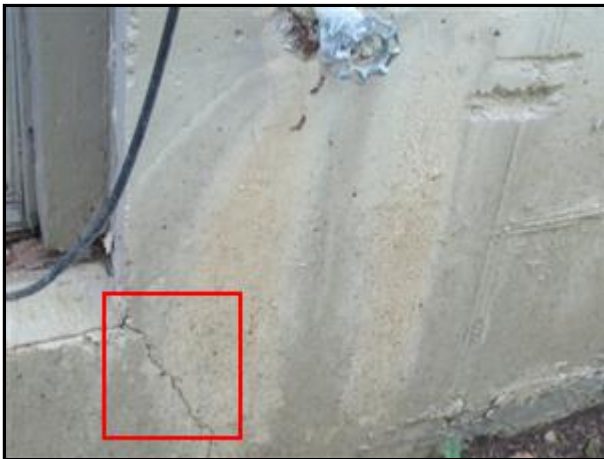
9.0 Picture 2

Small cracks, gaps, etc were noted in the foundation walls mainly on the buildings left side. These are often caused by shrinkage or movement in the building or its materials, and in our opinion this is not uncommon for the age and type construction, combined with expansive soils. We recommend keeping any crack, gap or utility penetration well sealed to be able to monitor for future movements or help prevent leakage. If either condition should ever occur, repairs could be needed.

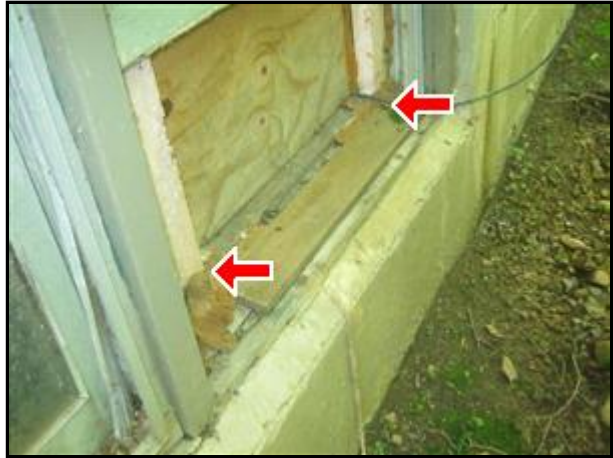
Wood rot, moisture damage or other damage was noted at in areas all around the building. This includes window trim, frames, siding, wood windows, etc. Repair and Paint needed.

9.1 Picture 2 Window Sills

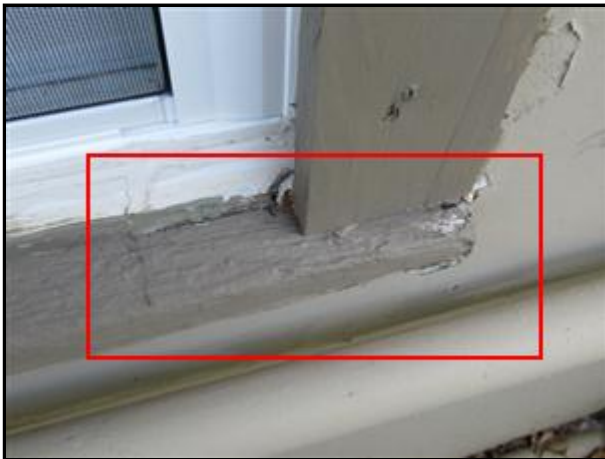
9.1 Picture 3 Window Sill

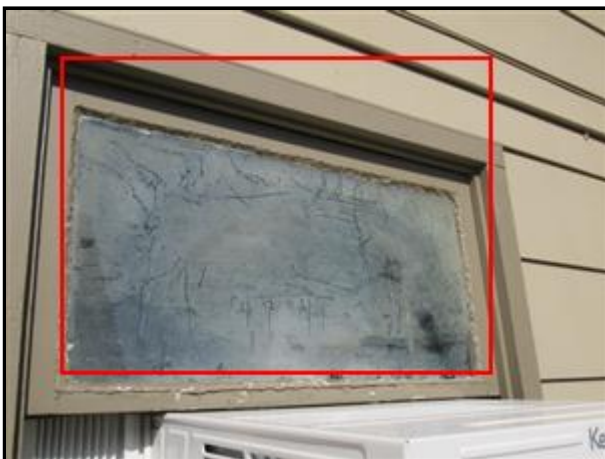
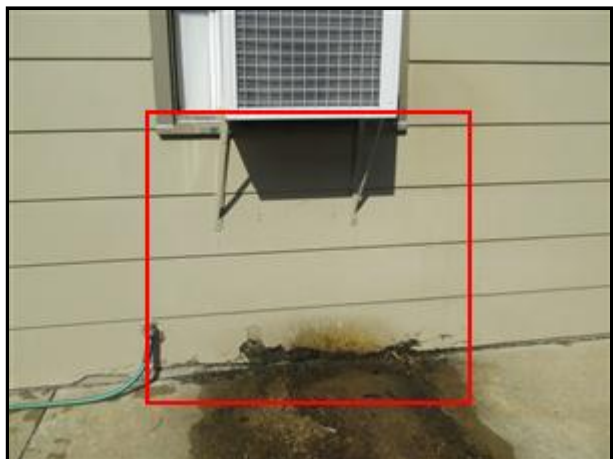
9.1 Picture 5 Window

9.1 Picture 6 Siding

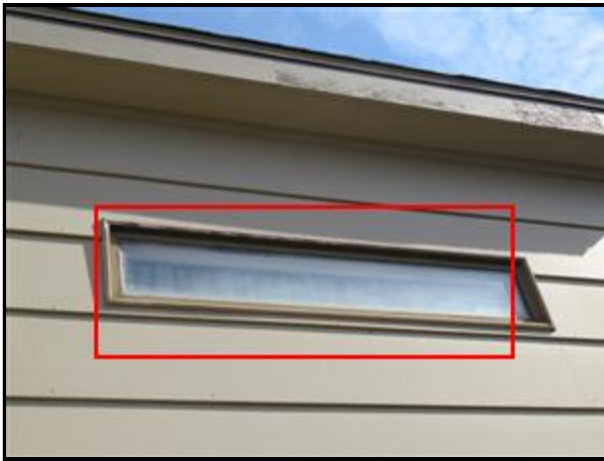
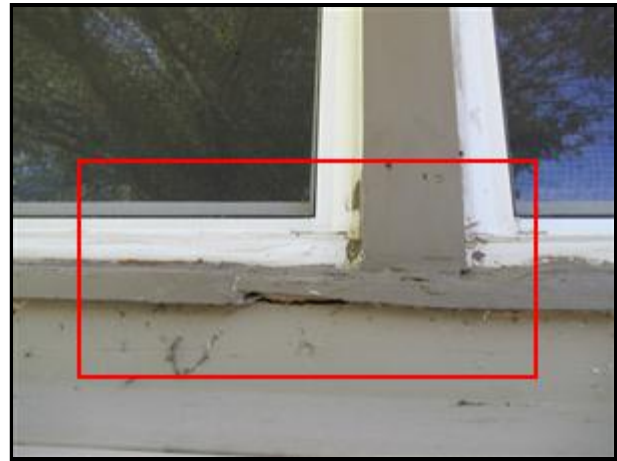
9.1 Picture 7 Window

9.1 Picture 8 Window Sill

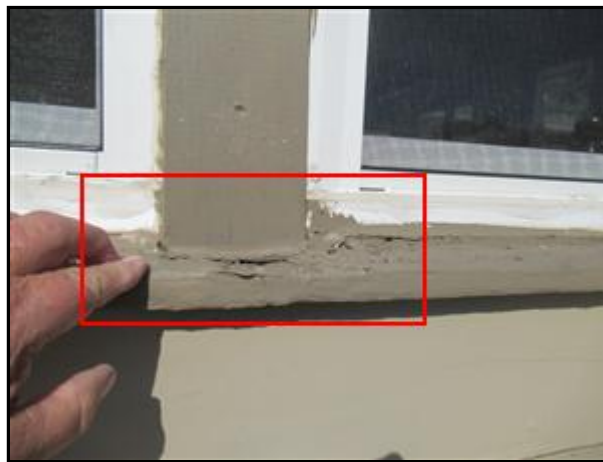
9.1 Picture 9 Window Sill

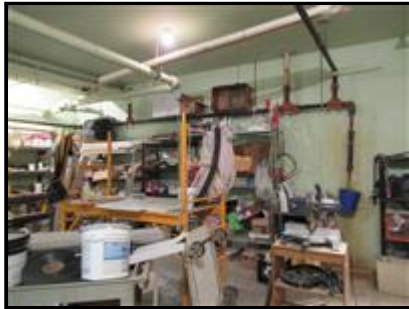
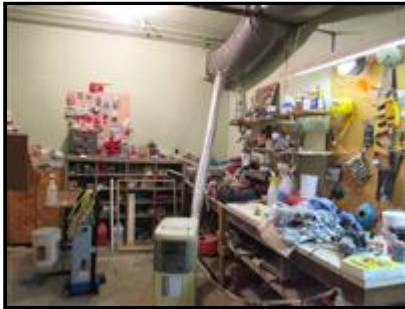
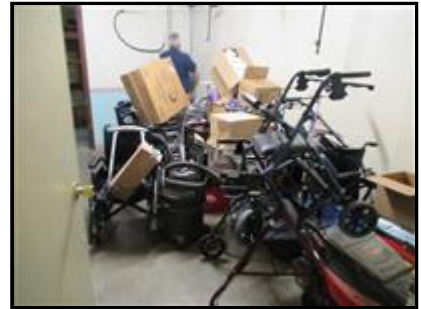
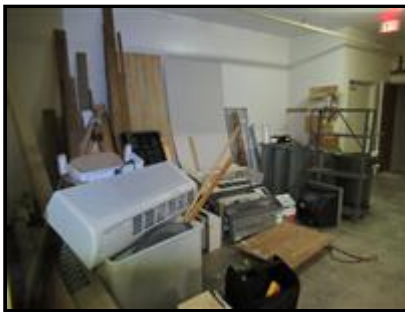
We were unable to fully view the foundation walls, structural components and floor slab(s) at all locations due to finish materials, storage and personal belongings. This prevents the inspector from seeing, testing or having access to every area or component. In brief, it prevents the inspector from accessing and checking everything. Concealed defects are not within the scope of our inspection. Along with defects that might not have been seen or noted due to such conditions, there may be deferred maintenance or items needing further evaluation, service or repair. We recommend that you do a careful check and a final walk-through of this area prior to closing.

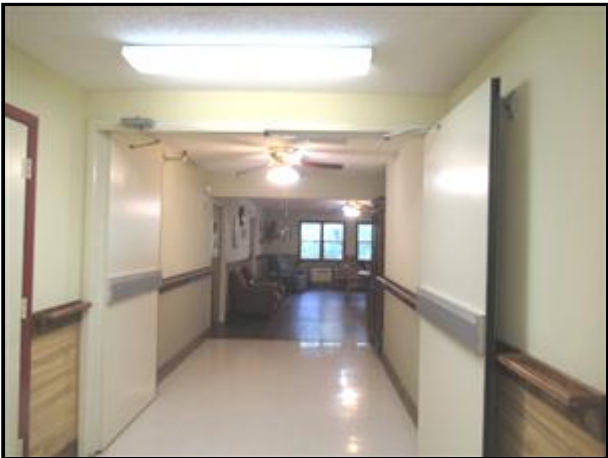
11.1 Picture 6 Main Hall / Front to Back

(2) We noted cracks, moisture stains, holes in ceiling tiles or drywall or movements that in our opinion are consistent with the use and function of the component, and not uncommon for a building of this age.

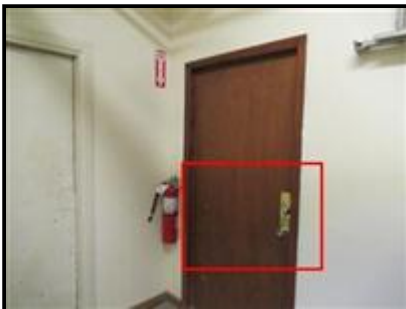
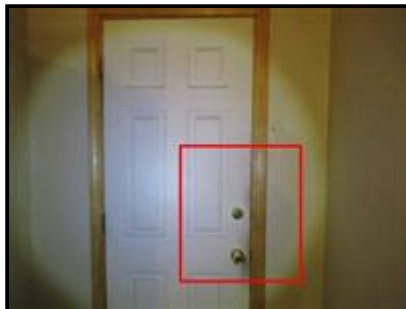
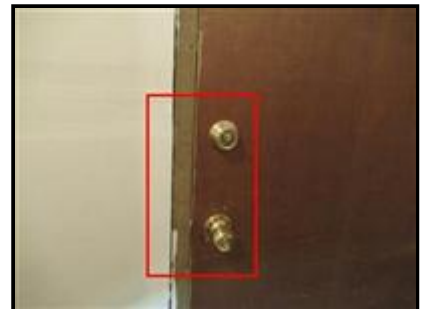
(3) There were several locked doors at the basement and main level. We did not gain entry to those rooms.

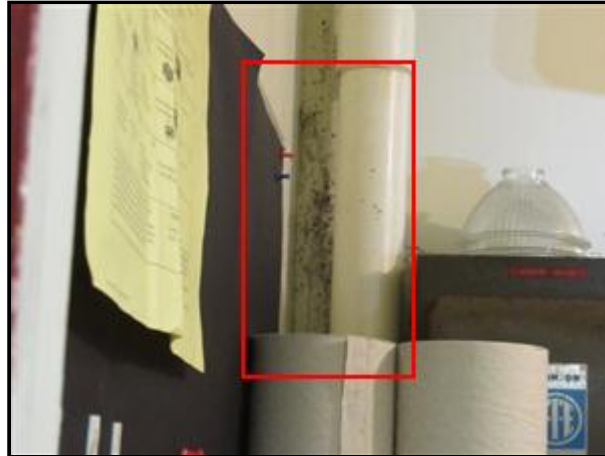
There were visual indications that indicate the presence of mold in the building at some areas like in the various areas. A competent mold or indoor air quality specialist can provide further testing or evaluation for you to determine what types of mold (allergenic or toxic) which can tell you the type of cleanup or remediation required.

13.6 Picture 1 Mold / Chemical Store Room

The cost of doing this is unknown to us, so you should consult with a contractor to determine the exact costs prior to the end of your due diligence period. In our opinion we would anticipate mold testing on a building that size could start at \$500 - \$750 and go up depending on whether you tested 1-2 areas OR the entire building. Mold cleanup or remediation can exceed \$3,000.

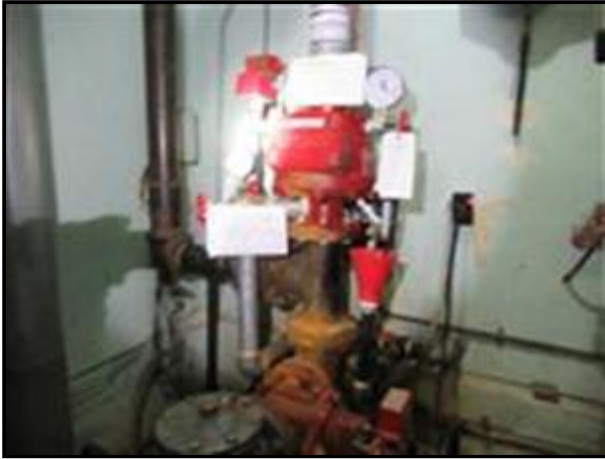
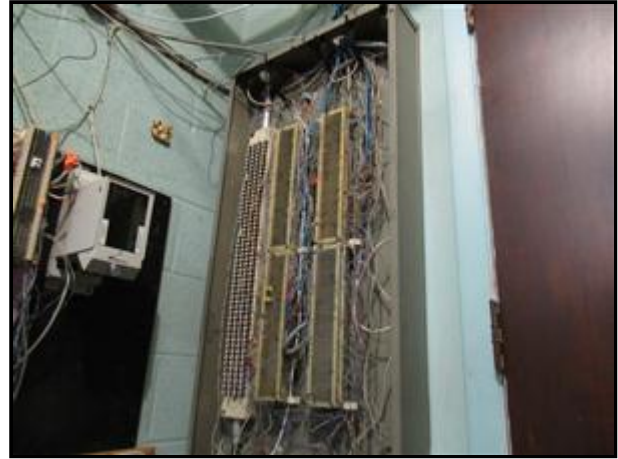
(6) **SPECIAL SYSTEMS:** Under the **SoP** (Standards-of Practice) for our inspections, Specialized Systems like these are excluded and **NOT** inspected as part of the General Inspection. We **DID NOT** inspect these.

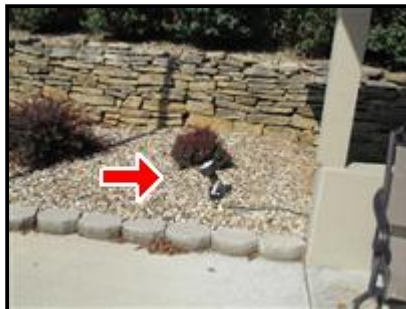
(7) Under the **SoP** (Standards-of Practice) for our inspections, landscape OR other low voltage outside lighting are excluded and **NOT** inspected as part of the General Inspection. We **DID NOT** inspect any landscape OR other low voltage lighting on the property.

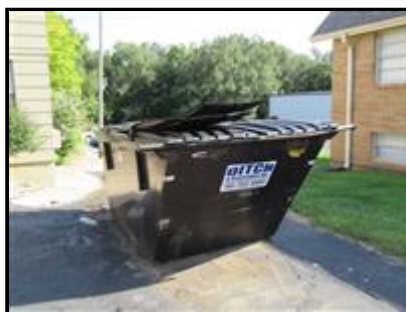
We saw a trash dumpster at the side of the parking lot. Ask seller to verify about trash pick-up schedules and if this is a public or private service.
