Inspection Report

Property Address:
330 & 332 SE Somewhere
Lee's Summit MO 64063

Holmes Inspection Company

Date: 7/30/2013	Time: 09:36 AM	Report ID: 42785 - 346
Property: 330 & 332 SE Somewhere Lee's Summit MO 64063	Customer: Nancy Buyer

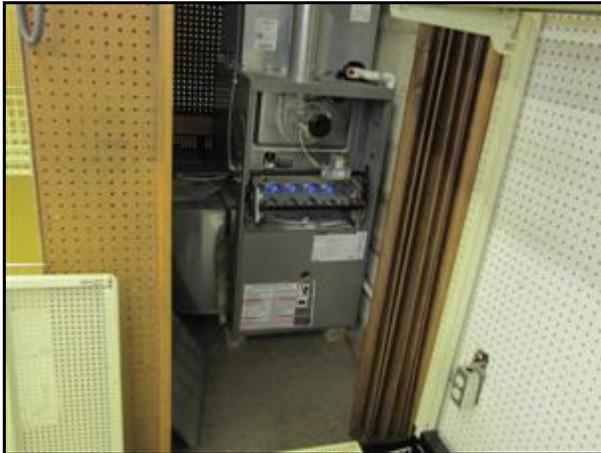
3.1.B Picture 3 South Wall

(2) Both units were running and heating. Service both units and check operation, controls, etc.

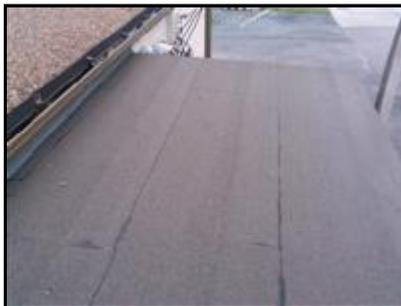
6.0.B Picture 2

(2) Rear attached shed roof #332 (modified bitumen)

The general condition appears serviceable with signs of weathering or aging. Regular maintenance and inspection is advised to achieve continued service.

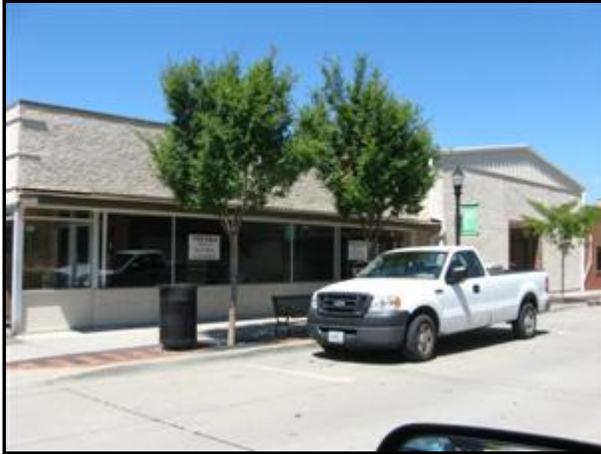
#332 is on Left / #330 is on Right in Pic #1

7.1 Picture 1 Front of 332 & 330

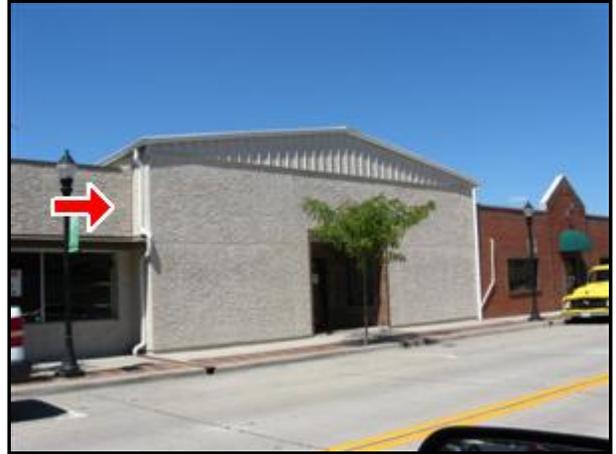
7.1 Picture 2 Front of #330

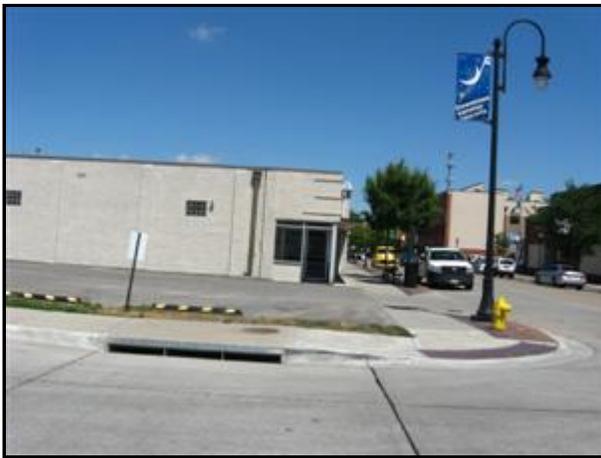
7.1 Picture 3 South Side #332 & Parking Lot

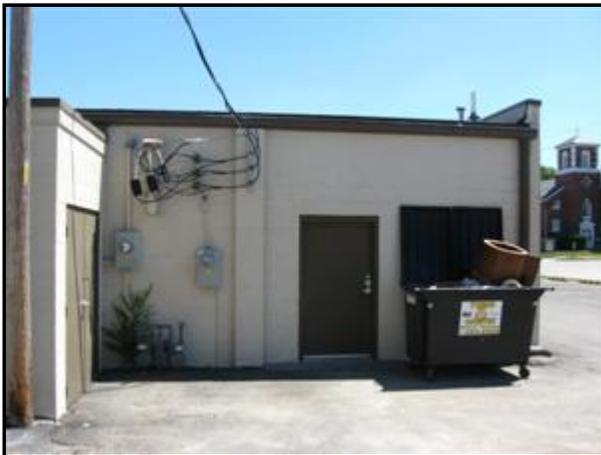
7.1 Picture 5 Rear of #332

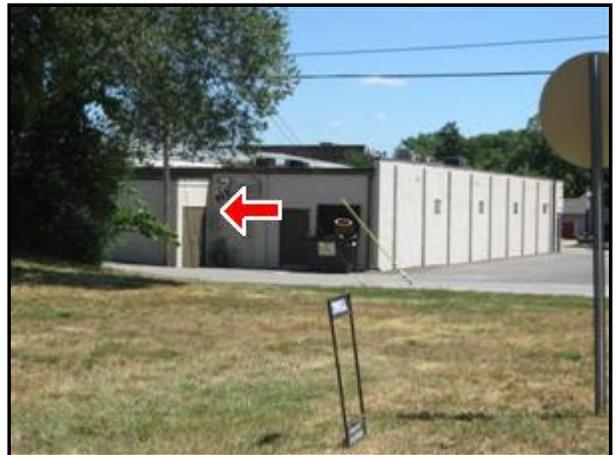
7.1 Picture 6 Store Shed Behind #332

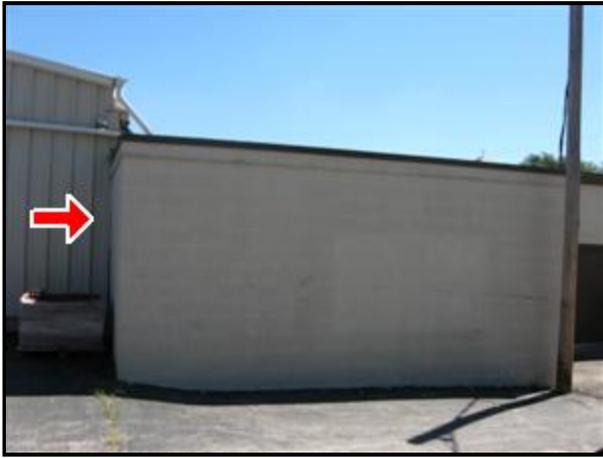
7.1 Picture 7 Back of Store Shed at #332

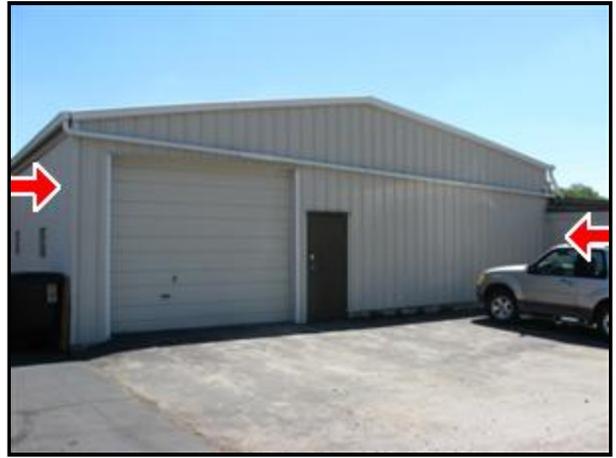
7.1 Picture 8 Rear of #330

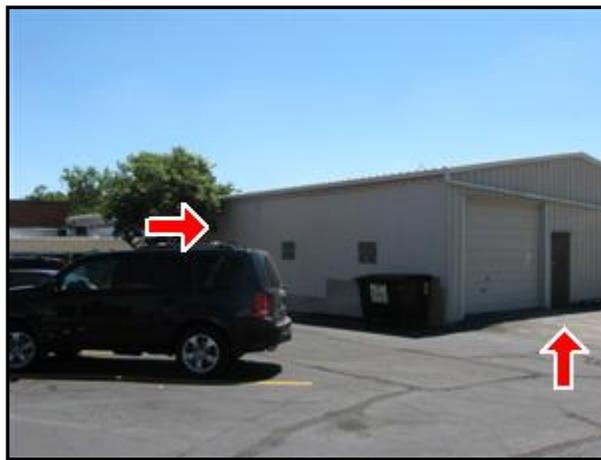
7.1 Picture 9 North & West Wall #330

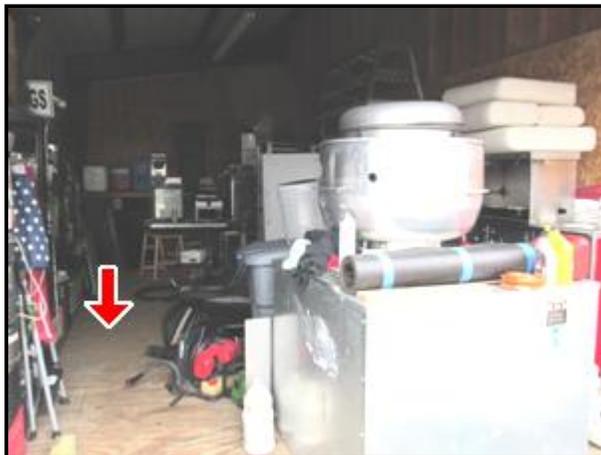
10.0.A Picture 1

The structure was being used which obstructs our examination of this area. The garage floor and footings were not fully visible due to personal belongings, shelving, boxes, heavy storage, etc which obstructs our examination of this area. This prevents the inspector from seeing, testing or having access to all areas or components. In brief, it prevents the inspector from accessing everything. Concealed defects are not within the scope of our inspection. Along with defects that we might not have seen or noted due to such conditions, there may be deferred maintenance or items needing further evaluation, service or repair that are present by the time escrow closes. We recommend that you do a careful check of the area at your final walk-through of this area prior to closing.

NOTE: part of the garage floor is NOT intended for driving on (It's Wood).

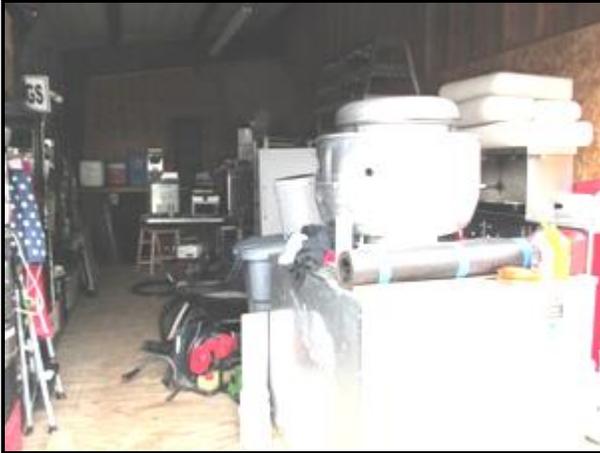
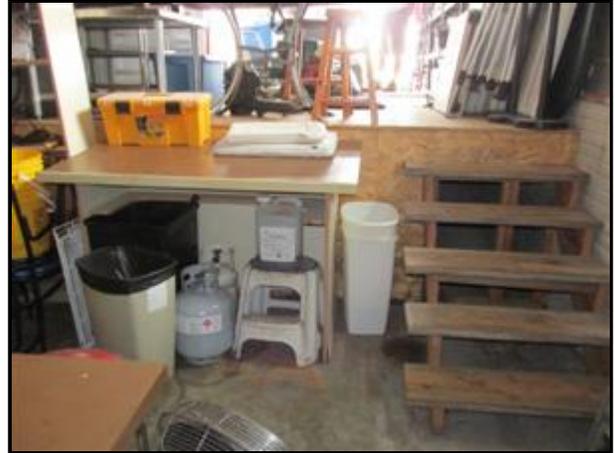
The structure was being used. which obstructs our examination of this area. The garage walls and/or ceiling are partially covered by surface finishes. The garage walls and/or ceiling were not fully visible due to personal belongings, shelving, boxes, heavy storage, etc which obstructs our examination of this area. This prevents the inspector from seeing, testing or having access to all areas or components. In brief, it prevents the inspector from accessing everything. Concealed defects are not within the scope of our inspection. Along with defects that we might not have seen or noted due to such conditions, there may be deferred maintenance or items needing further

evaluation, service or repair that are present by the time escrow closes. We recommend that you do a careful check of the walls and/or ceiling at your final walk-through of this area prior to closing.

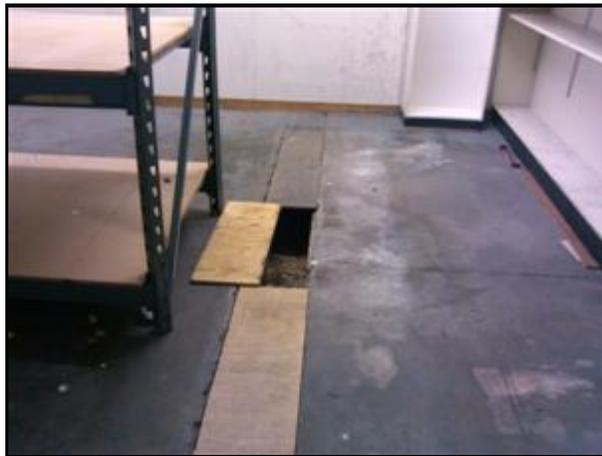
11.6 Picture 1 Trench Drain.

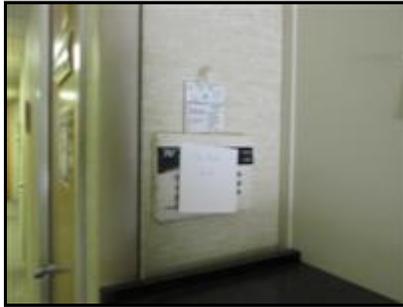
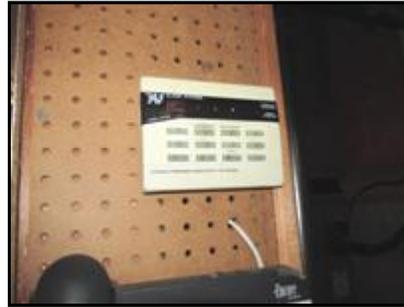
(2) **ALARMS:** An alarm or security system of some type was present in both units. We are not specialists in these type of systems and **DID NOT** perform any analysis, operation or other type testing on the system. Consultation and evaluation by a competent and licensed specialist in security systems can provide information or testing of the system to verify the operation and proper function of the system and its components.
