HOLMES INSPECTION CO.

Re: General Building Inspection
3456 – 3460 Older Street
Kansas City, MO

COMMERCIAL BUILDING(S)

3456 – 3460 OLDER STREET

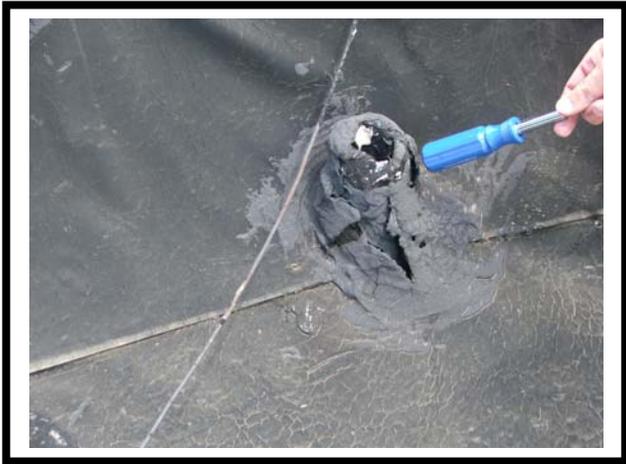
Photo 15 – Flashing Not Visible – Heavily Caulked Over - Separation/Gaps in Flashing

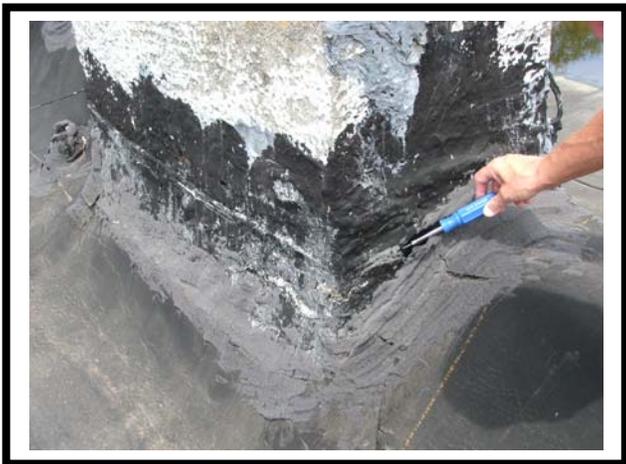
Photo 17 – No Flashing Visible - Heavily Caulked Over - Separation/Gaps at Chimney

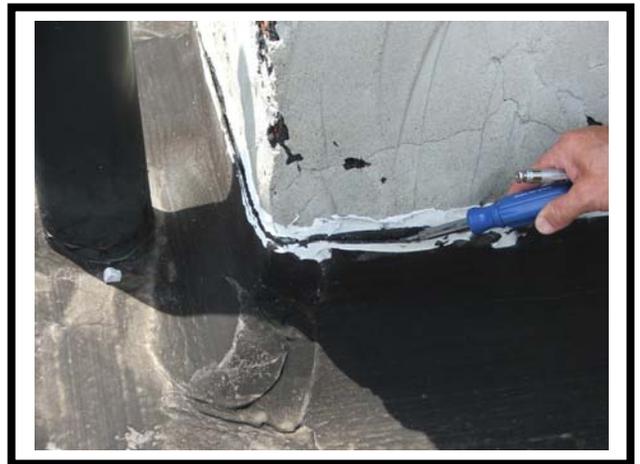
Photo 18 - Separation/Gap by Flashing Area

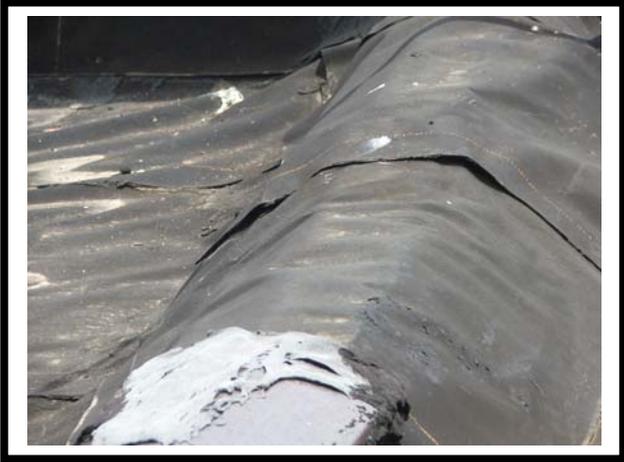
Photo 19 – Open Seams at Parapet Walls

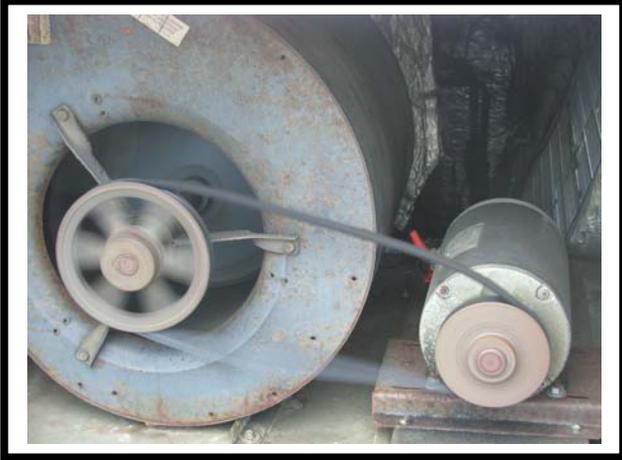
There was 1 Package HVAC unit (photo #40) on the roof over the Mexican Shop (3704/3706). Its data tag indicated it was a Goodman brand and could provide both heating/cooling. This could be hard to do without gas service. The condensate line was broken off and draining onto the roof (photo #38); the blower belt was loose and it had exposed wire splices (photo #39); the electrical disconnect was falling off, corroded, leaking water (photo #41); and the utility line penetrations to the business below was open and can leak water (photo #42). The unit has 2 fans and 2 compressors. Both fans were running, but only 1 compressor was operating on a hot day. We believe the unit to be at least 15-16 years old.

Photo 39 – Blower Belt Loose – Exposed Electrical Wire Splices on Goodman Unit in Photo #38

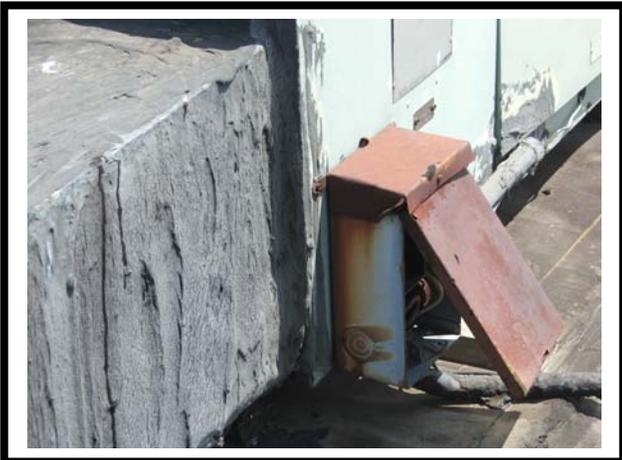
Photo 41 – Rusted / Corroded A/C Panel on Roof was Falling Off and Leaking Water

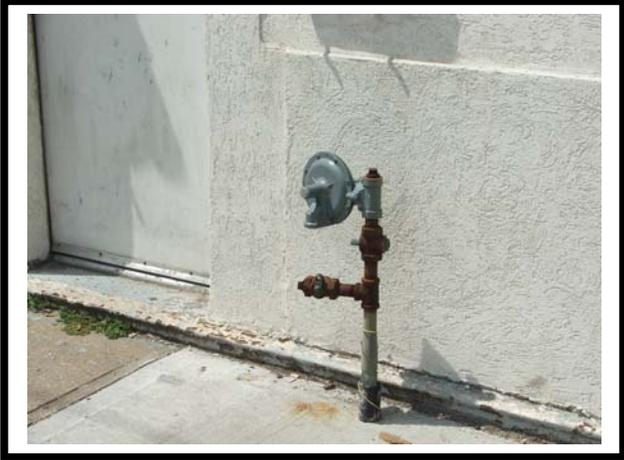
Photo 49 – Gas Lines at Front of Building on Sidewalk Capped Off & Gas Meter Missing. Is There Gas into The Buildings ???

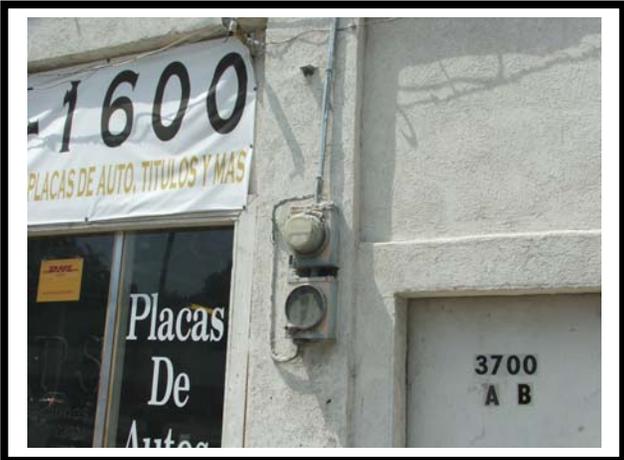
The electrical service to the building enters thru overhead service. There were multiple electrical meters and disconnects present outside that we could see. They were not marked as to where they went or what they control. There was 1 electrical meter at the sidewalk area on the front of the building by the door leading to the upper level apartments (**photo #51**). There was another meter on the front of the building by the Saigon Store & Mexican Shop (**photo #54**). There were 2 electrical meters and a 100 Amp fuse disconnect panel on the outside wall on the west side of Bldg 3700 (**photo #52**). There was 1 electrical meter and 2 disconnect panels on the west side of Bldg 3700 that were behind foliage, and behind a locked fence (**photo #53**). Their size and type is unknown. There may be another meter back behind the bushes. There was a main electrical disconnect inside the locked fence at the rear of the building. We accessed it from being on the roof and raising the cover. It is a newer looking 100 Amp fuse box with copper wiring.

Photo 51 – Electrical Meter on Wall Outside Front Door to Upper Level Apartments. Not Marked as to who or What it Controls

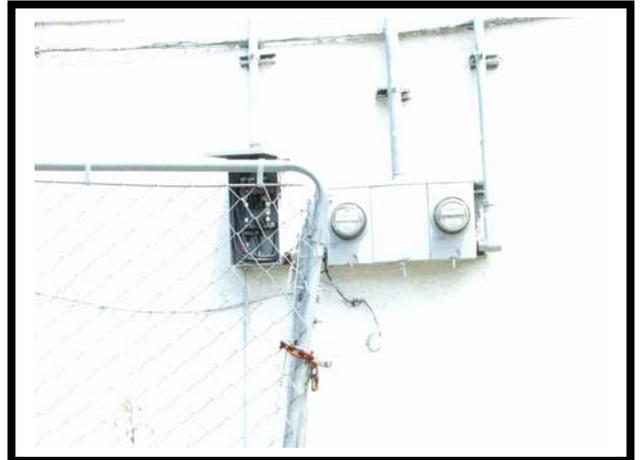
Photo 52 – Two Meters & One Disconnect Panel on West Side of “Servicios Latinos” Bldg. Not Marked as to What they Control

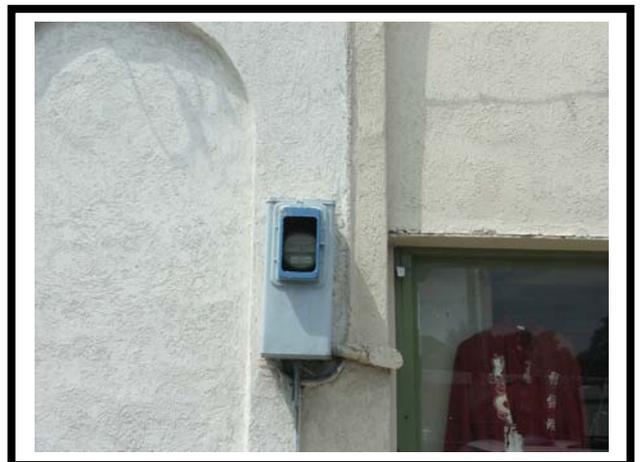
Photo 54 – Meter on Front Wall Facing Street – By Saigon Store and Mexican Restaurant – Not Marked Whose it Is

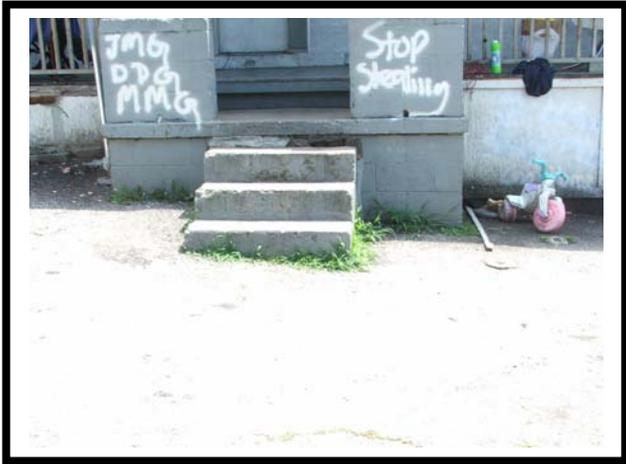
Photo 55 – Uneven Step Height at Rear Pkg Lot up to the Apts. No Handrail at Steps

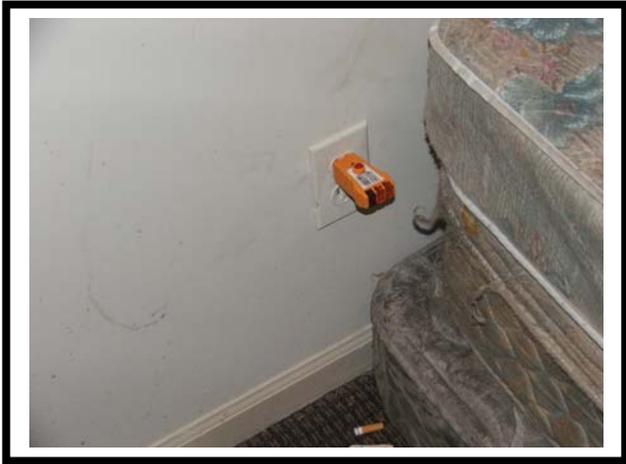
Photo 13 – Bedroom outlet was dead.

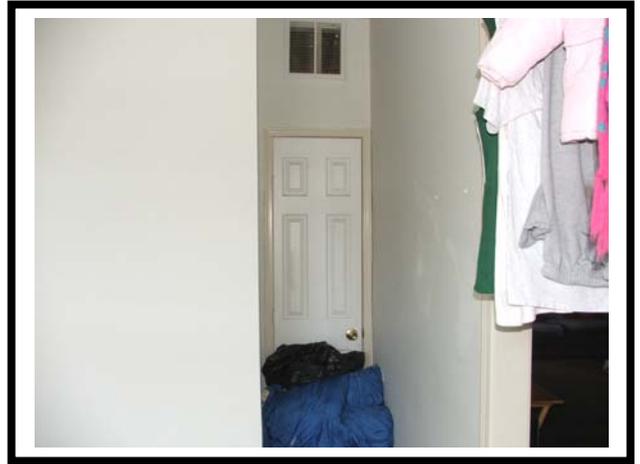
Photo 14 – Door to furnace was blocked.
Not viewed or inspected.

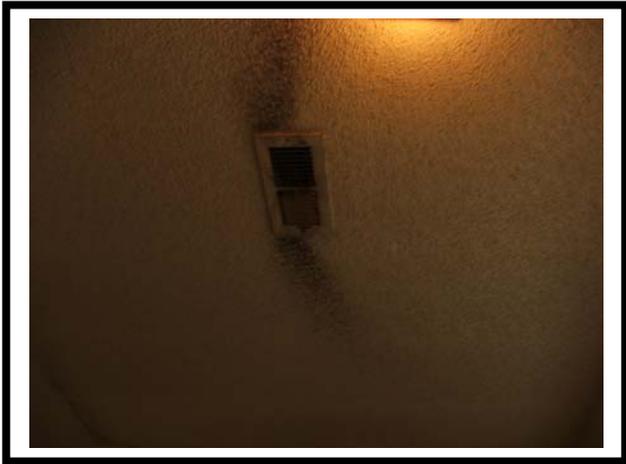
Photo 15 – Old soot or ??? marks at the
ceiling register by kitchen.

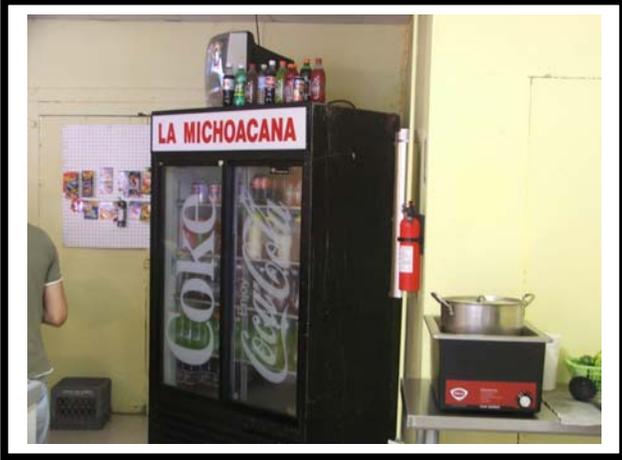
Photo 21 – Soda cooler blocks the electrical sub-panel and electric water heater behind it. They were not inspected.

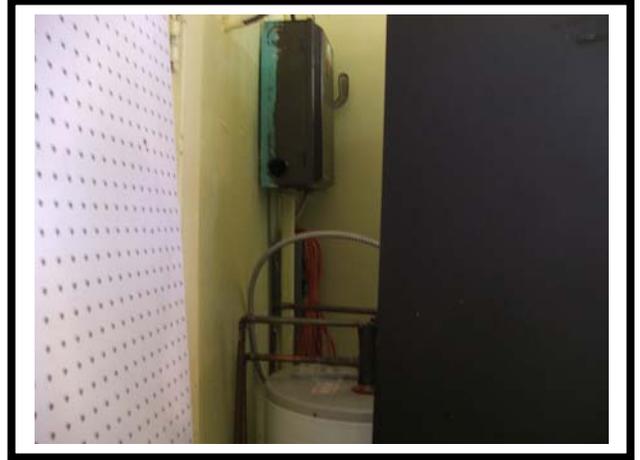
Photo 22 – Sub-panel & water heater. Can't get to them to access or inspect them.

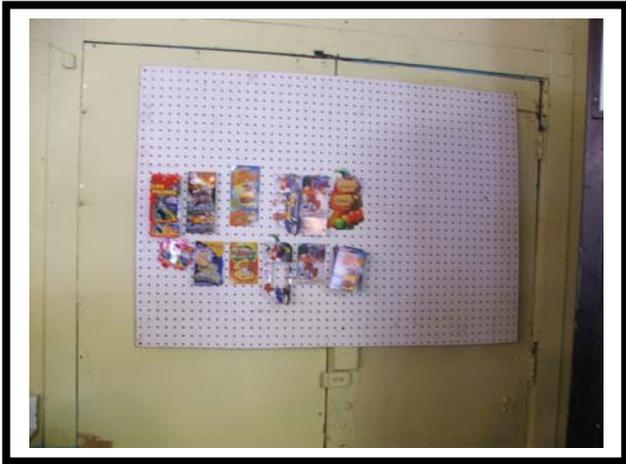
Photo 27 – Doors stick and pegboard nailed over them. Tenant thinks this may be access to cellar / crawlspace area. Not accessed.

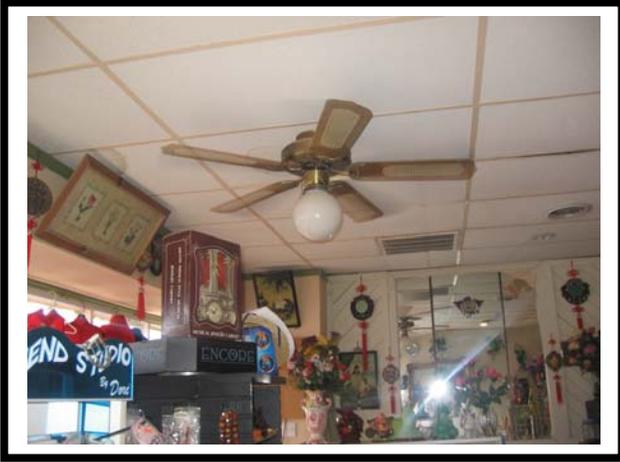
Photo 31 – A/C's not working. They're using ceiling fans to cool building.

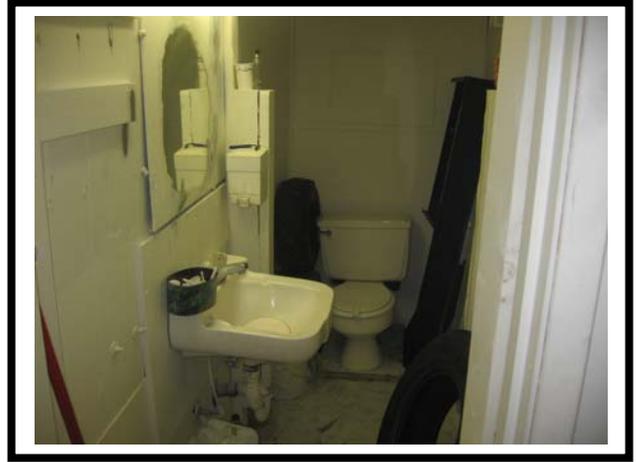
Photo 32 – There is no hot water to sink. Faucet steadily drip. Vent fan not working.

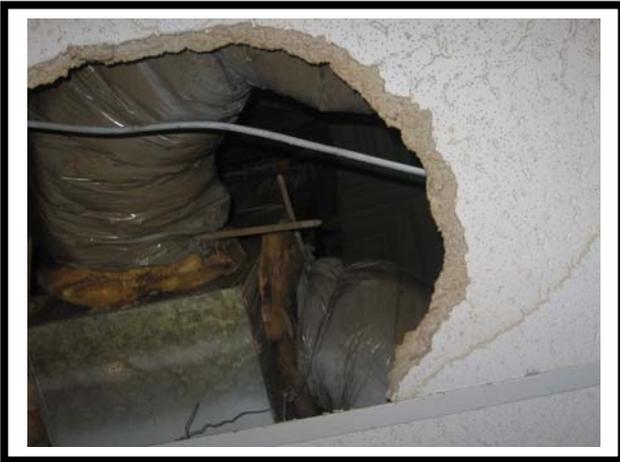
Photo 33 – Roof leak at ceiling area under A/C unit ducting, etc.

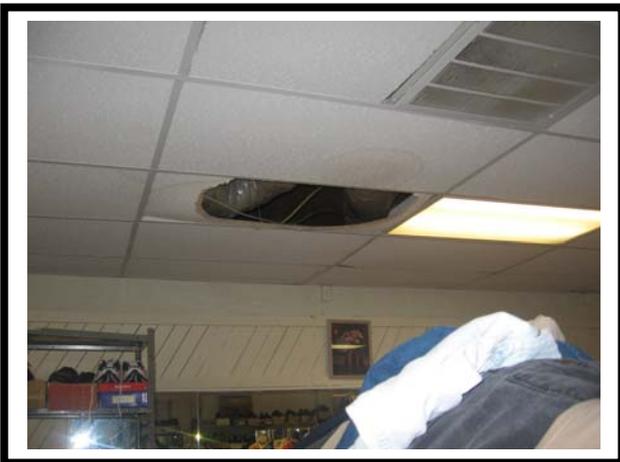
Photo 35 – Water damage and mold - from roof leaking above.

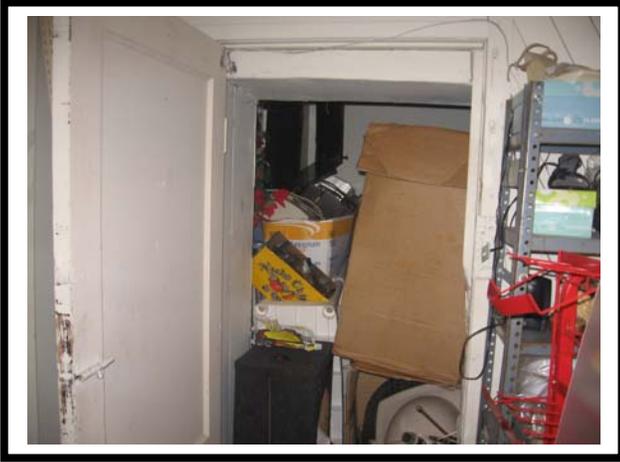
Photo 37 – Storage room access blocked. The room / area inside not seen or inspected.

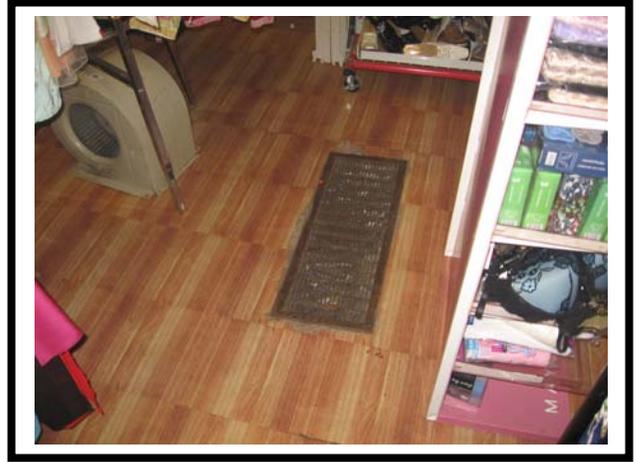
Photo 38 – The floor grate opening was covered from underneath and not in use.

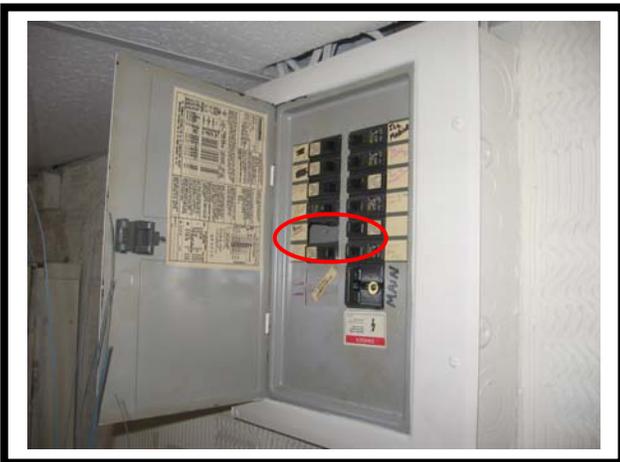
Photo 41 – Unsealed openings in panels at both main and sub-panel.

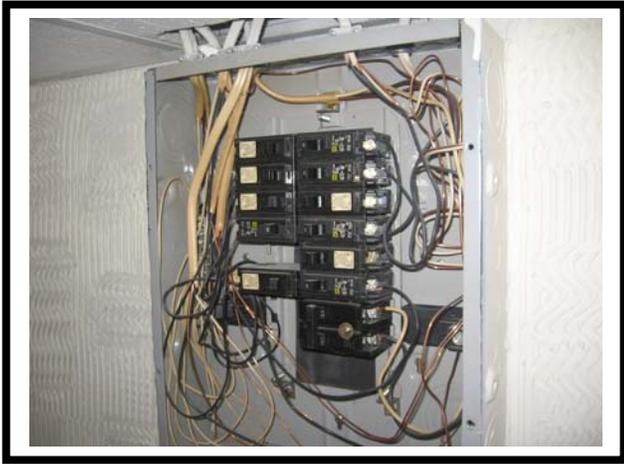
Photo 43 – Sub-panel has ground & neutral wires mixed and breakers oversized for the wire circuits they control. Safety issue.

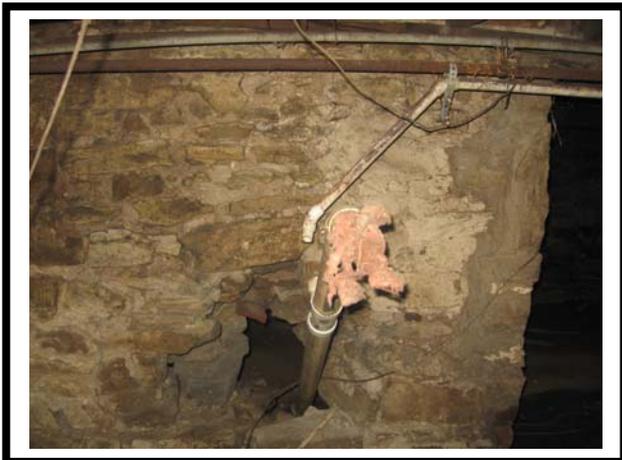
Photo 51 – Open drain lines in crawlspace.

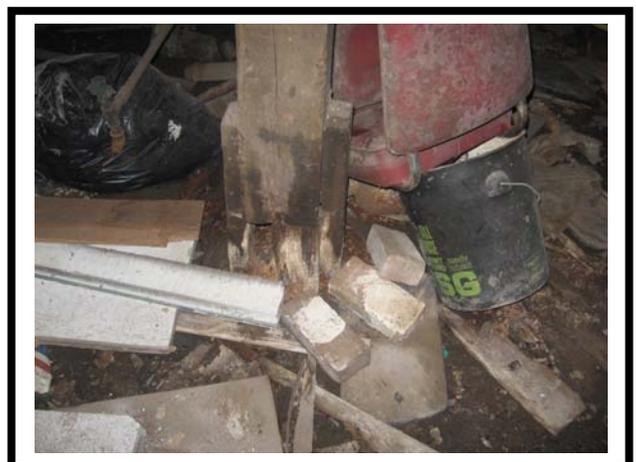
Photo 54 – The base of the main support post in crawlspace is rotted out.

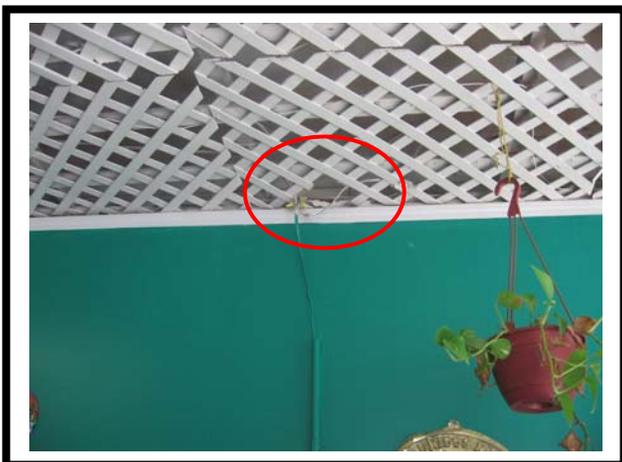
Photo 59 – Exposed wire splices and exposed wiring (should be in conduit).
